ARCHITECT'S FIELD REPORT

008

PROJECT **Eagle's Nest Townhouses** **DATE** 6/28/10
 11 Morning Glory Way & 31 Marcellina Lane
 Mt. Crested Butte, CO 81225

| WORK OBSERVED |
|---|
| Observations of moisture in crawlspaces – week number 5 |

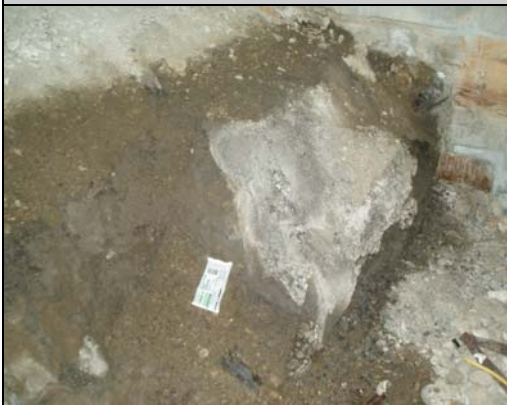
| PHOTO -WORK ITEM | DESCRIPTION | ACTION |
|---|--|---|
| | <p>6/28/10 – Photo 1a Unit 10</p> <p>Area of moisture in bedrock appears consistent. No dripping or running water noted.</p> | <p>None</p> |

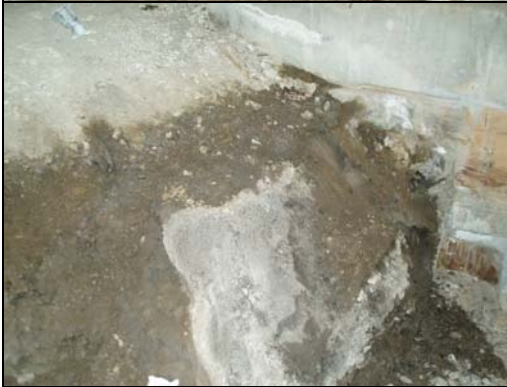
| PHOTO -WORK ITEM | DESCRIPTION | ACTION |
|---|--|---|
| | <p>4/15/10 – Photo 1b Unit 10</p> <p>Comparison photograph from Field Report 05 – April 15th.</p> | <p>None</p> |

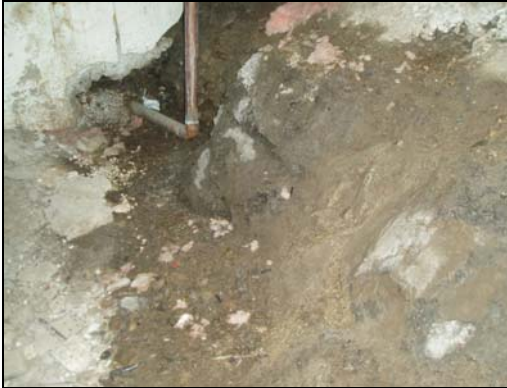
| PHOTO -WORK ITEM | DESCRIPTION | ACTION |
|---|--|---|
| | <p>6/28/10 – Photo 2a Unit 10</p> <p>Moisture in bedrock – unchanged from Field Report 07.</p> | <p>None</p> |

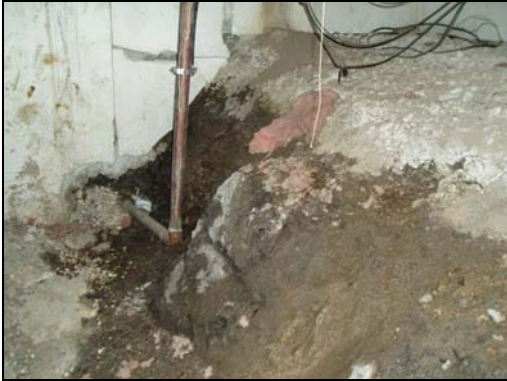
| PHOTO -WORK ITEM | DESCRIPTION | ACTION |
|---|--|---|
| | <p>4/15/10 – Photo 2b Unit 10</p> <p>Comparison photograph from Field Report 05 – April 15th.</p> | <p>None</p> |

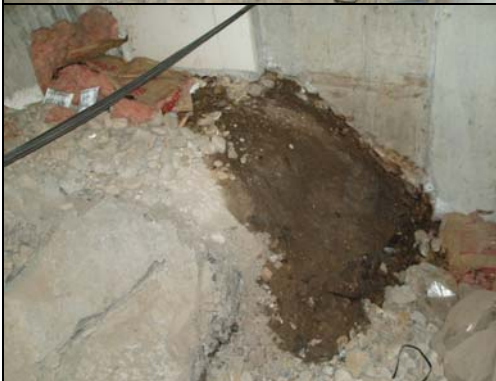
| PHOTO -WORK ITEM | DESCRIPTION | ACTION |
|---|--|---|
| | <p>4/15/10 – Photo 3b Unit 9</p> <p>Comparison photograph from Field Report 05 – April 15th.</p> | <p>None</p> |

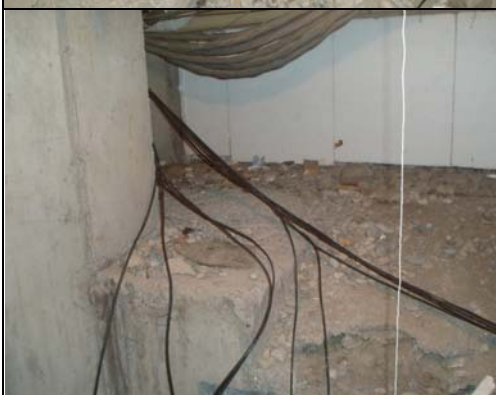
| PHOTO -WORK ITEM | DESCRIPTION | ACTION |
|---|--|---|
| | <p>6/28/10 – Photo 4a Unit 9</p> <p>Elevated area in southwest corner consistently dry.</p> | <p>None</p> |

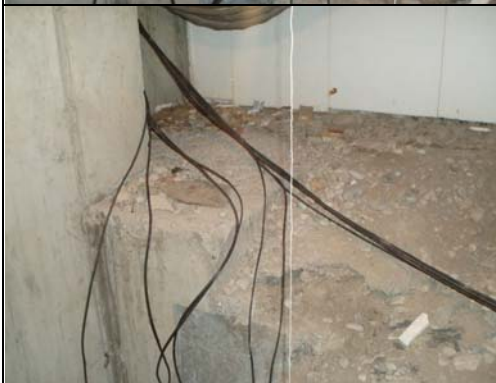
| PHOTO -WORK ITEM | DESCRIPTION | ACTION |
|---|--|---|
| | <p>4/27/10 – Photo 4b Unit 9</p> <p>Comparison photograph from Field Report 06 – April 27th.</p> | |

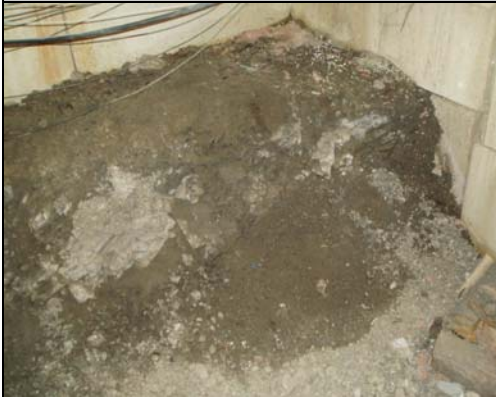
| PHOTO –WORK ITEM | DESCRIPTION | ACTION |
|---|---|---|
| | <p>6/28/10 – Photo 5a Unit 17</p> <p>Moisture in crawlspace appears unchanged.</p> | <p>None</p> |

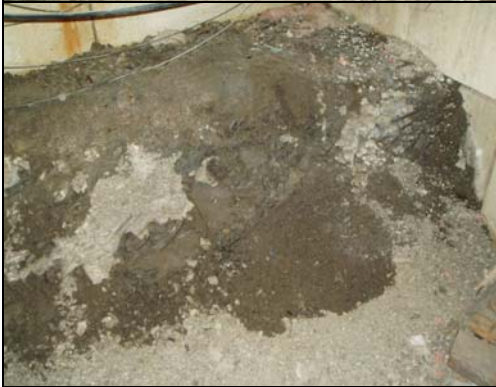
| PHOTO –WORK ITEM | DESCRIPTION | ACTION |
|---|---|---|
| | <p>4/15/10 – Photo 5b Unit 17</p> <p>Comparison photograph from Field Report 05 – April 15th.</p> | <p>None</p> |

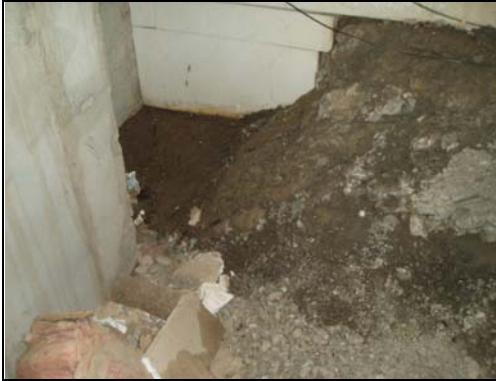
| PHOTO –WORK ITEM | DESCRIPTION | ACTION |
|---|---|---|
| | <p>6/28/10 – Photo 6a Unit 17</p> <p>No pooled water visible but moisture content appears to have increased. No flowing water at pipe penetration observed.</p> | <p>None</p> |

Surface mitigation techniques such as shallow foundation drains or drainage planes would likely have minimal effect on persistent moisture in the crawlspaces due to sub-surface drainage. It is recommended that sealing all pipe penetrations into the crawlspaces be included with any mitigation work.

B.) Seal all pipe penetrations into crawlspaces to prohibit water intrusion.

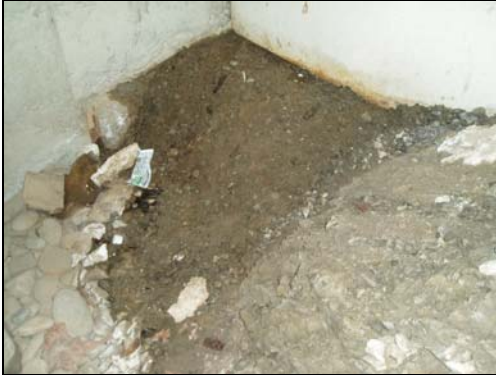
| PHOTO –WORK ITEM | DESCRIPTION | ACTION |
|---|---|---|
| | <p>4/15/10 – Photo 6b Unit 17</p> <p>Comparison photograph from Field Report 05 – April 15th.</p> | <p>None</p> |

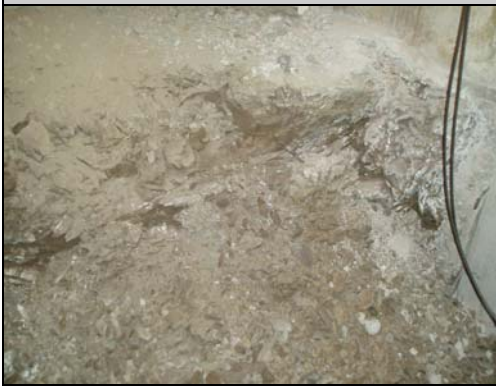
| PHOTO –WORK ITEM | DESCRIPTION | ACTION |
|---|---|---|
| | <p>6/28/10 – Photo 9a Unit 40</p> <p>North crawlspace appears consistently dry.</p> | None |

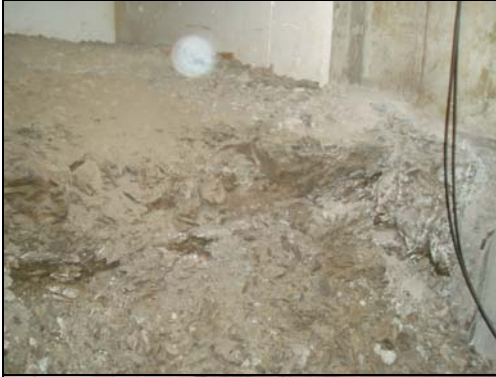
| PHOTO –WORK ITEM | DESCRIPTION | ACTION |
|---|---|---|
| | <p>4/15/10 – Photo 9b Unit 40</p> <p>Comparison photograph from Field Report 05 – April 15th.</p> | None |

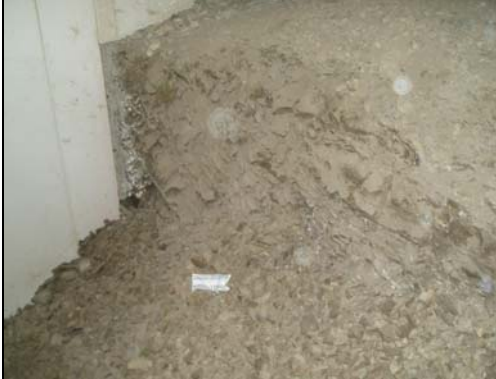
| PHOTO –WORK ITEM | DESCRIPTION | ACTION |
|---|---|---|
| | <p>6/28/10 – Photo 10a Unit 40</p> <p>Area of slight moisture evident in corner of step foundation. First appearance of moisture in Unit 40 since observations began.</p> | None |

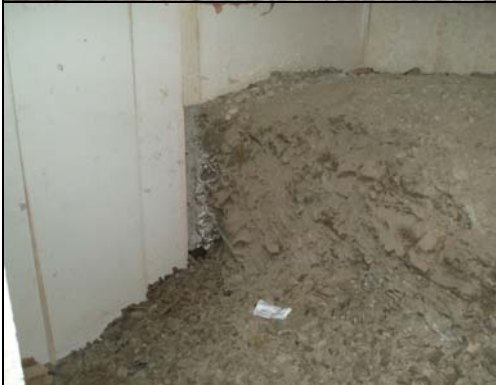
| PHOTO –WORK ITEM | DESCRIPTION | ACTION |
|---|---|---|
| | <p>4/27/10 – 10b Unit 40</p> <p>Comparison photograph from Field Report 06 – April 27th.</p> | None |
