ARCHITECT'S FIELD REPORT

012

PROJECT **Eagle's Nest Townhouses** **DATE** 8/10/10
 11 Morning Glory Way & 31 Marcellina Lane
 Mt. Crested Butte, CO 81225

WORK OBSERVED
Phase I – Construction Field Report 04
TRADES PRESENT
Holgate Construction

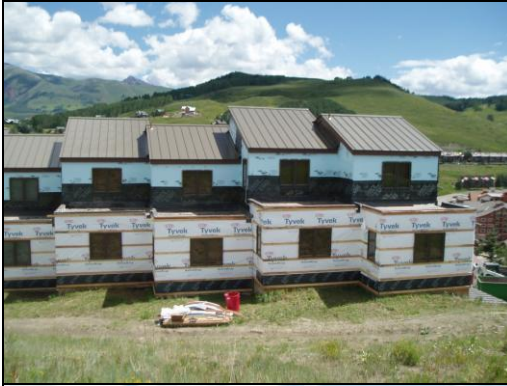
<p>8/10/10 – Photo 1 Units 1 through 4</p> <p>Note the Grace “Ultra” around the lower edge, 3rd floor. Tyvek house wrap overlaps the Ultra by approximately 12”. Ice & Water Shield waterproof membrane is installed on the 4th Floors.</p>	<p>None</p>

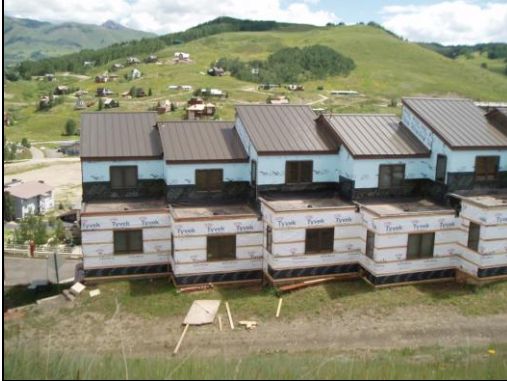
<p>8/10/10 – Photo 2 Units 5 through 8</p> <p>Waterproofing sag on Unit 8 has been repaired.</p>	<p>None</p>

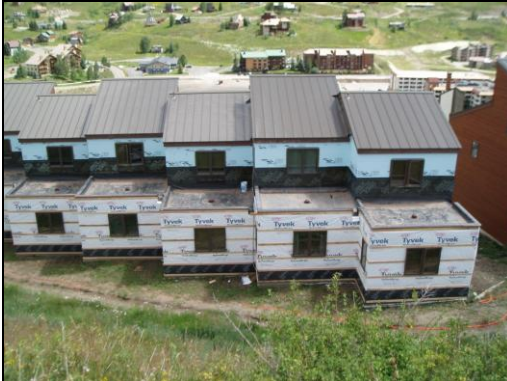
<p>8/10/10 – Photo 3 Units 9 through 12</p> <p>Please note the clean site conditions.</p>	<p>None</p>

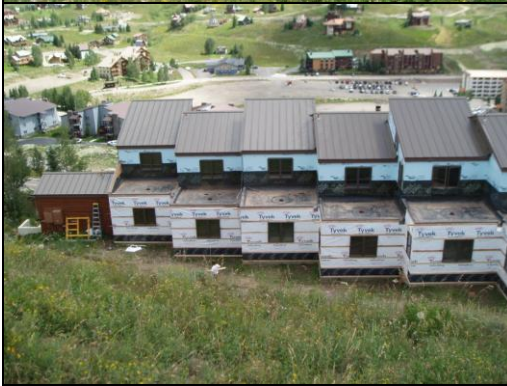
<p>8/10/10 – Photo 4 Units 13 through 16</p> <p>Furring strip installation is being completed on Unit 16.</p>	<p>None</p>

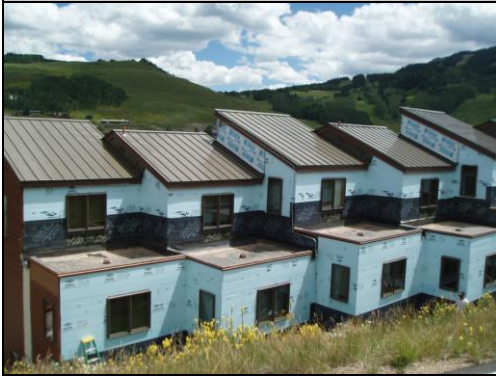
<p>8/10/10 – Photo 5 Units 17 through 20</p> <p>Note installation of Grace “Ultra” 32” up rear wall. (Black membrane on the blue rigid insulation.)</p>	None

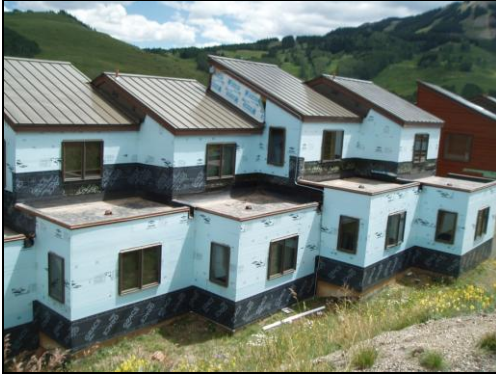
<p>8/10/10 – Photo 6 Units 21 through 24</p> <p>Photo clearly shows the Ultra waterproofing at the 3rd Floor and Ice & Water Shield at the 4th Floor.</p>	None

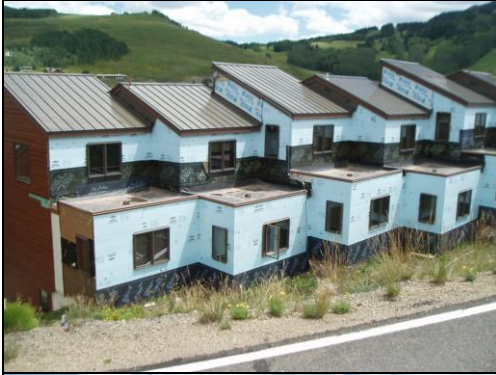
<p>8/10/10 – Photo 7 Units 25 through 28</p> <p>End conditions will be demolished and re-sided via scaffolding.</p>	None

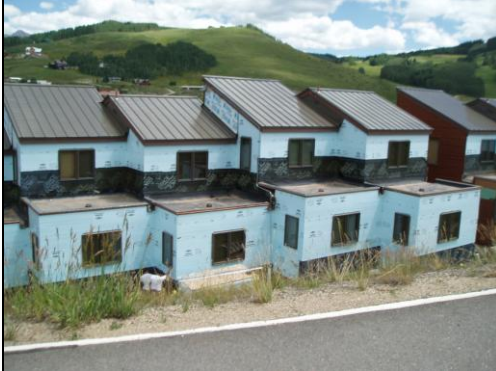
<p>8/10/10 – Photo 8 Units 29 through 32</p> <p>Ultra waterproofing being applied.</p>	None

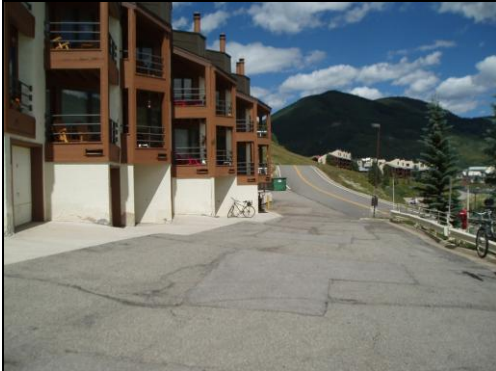
<p>8/10/10 – Photo 13 Lower Units Looking North</p> <p>Site is completely clean.</p>	<p>None</p>

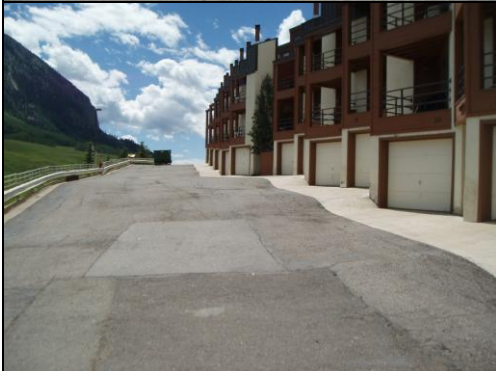
<p>8/10/10 – Photo 14 Lower Units Looking South</p> <p>Dumpster at south end is the only indication of construction work on the site.</p>	<p>None</p>

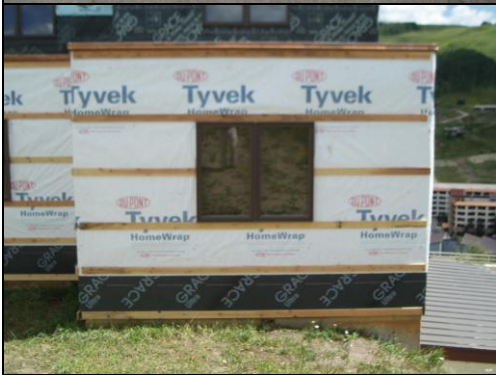
<p>8/10/10 – Photo 15 Unit 1 – Example Photo</p> <p>From top of photo – Ice & Water Shield at 4th Floor, Existing Parapet Cleat on existing wood blocking, Tyvek, horizontal furring strips, and Ultra at the bottom.</p>	<p>Non</p>

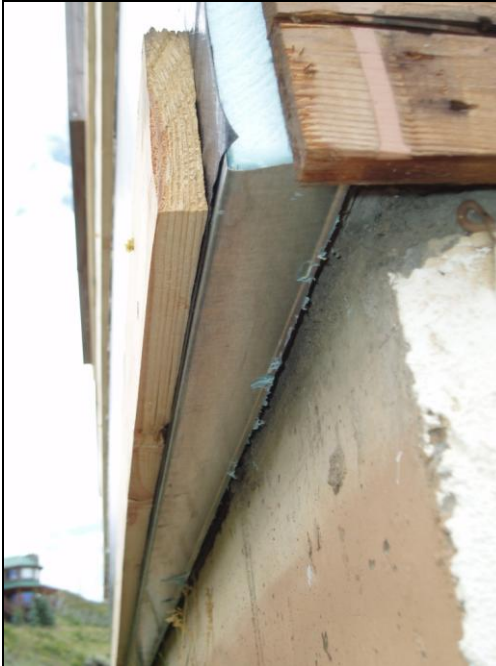
<p>8/10/10 – Photo 16 Unit 1 – Wall Assembly Example</p> <p>Note the horizontal wood furring strip holding the bottom edge of the Ultra. The Ultra waterproof membrane laps over the top of the metal flashing which protects the bottom edge of the rigid insulation.</p> <p>Existing siding (end unit condition) is seen in the top right hand corner.</p>	<p>None</p>

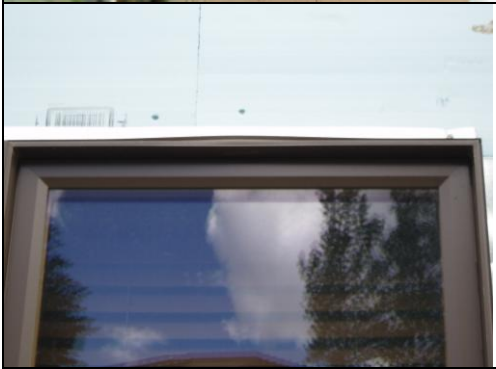
<p>8/10/10 – Photo 17 Unit 32, 3rd Level Rear Window</p> <p>Note the bowed window frame at the top of the window. Mick speculates this was caused by freezing water. Correct metal window flashing should prevent future damage.</p>	<p>None</p>
