ARCHITECT'S FIELD REPORT

092

PROJECT	Eagle's Nest Townhouses 11 Morning Glory Way & 31 Marcellina Lane Mt. Crested Butte, CO 81225	DATE	10/03/12
---------	--	------	----------

WORK OBSERVED	
Phase III Construction – Stone Installation	
TRADES PRESENT	
Rocky Mountain Masonry

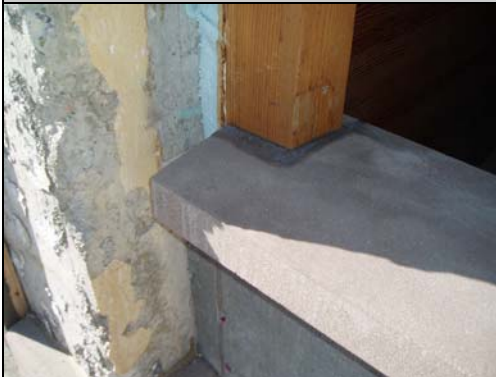
<p>10/03/12 – Photo 5 Upper Level Hot Tub</p> <p>Detail of cap at south column. Note: the cap is held back approximately 3" to allow the stone to pass behind.</p>	<p>Note</p>

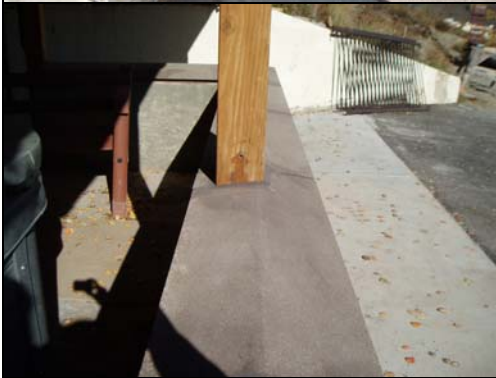
<p>10/03/12 – Photo 6 Upper Level Hot Tub</p> <p>Looking north along the top of the cap.</p>	<p>Note</p>

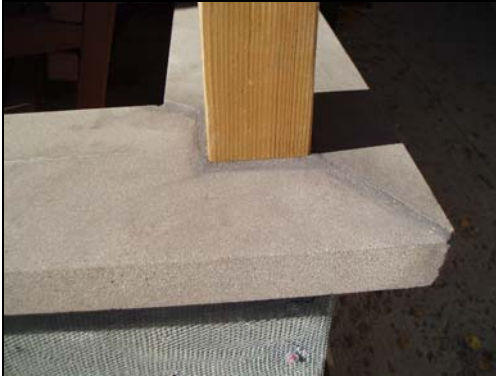
<p>10/03/12 – Photo 7 Upper Level Hot Tub</p> <p>Detail of the north corner of the cap.</p>	<p>Note</p>

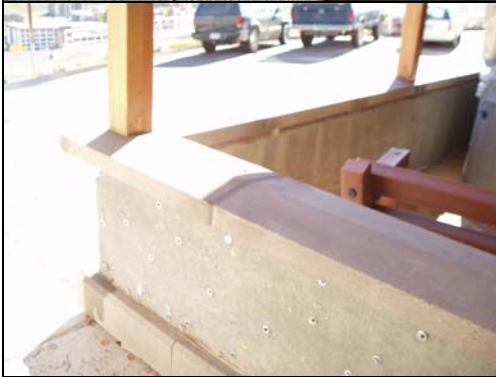
<p>10/03/12 – Photo 8 Upper Level Hot Tub</p> <p>Looking southeast at the precast cap.</p>	<p>Note</p>

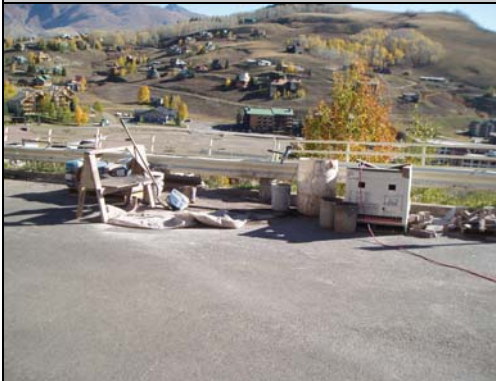
<p>10/03/12 – Photo 9 Upper Level Work Area</p> <p>Area is relatively well-kept and organized.</p>	<p>Note</p>

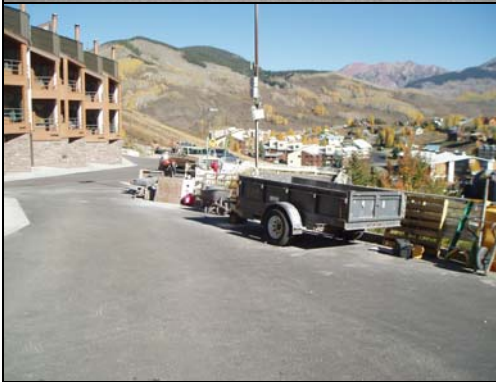
<p>10/03/12 – Photo 10 Upper Level Work Area</p> <p>Area is relatively well-kept and organized. Some minor clean-up remains.</p>	<p>Note</p>

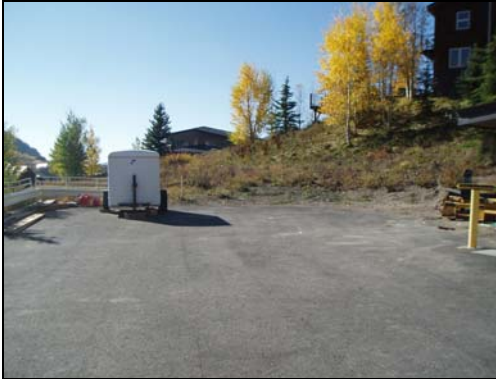
<p>10/03/12 – Photo 11 Upper Level Work Area</p> <p>The area is clean and well organized.</p>	<p>Note</p>
