**ARCHITECT'S FIELD REPORT**

**017**

**PROJECT**      **Eagle's Nest Townhouses**      **DATE**      9/17/10  
 11 Morning Glory Way & 31 Marcellina Lane  
 Mt. Crested Butte, CO 81225

WORK OBSERVED
Phase I – Construction Field Report 09
TRADES PRESENT
None – site visit performed after construction working hours.

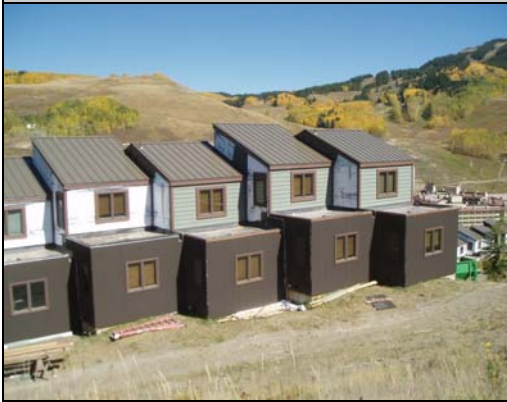
<p>9/16/10 – Photo 3 Units 1 through 4</p> <p>Horizontal steel siding is being installed.</p>	<p>None</p>

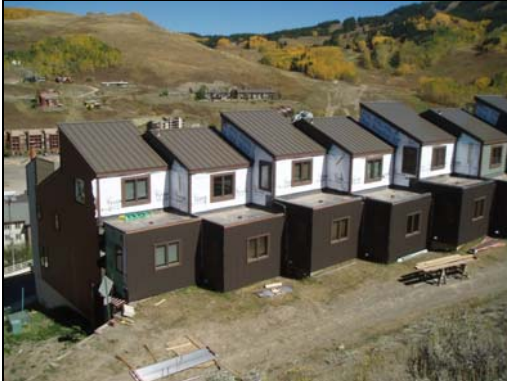
<p>9/16/10 – Photo 4 Units 5 through 8</p> <p>Corrugated Metal installation, except for corner trim, is complete. Units are ready for horizontal steel siding.</p>	<p>MHC</p>

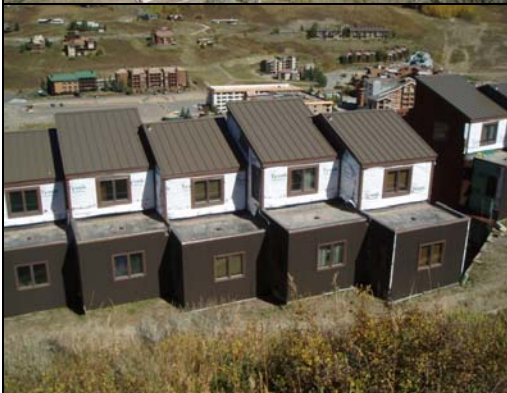
<p>9/16/10 – Photo 5 Units 9 through 12</p> <p>Corrugated Metal installation, except for corner trim, is complete. Units are ready for horizontal steel siding.</p>	<p>MHC</p>

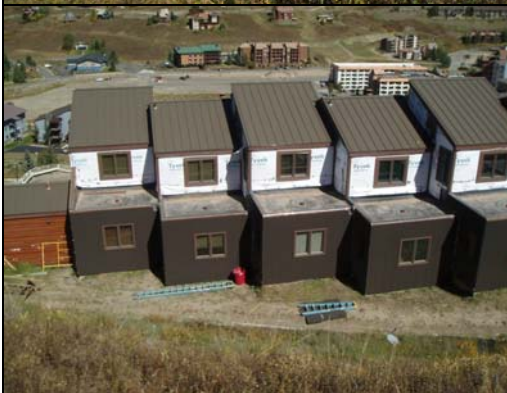
<p>9/16/10 – Photo 6 Units 13 through 16</p> <p>Corrugated Metal installation, except for corner trim, is complete. Units are ready for horizontal steel siding.</p>	<p>None</p>

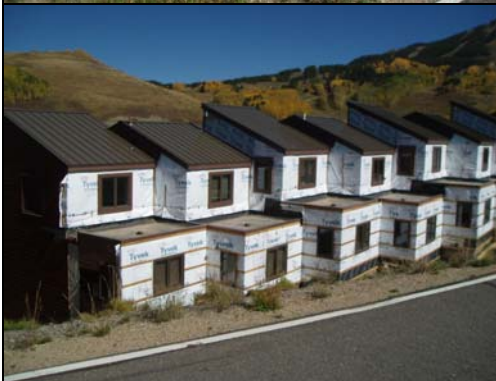
<p>9/16/10 – Photo 9 Units 25 through 28</p> <p>Wood window trim has been installed. Coax cable runs are complete. 3<sup>rd</sup> Floor J-Trim is in place. Units are ready for siding and corner trim.</p>	<p>None</p>

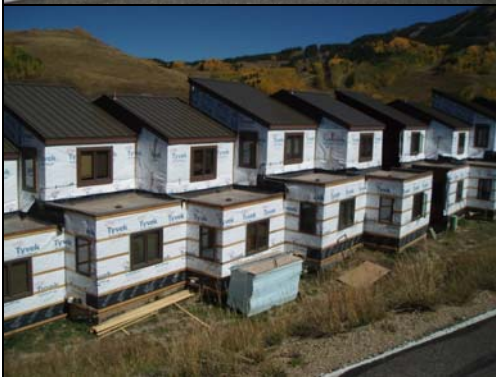
<p>9/16/10 – Photo 11 Units 29 through 32</p> <p>Wood window trim has been installed except Unit 31, 3<sup>rd</sup> Floor. Coax cable runs are complete. Units are ready for siding and corner trim.</p>	<p>None</p>

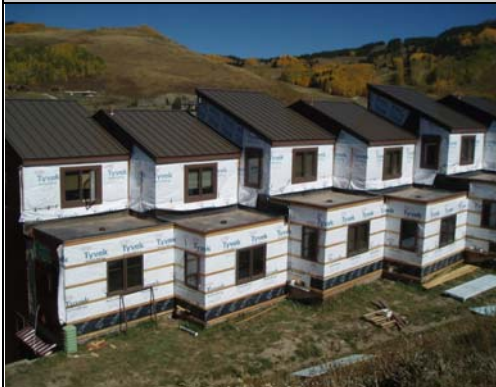
<p>9/16/10 – Photo 11 Units 33 through 36</p> <p>Wood window trim has been installed. Coax cable runs are complete. Units are ready for siding and corner trim.</p>	<p>None</p>

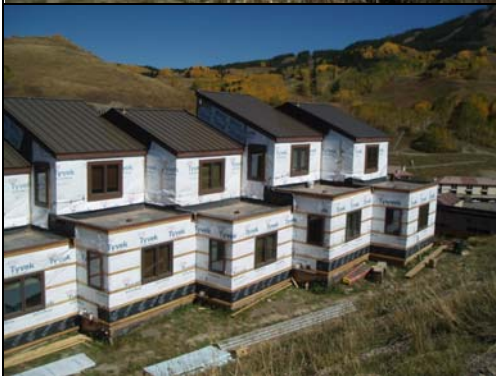
<p>9/16/10 – Photo 12 Units 37 through 40</p> <p>Wood window trim has been installed. Coax cable runs are complete. Units are ready for siding and corner trim.</p>	<p>None</p>

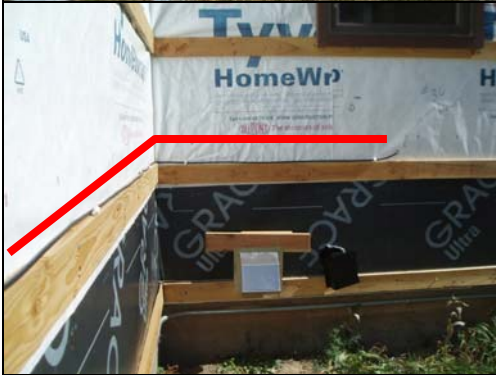
<p>9/16/10 – Photo 13 Unit 30</p> <p>Note: “Red” marker line follows coax cable installation on top side of wood furring strips. Coax is attached approximately every 3’-0”.</p>	<p>None</p>

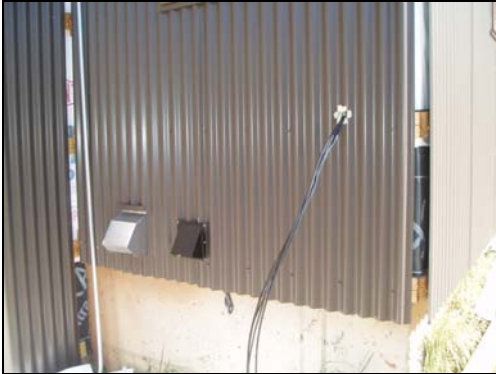
<p>9/16/10 – Photo 14 Unit 14</p> <p>Coax Cable runs complete.</p>	<p>None</p>

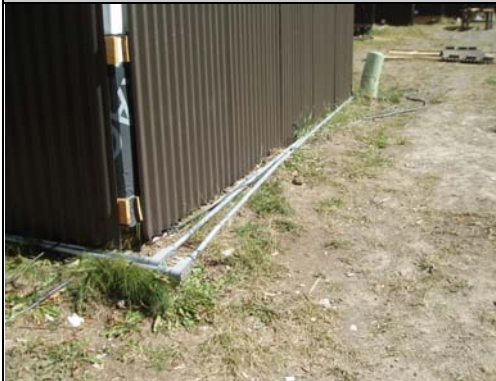
<p>9/16/10 – Photo 18 Unit 24</p> <p>Note proximity of grade to metal siding. Recommend excavating 4 to 6 inches of soil at perimeter grade to allow for the re-installation of electrical lines.</p>	<p>MHC</p>

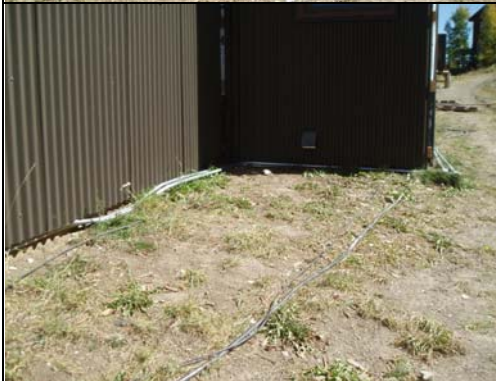
<p>9/16/10 – Photo 19 Unit 23 &amp; 24</p> <p>Note proximity of grade to metal siding. Recommend excavating 4 to 6 inches of soil at perimeter grade to allow for the re-installation of electrical lines.</p>	<p>MHC</p>

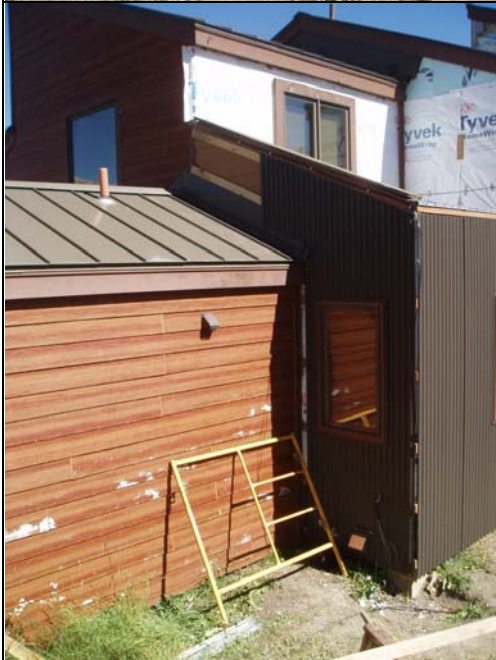
<p>9/16/10 – Photo 20 Unit 16, North 3<sup>rd</sup> Floor Elevation</p> <p>Note the unique condition at Unit 16. Vertical corrugated metal will extend the entire length of the parapet cap.</p>	<p>None</p>

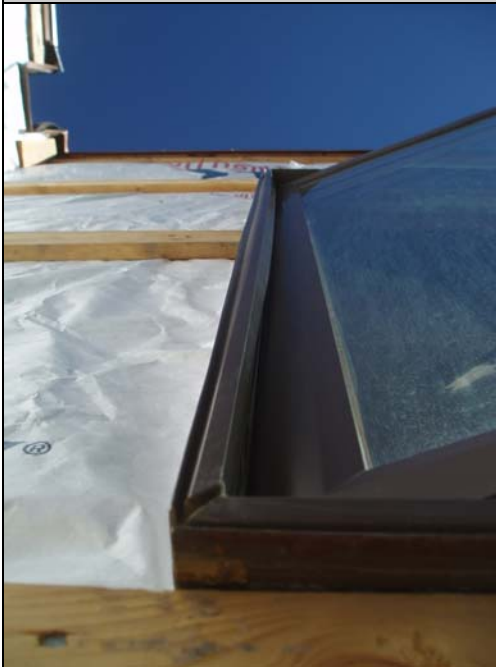
<p>9/16/10 – Photo 21 Unit 32, North 3<sup>rd</sup> Floor Window</p> <p>Note excessive bulge in aluminum window frame and separation of mitered bottom corner.</p> <p>While this condition does not seem to affect the operation of the window, it does prohibit the installation of wood window trim tight to the frame. Holgate Construction is addressing these conditions on a case-by-case basis.</p>	<p>None</p>

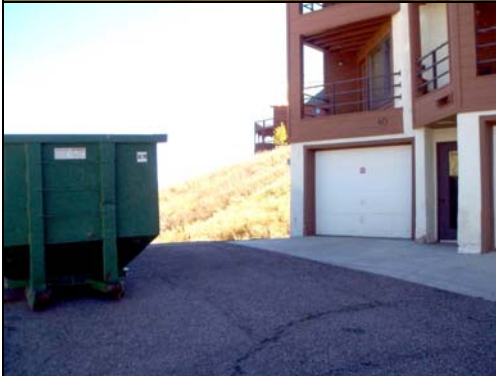
<p>9/16/10 – Photo 22 Unit 40 Garage</p> <p>Note Location of 30 Yard Dumpster: access to Unit 40 garage may be difficult.</p>	<p>MHC</p>
