ARCHITECT'S FIELD REPORT

067

PROJECT	Eagle's Nest Townhouses 11 Morning Glory Way & 31 Marcellina Lane Mt. Crested Butte, CO 81225	DATE	3/20/12
----------------	------------------------------------------------------------------------------------------------------------	-------------	---------

WORK OBSERVED	
Visual Inspection of Garage Aprons at 8 Months	
TRADES PRESENT	
None

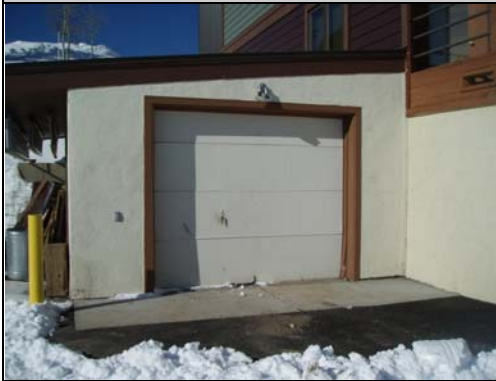
<p>03/20/12 – Photo 1 Maintenance Shed Apron</p> <p>No signs of cracks or heaving. Apron is unheated and pitched away from the garage door.</p>	<p>Note</p>

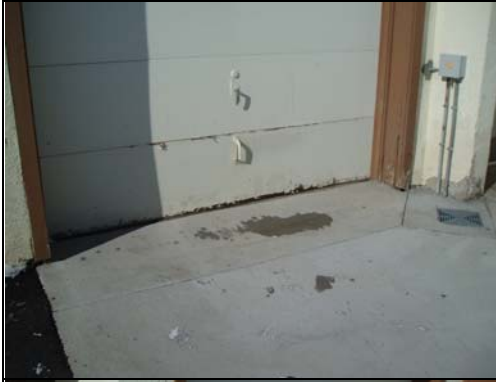
<p>03/20/12 – Photo 2 Unit 1</p> <p>No sign of cracks or heaving. Apron is pitched to drain.</p>	<p>Note</p>

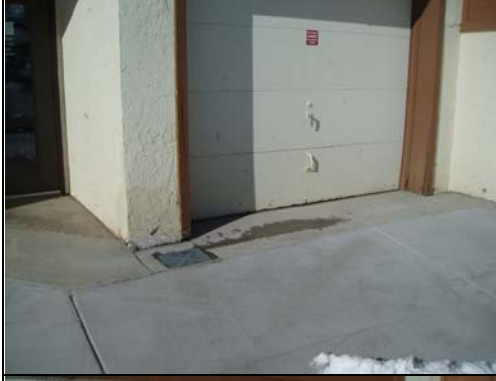
<p>03/20/12 – Photo 3 Unit 2</p> <p>No sign of cracks or heaving. Apron is pitched to drain.</p>	<p>Note</p>

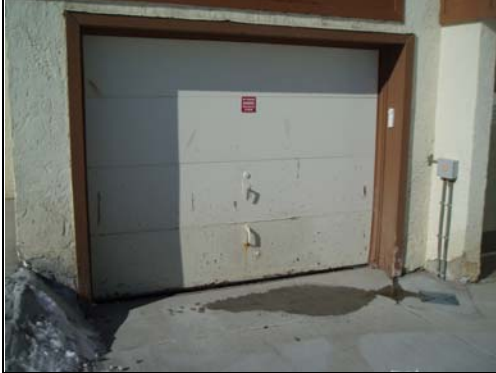
<p>03/20/12 – Photo 4 Unit 3</p> <p>No sign of cracks or heaving. Apron is pitched to drain.</p>	<p>Note</p>

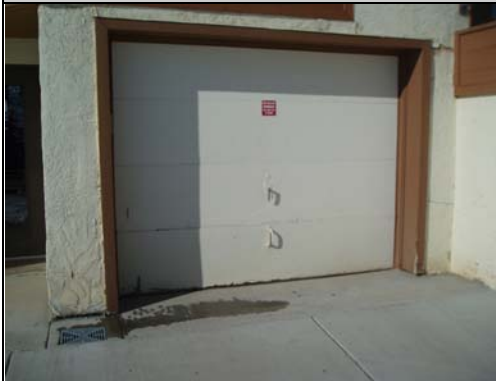
<p>03/20/12 – Photo 5 Unit 4</p> <p>No sign of cracks or heaving. Apron is pitched to drain.</p>	<p>Note</p>

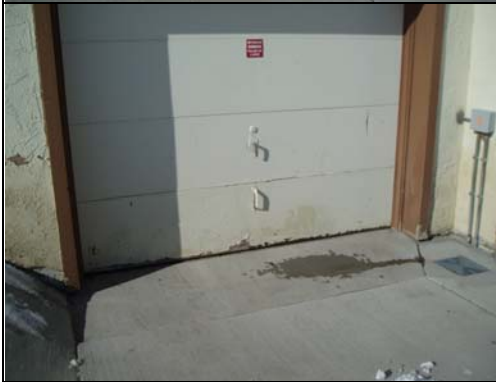
<p>03/20/12 – Photo 6 Unit 5</p> <p>No sign of cracks or heaving. Apron is pitched to drain.</p>	<p>Note</p>

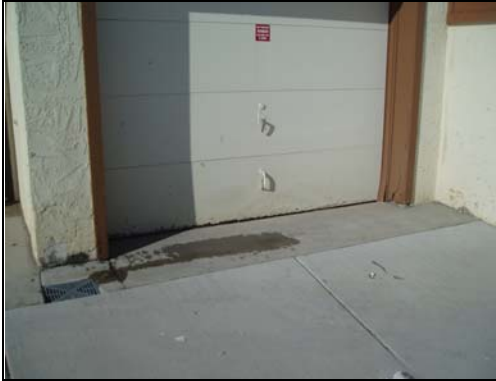
<p>03/20/12 – Photo 7 Unit 6</p> <p>No sign of cracks or heaving. Apron is pitched to drain.</p>	<p>Note</p>

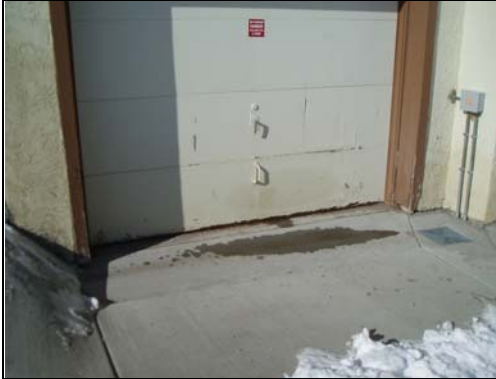
<p>03/20/12 – Photo 8 Unit 7</p> <p>No sign of cracks or heaving. Apron is pitched to drain.</p>	<p>Note</p>

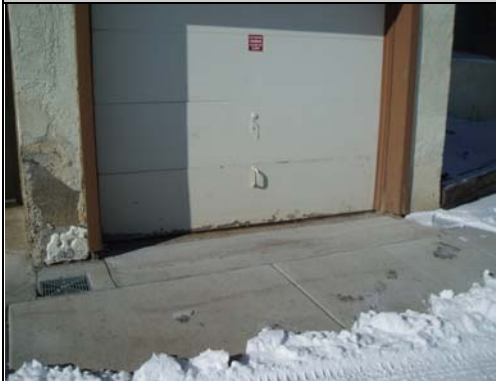
<p>03/20/12 – Photo 9 Unit 8</p> <p>No sign of cracks or heaving. Apron is pitched to drain.</p>	<p>Note</p>

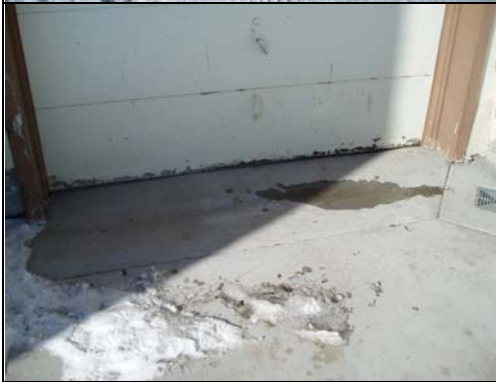
<p>03/20/12 – Photo 10 Unit 9</p> <p>No sign of cracks or heaving. Apron is pitched to drain.</p>	<p>Note</p>

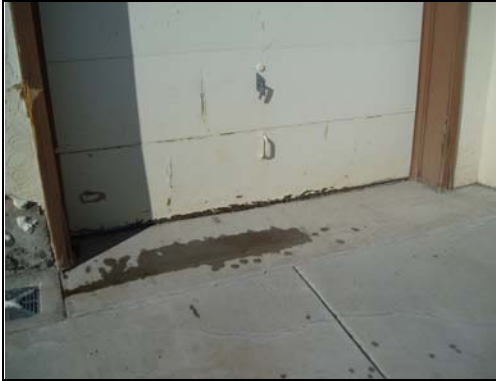
<p>03/20/12 – Photo 11 Unit 10</p> <p>No sign of cracks or heaving. Apron is pitched to drain.</p>	<p>Note</p>

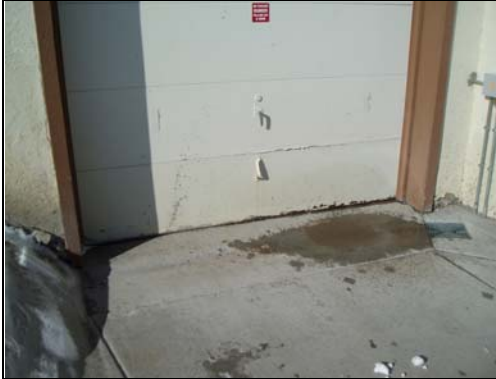
<p>03/20/12 – Photo 12 Unit 11</p> <p>No sign of cracks or heaving. Apron is pitched to drain.</p>	<p>Note</p>

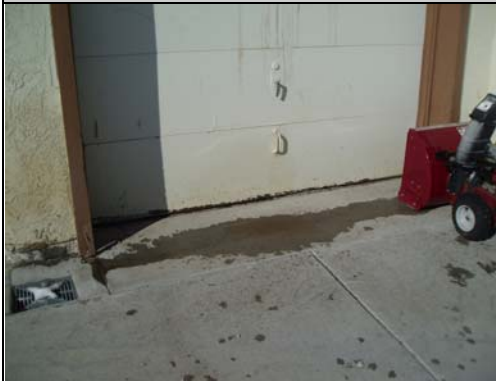
<p>03/20/12 – Photo 13 Unit 12</p> <p>No sign of cracks or heaving. Apron is pitched to drain.</p>	<p>Note</p>

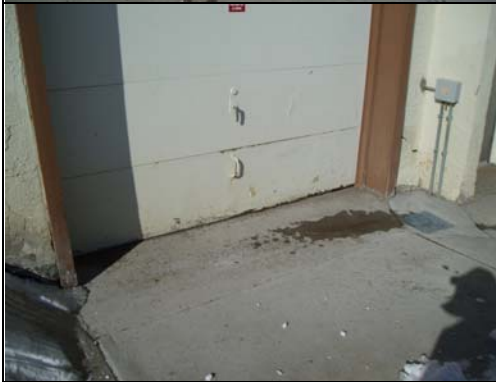
<p>03/20/12 – Photo 14 Unit 13</p> <p>No sign of cracks or heaving. Apron is pitched to drain.</p>	<p>Note</p>

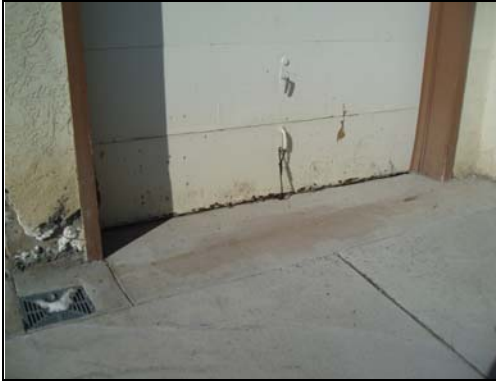
<p>03/20/12 – Photo 15 Unit 14</p> <p>No sign of cracks or heaving. Apron is pitched to drain.</p>	<p>Note</p>

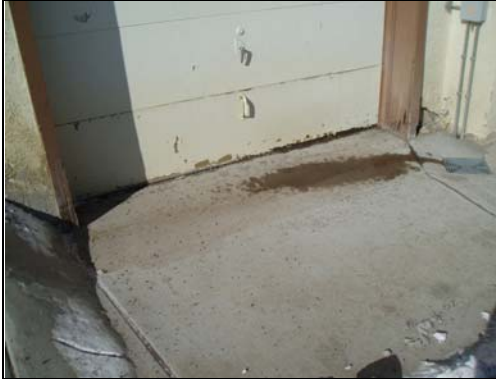
<p>03/20/12 – Photo 16 Unit 15</p> <p>No sign of cracks or heaving. Apron is pitched to drain.</p>	<p>Note</p>

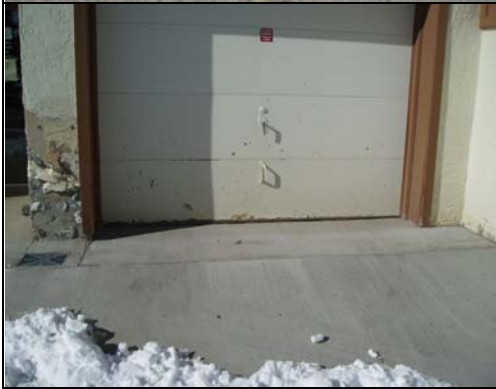
<p>03/20/12 – Photo 30 Unit 19</p> <p>No sign of cracks or heaving. Apron is pitched to drain.</p>	<p>Note</p>

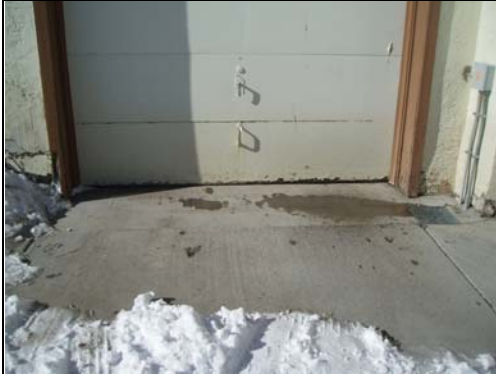
COMMENTS & OBSERVATIONS
<ol style="list-style-type: none"> 1. Visually inspected all 41 concrete aprons and heated valley pans. 2. The heat was on and operational at all 40 valley pan locations. 3. Using a torpedo level and 3' metal channel, as of this field report, all valley pans are pitched to the area drain per the Phase II design. No valley pans exhibited signs of vertical movement. 4. The heated valley pan at Unit 20 was cracked (hairline) about mid-span. This was the only valley pan that appeared to have a crack or damage. 5. There were no signs of heaving or cracking at any of the Upper Level Units. 6. Units 17, 18, and 32 exhibited signs of slab movement that could be considered cosmetic. 7. Units 22, 28, and 36 show signs of slab movement that, if uncorrected, could cause damage to the concrete aprons. 8. Units 20 and 35 show signs of slab movement and damaged (cracking) concrete.

<p>03/20/12 – Photo 31 Unit 20</p> <p>Signs of slab movement. Valley pan shows a slight crack. Valley pan is sloped to the drain.</p>	<p>Note</p>

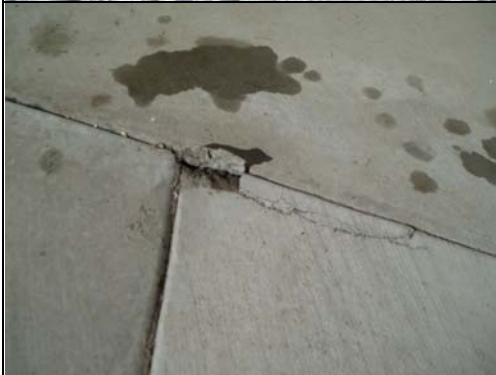
<p>03/20/12 – Photo 32 Unit 20</p> <p>Slight scaling of concrete at entrance door; damage is approximately 11” long and ½” deep.</p>	<p>Note</p>

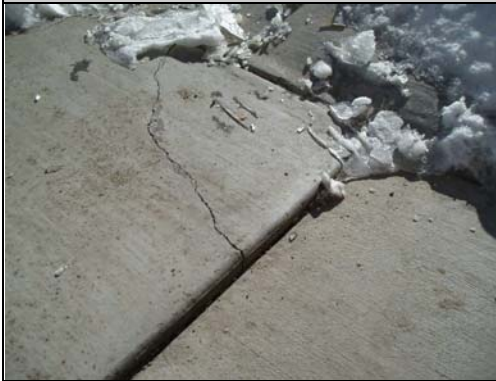
<p>03/20/12 – Photo 33 Unit 20</p> <p>Cracked corner at concrete heave – south corner of unheated apron.</p>	<p>Note</p>

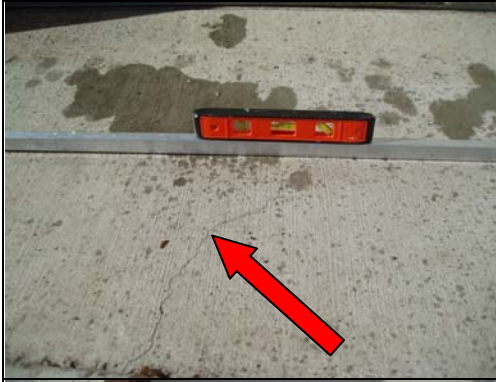
<p>03/20/12 – Photo 34 Unit 20</p> <p>Level shows slope per the design.</p> <p>Note hairline crack at valley pan.</p>	<p>Note</p>

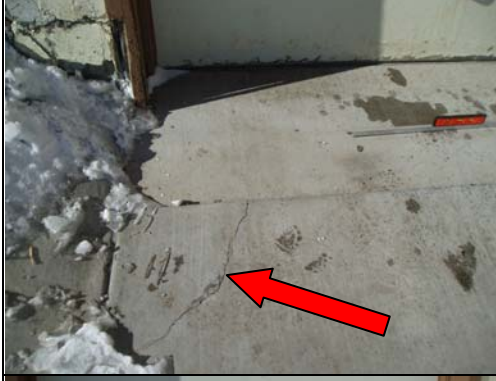
<p>03/20/12 – Photo 35 Unit 20</p> <p>Note cracked corner at unheated apron.</p>	<p>Note</p>

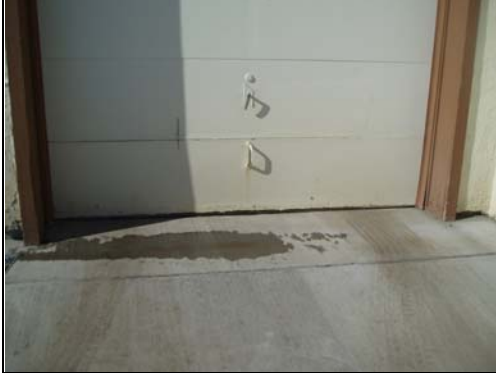
<p>03/20/12 – Photo 36 Unit 21</p> <p>No sign of cracks or heaving. Apron is pitched to drain.</p>	<p>Note</p>

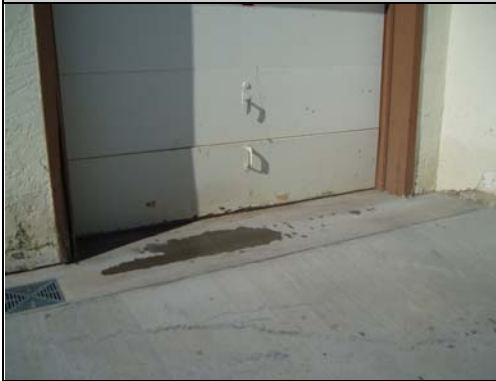
<p>03/20/12 – Photo 41 Unit 23</p> <p>No sign of cracks or heaving. Apron is pitched to drain.</p>	<p>Note</p>

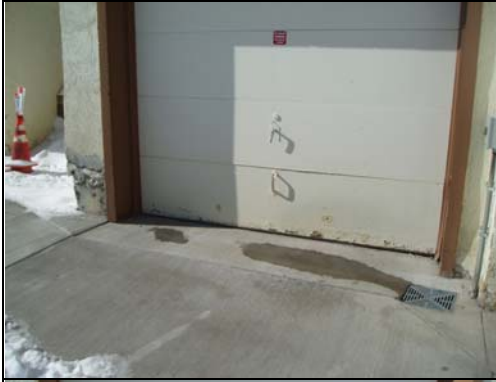
<p>03/20/12 – Photo 42 Unit 24</p> <p>No sign of cracks or heaving. Apron is pitched to drain.</p>	<p>Note</p>

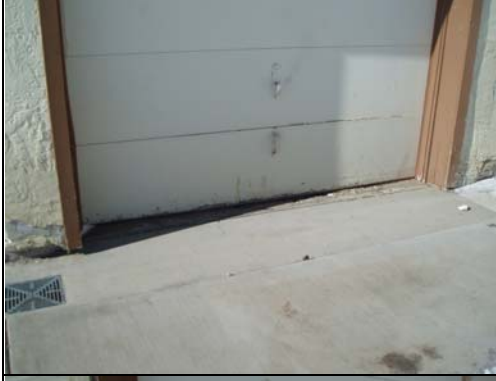
<p>03/20/12 – Photo 43 Unit 25</p> <p>No sign of cracks or heaving. Apron is pitched to drain.</p>	<p>Note</p>

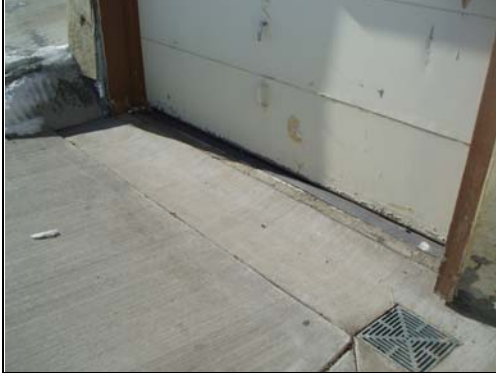
<p>03/20/12 – Photo 44 Unit 26</p> <p>No sign of cracks or heaving. Apron is pitched to drain.</p>	<p>Note</p>

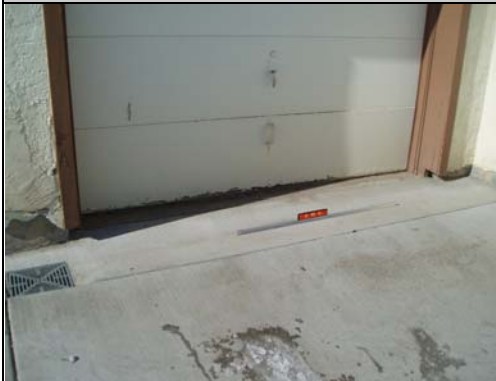
<p>03/20/12 – Photo 49 Unit 29</p> <p>No sign of cracks or heaving. Apron is pitched to drain.</p>	<p>Note</p>

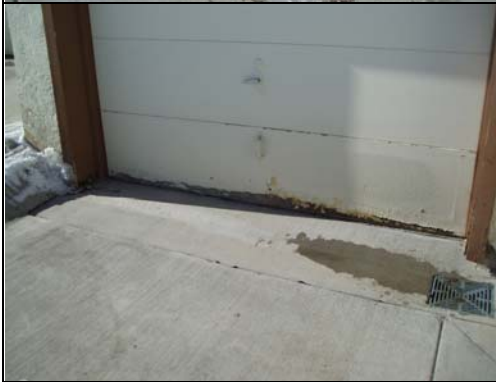
<p>03/20/12 – Photo 50 Unit 30</p> <p>No sign of cracks or heaving. Apron is pitched to drain.</p>	<p>Note</p>

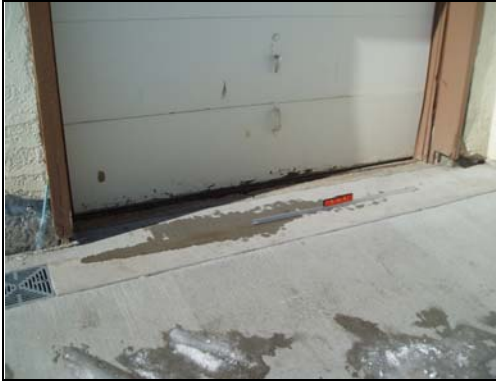
<p>03/20/12 – Photo 51 Unit 31</p> <p>No sign of cracks or heaving. Apron is pitched to drain.</p>	<p>Note</p>

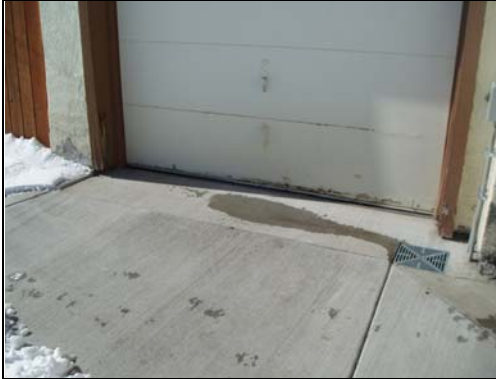
<p>03/20/12 – Photo 52 Unit 32</p> <p>Signs of slab movement.</p> <p>No cracks visible. Valley pan is sloped to the drain.</p>	<p>Note</p>

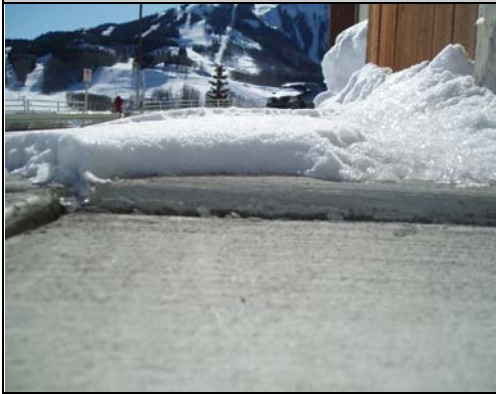
<p>03/20/12 – Photo 53 Unit 32</p> <p>South valley pan elevation is approximately ½” lower than adjacent unheated concrete.</p> <p>Condition could be considered cosmetic.</p>	<p>Note</p>

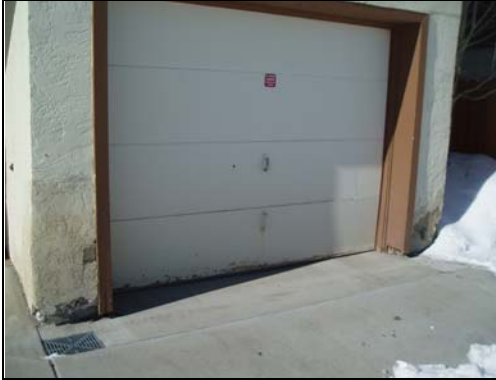
<p>03/20/12 – Photo 54 Unit 33</p> <p>No sign of cracks or heaving. Apron is pitched to drain.</p>	<p>Note</p>
 	<p>03/20/12 – Photo 55 Unit 34</p> <p>No sign of cracks or heaving. Apron is pitched to drain.</p>	<p>Note</p>

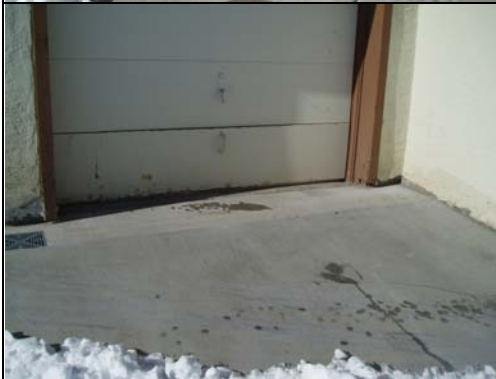
<p>03/20/12 – Photo 56 Unit 35</p> <p>Signs of slab movement.</p> <p>Valley pan is sloped to the drain.</p>	<p>Note</p>

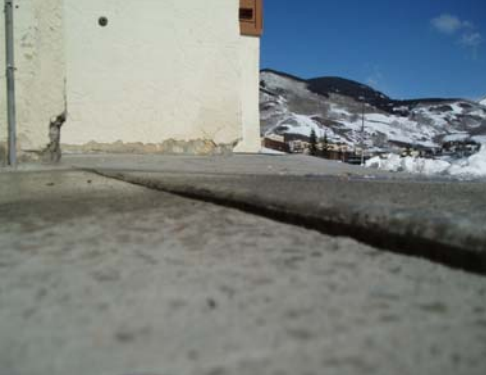
<p>03/20/12 – Photo 61 Unit 36</p> <p>Difference in elevation is approximately 3/4”.</p>	<p>Note</p>

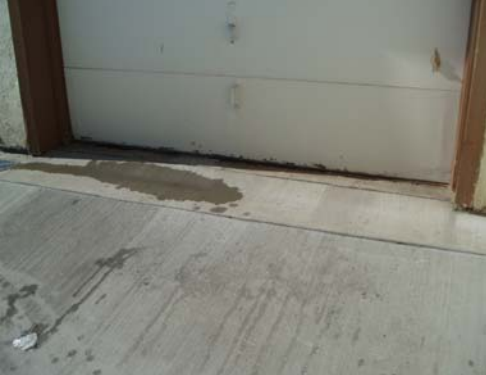
<p>03/20/12 – Photo 62 Unit 37</p> <p>No sign of cracks or heaving. Apron is pitched to drain.</p>	<p>Note</p>

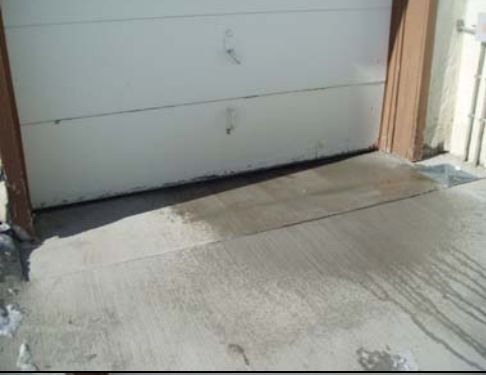
<p>03/20/12 – Photo 63 Unit 38</p> <p>No sign of cracks or heaving. Apron is pitched to drain.</p>	<p>Note</p>

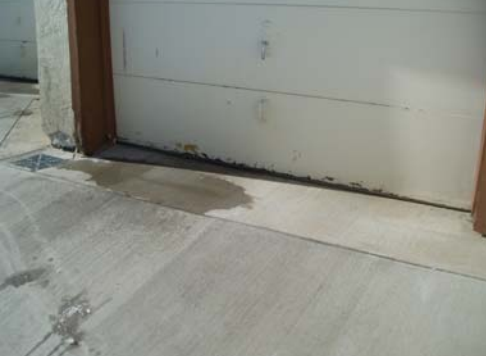
<p>03/20/12 – Photo 64 Unit 39</p> <p>No sign of cracks or heaving. Apron is pitched to drain.</p>	<p>Note</p>
