# ARCHITECT'S FIELD REPORT

121

<b>PROJECT</b>	<b>Eagle's Nest Townhouses</b> 11 Morning Glory Way & 31 Marcellina Lane Mt. Crested Butte, CO 81225	<b>DATE</b>	9/04/13
----------------	--	-------------	---------

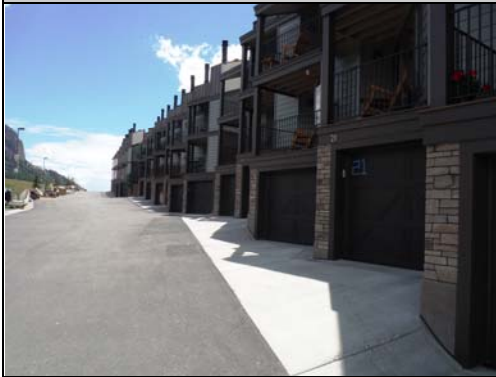
<p>9/04/13 – Photo 1 Lower Level Units Looking South</p> <p>Unit address numbers are installed.</p>	<p>Note</p>

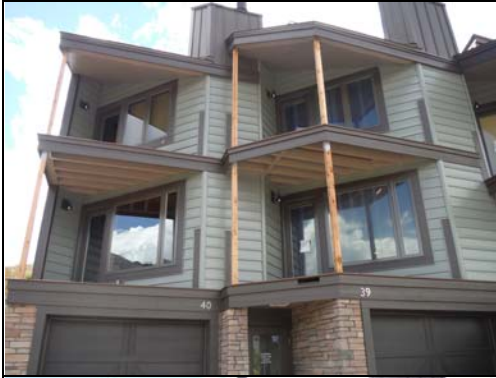
<p>9/04/13 – Photo 2 Units 40 &amp; 39</p> <p>Siding, Lighting, and Electrical Outlets are complete. Awaiting post wraps and guardrails.</p>	<p>Note</p>

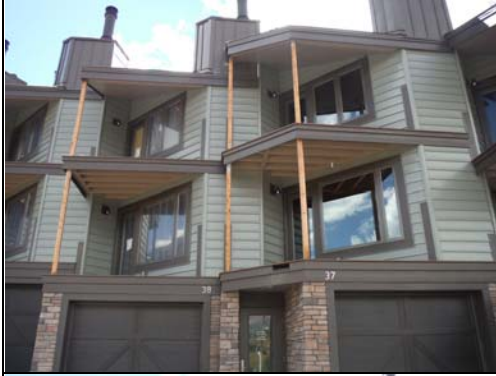
<p>9/04/13 – Photo 3 Unit 38 &amp; 37</p> <p>Awaiting post wraps and guardrails.</p>	<p>Note</p>

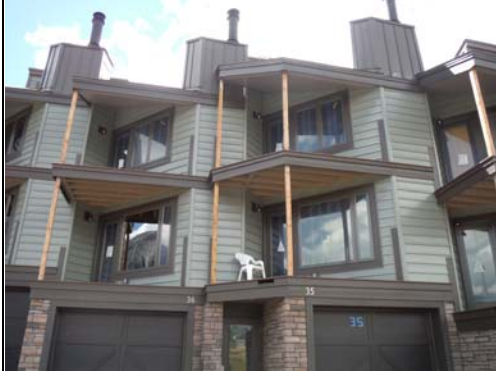
<p>9/04/13 – Photo 4 Units 36 &amp; 35</p> <p>Awaiting post wraps and guardrails.</p>	<p>Note</p>

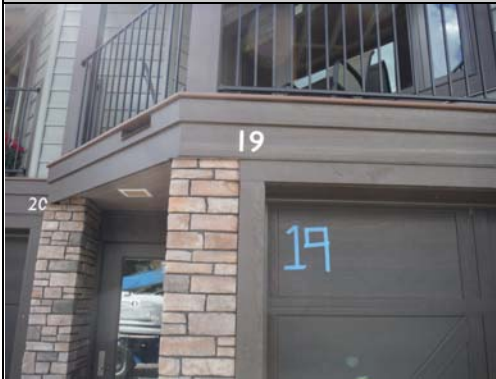
<p>9/04/13 – Photo 9 Unit 19 Address Number</p> <p>Address numbers have been installed.</p>	<p>Note</p>

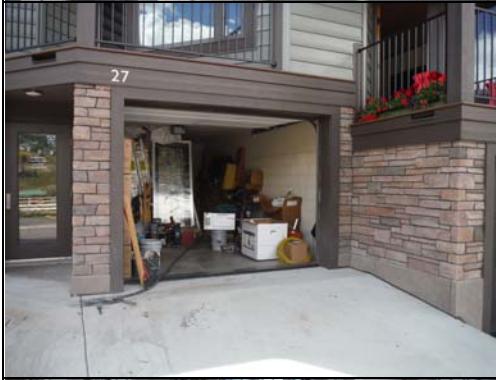
<p>9/04/13 – Photo 10 Unit 27 Storage Garage</p> <p>Recommend alerting Mick prior to occupancy. Path to laundry room may not be clear.</p>	<p>Note</p>
