## ARCHITECT'S FIELD REPORT

PROJECT	<b>Eagle's Nest Townhouses</b> 11 Morning Glory Way & 31 Marcellina Lane Mt. Crested Butte, CO 81225	DATE	12/18/13
---------	--	------	----------

WORK OBSERVED	
Phase IV Construction – Upper Level Renovations	
TRADES PRESENT	
Holgate Construction

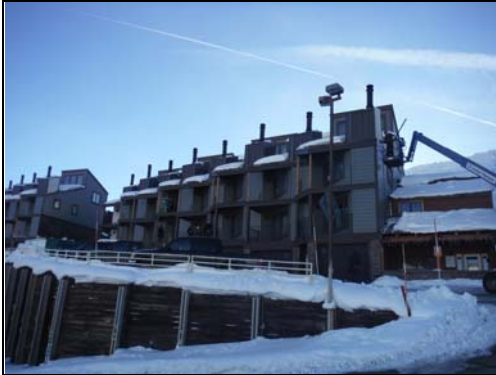
<p>12/18/13 – Photo 1 Building A from Below</p> <p>Wood post wraps are being installed. Guardrails are following in sequence.</p>	Note

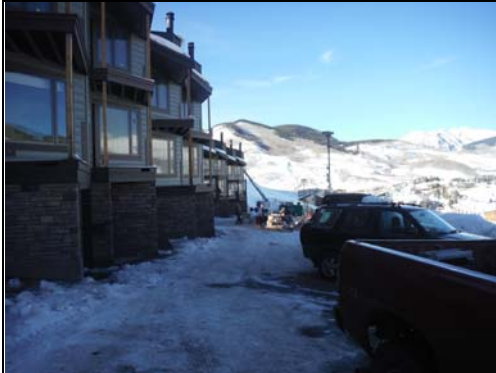
<p>12/18/13 – Photo 2 Upper Level Work Area Looking North</p> <p>Site is generally icy. Work is being performed midway between the two buildings.</p>	Note

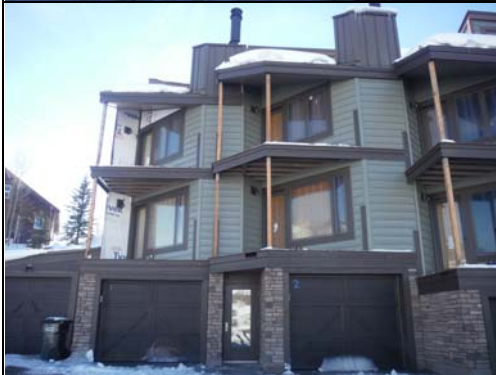
<p>12/18/13 – Photo 3 Units 1 &amp; 2</p> <p>Unit awaiting post wraps and guardrails. Note the small amount of siding on the north side of Unit 1. Siding is awaiting the wood corn trim.</p>	Note

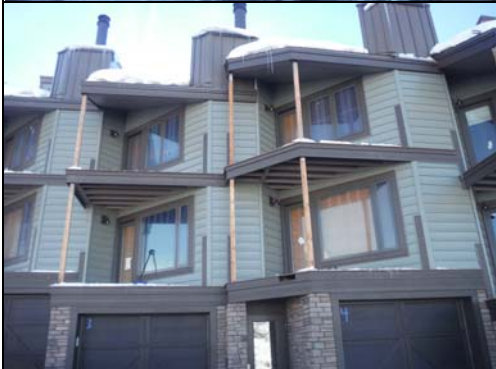
<p>12/18/13 – Photo 4 Units 3 &amp; 4</p> <p>Unit awaiting post wraps and guardrails.</p>	Note

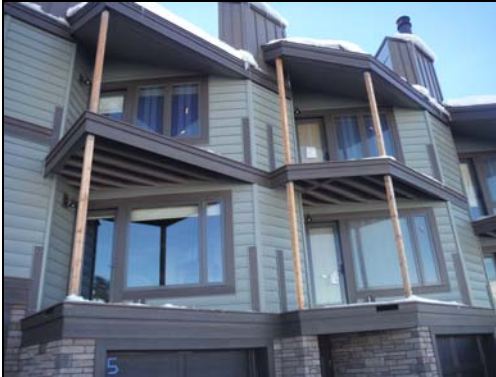
<p>12/18/13 – Photo 5 Units 5 &amp; 6</p> <p>Unit awaiting post wraps and guardrails.</p>	Note

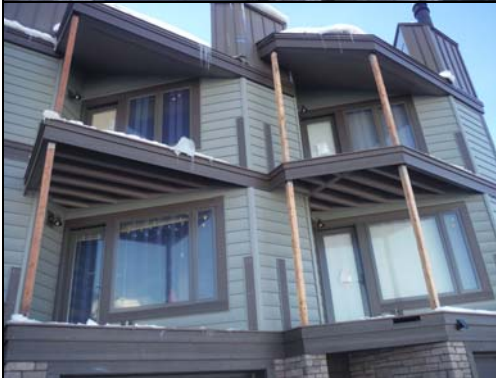
<p>12/18/13 – Photo 6 Units 7 &amp; 8</p> <p>Unit awaiting post wraps and guardrails.</p>	Note

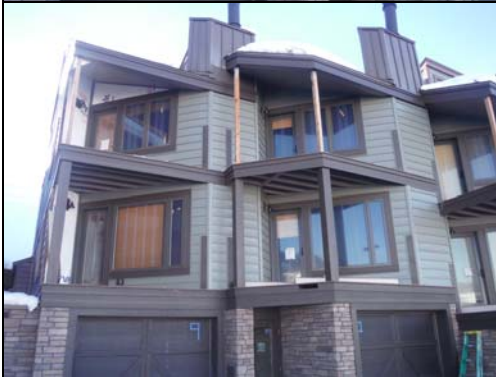
<p>12/18/13 – Photo 7 Units 9 &amp; 10</p> <p>Post wraps are complete on the 2<sup>nd</sup> level. Note the small amount of metal siding on the north end of Unit #9.</p>	Note

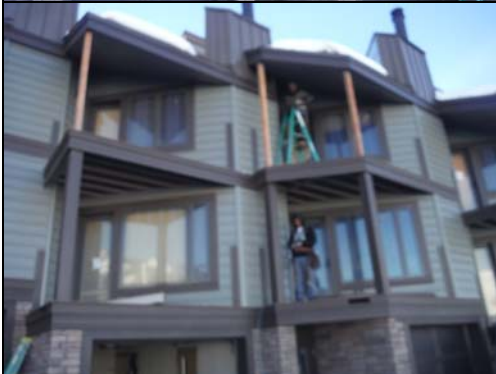
<p>12/18/13 – Photo 8 Units 11 &amp; 12</p> <p>Post wraps are complete on the 2<sup>nd</sup> level. Light fixtures have been installed.</p>	Note

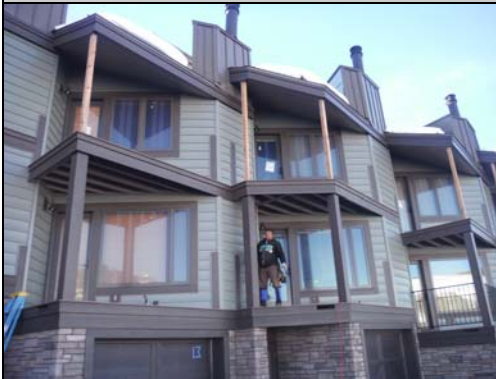
<p>12/18/13 – Photo 9 Units 13 &amp; 14</p> <p>Post wraps are complete on the 2<sup>nd</sup> level.</p> <p>Light fixtures have been installed.</p>	Note

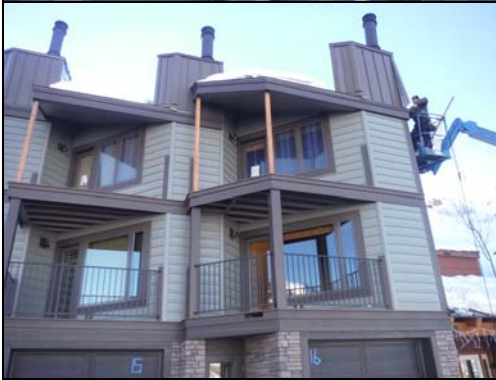
<p>12/18/13 – Photo 10 Units 15 &amp; 16</p> <p>Post wraps and guardrails are complete on the 2<sup>nd</sup> level.</p> <p>Light fixtures have been installed.</p>	Note

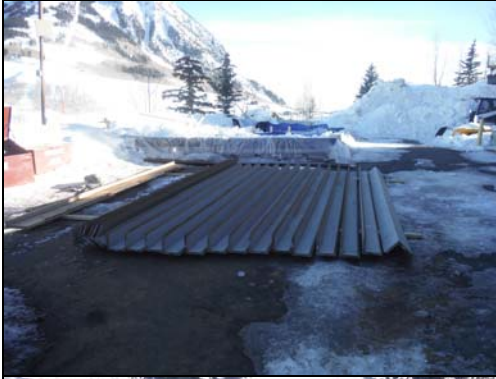
<p>12/18/13 – Photo 11 Maintenance Area Work Area</p> <p>Prepared corner trim pieces ready for installation.</p>	Note

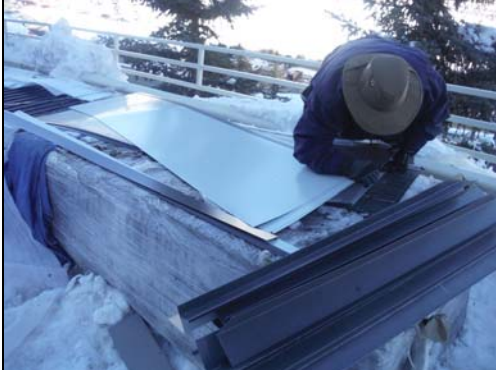
<p>12/18/13 – Photo 12 Chimney End Metal</p> <p>Mick is measuring the metal panels for the remaining chimney ends.</p>	Note

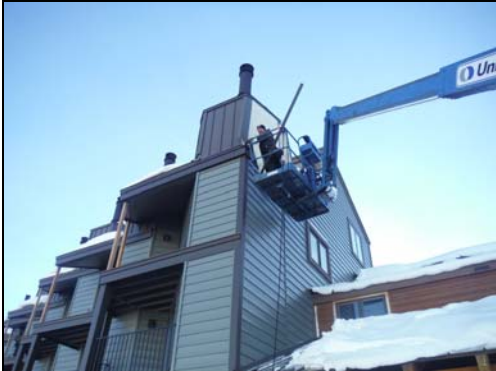
<p>12/18/13 – Photo 13 Unit 16 North Elevation</p> <p>Chimney end metal installation underway.</p>	Note

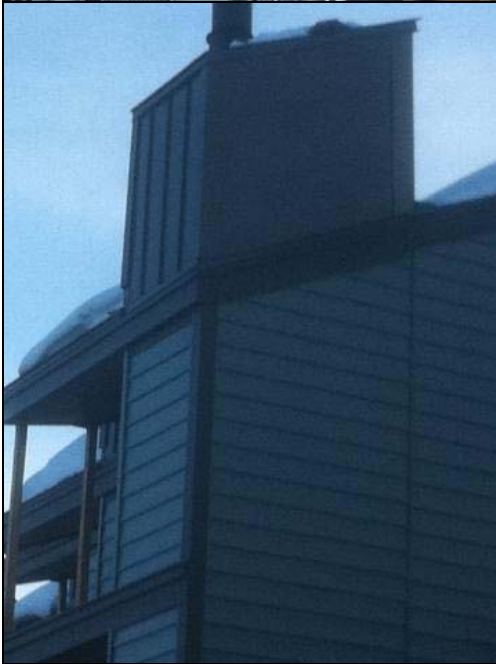
<p>12/18/13 – Photo 14 Unit 16 North Elevation (Photo from MH at 4:30 pm)</p> <p>Completed metal panels on the upper chimney of Unit 16.</p> <p>Note the differing conditions on Unit 16. Due to the position of the Maintenance Building, the belly band does not continue around the corner. The siding from Phase IV is even at the corner. A small transition piece was installed at the break.</p>	Note
