**ARCHITECT'S FIELD REPORT**

**059**

<b>PROJECT</b>	<b>Eagle's Nest Townhouses</b> 11 Morning Glory Way & 31 Marcellina Lane Mt. Crested Butte, CO 81225	<b>DATE</b>	7/19/11
----------------	--	-------------	---------

<b>WORK OBSERVED</b>	
Phase II – Sewer and Asphalt; BWA Punch List Walk	
<b>TRADES PRESENT</b>	
None

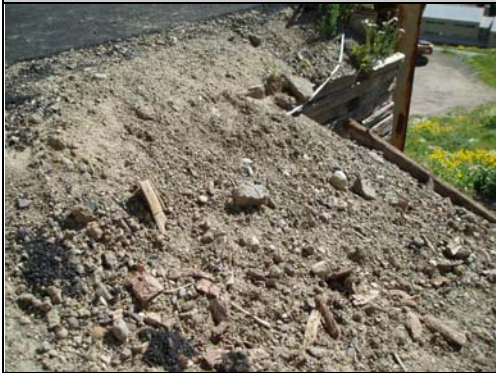
<p>7/19/11 – Photo 1 Lower Level South Retaining Wall</p> <p>Clean-up of road base debris recommended. Repair of the top level of retaining wall may be necessary.</p>	<p>LC</p>

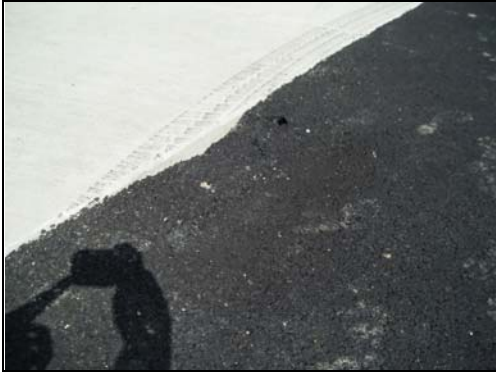
<p>7/19/11 – Photo 2 Unit 38</p> <p>Asphalt settling. Recommend removing asphalt, re-compacting subgrade and install new asphalt.</p>	<p>LC</p>

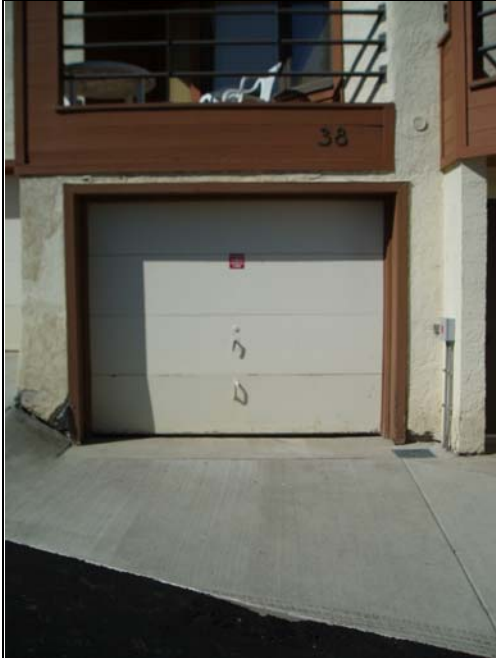
<p>7/19/11 – Photo 3 Unit 38</p> <p>Photo of settling asphalt from Photo 2.</p>	<p>LC</p>

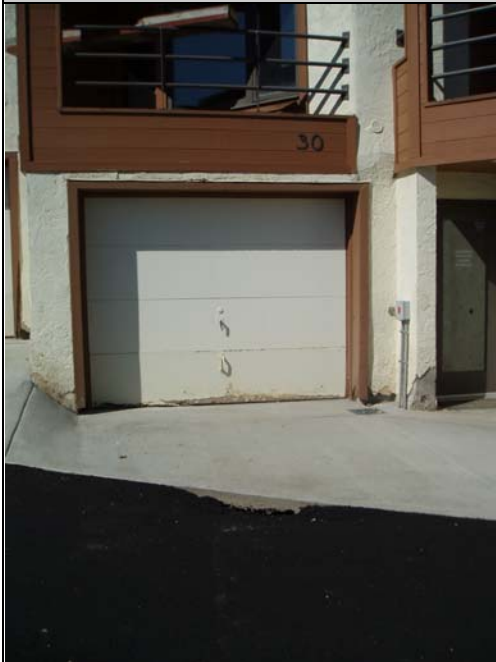
<p>7/19/11 – Photo 7 Unit 30</p> <p>Asphalt settling. Recommend removing asphalt, re-compacting subgrade and install new asphalt.</p>	<p>LC</p>

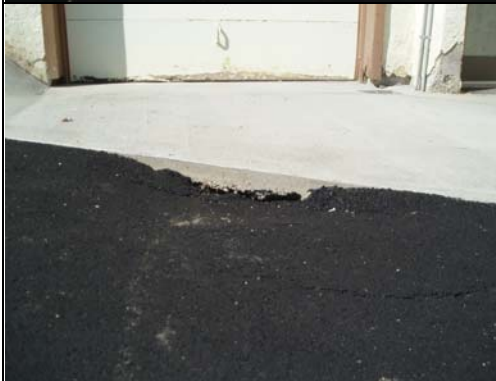
<p>7/19/11 – Photo 8 Unit 30</p> <p>Detail of Photo 7.</p>	<p>LC</p>

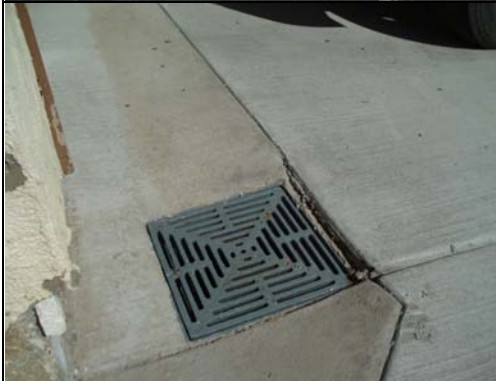
<p>7/19/11 – Photo 9 Area Drains</p> <p>General note: recommend sealing perimeter of area drains.</p>	<p>LC</p>

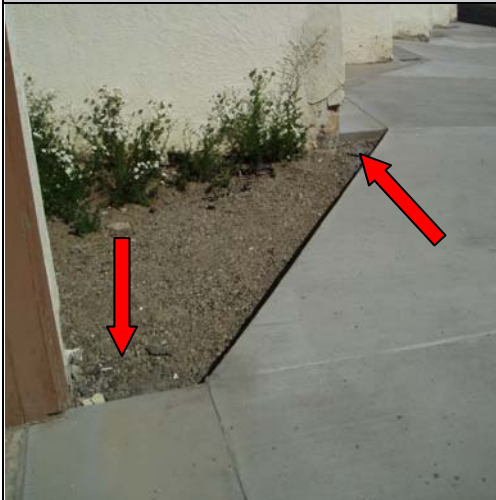
<p>7/19/11 – Photo 10 Units 24 and 25</p> <p>Additional concrete valley pans requested to catch roof drip from above.</p>	<p>LC</p>

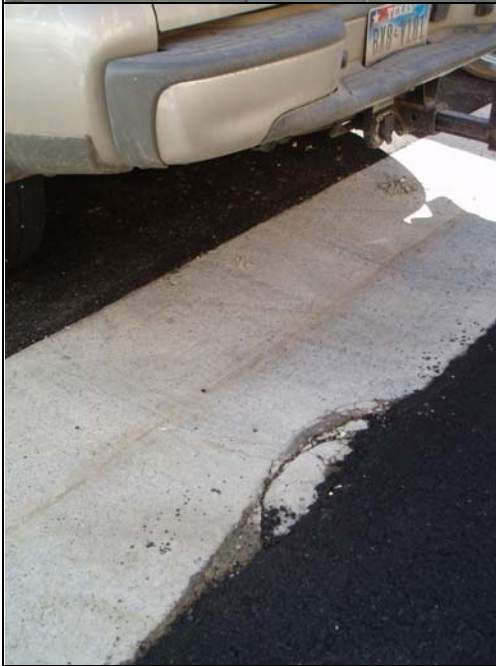
<p>7/19/11 – Photo 11 Lower Level Parking Area</p> <p>New valley pan concrete cracked. This area should be removed and replaced or repaired in a matter to prevent water from degrading the concrete.</p>	<p>LC</p>

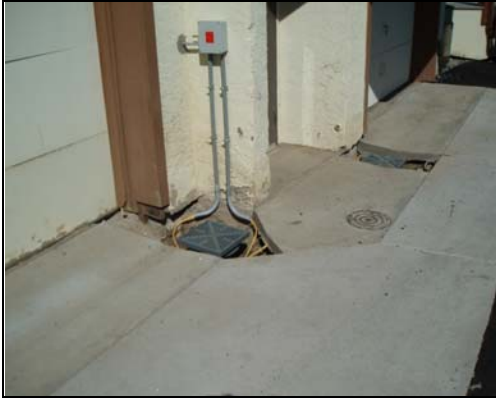
<p>7/19/11 – Photo 12 Units 17, 18 &amp; 19</p> <p>Install concrete around area drains.</p>	<p>LC</p>

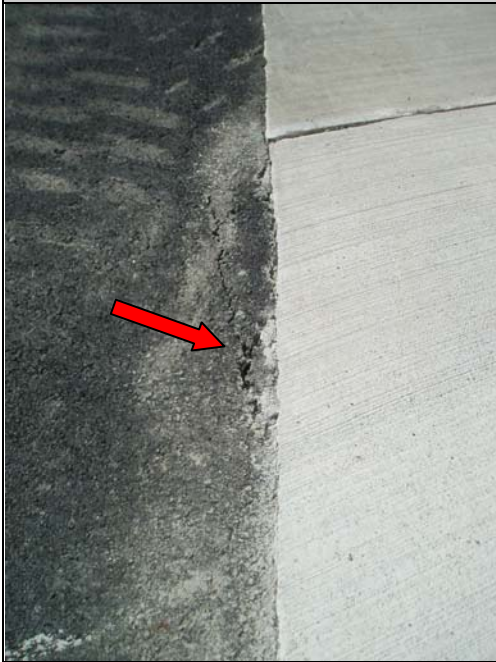
<p>7/19/11 – Photo 13 Unit 22</p> <p>Asphalt adjacent to the patched concrete is cracked. Recommend sealing this area to prevent water intrusion.</p>	<p>LC</p>

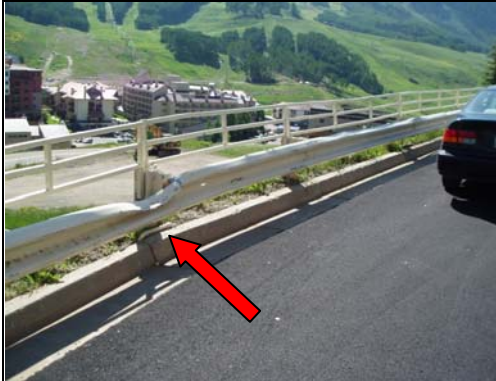
<p>7/19/11 – Photo 14 Lower Level Parking Area</p> <p>Guardrail is damaged.</p>	<p>LC</p>

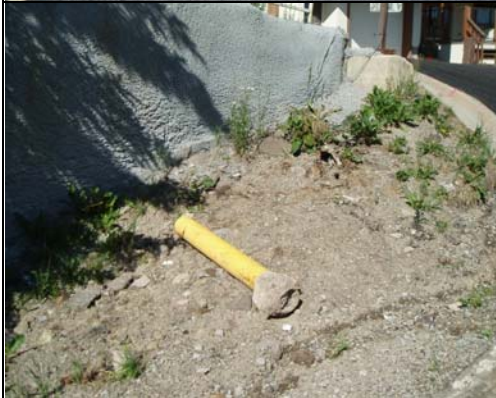
<p>7/19/11 – Photo 15 Lower Level Parking Area</p> <p>Bollard needs to be removed from the site as construction waste.</p>	<p>LC</p>

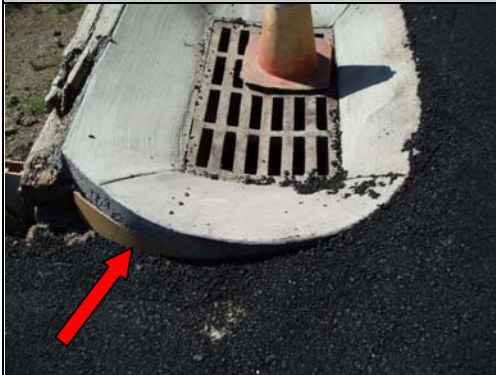
<p>7/19/11 – Photo 16 Upper Level Area Basin</p> <p>Recommend additional concrete curb around new area catch basin to prevent damage from vehicles.</p>	<p>LC</p>

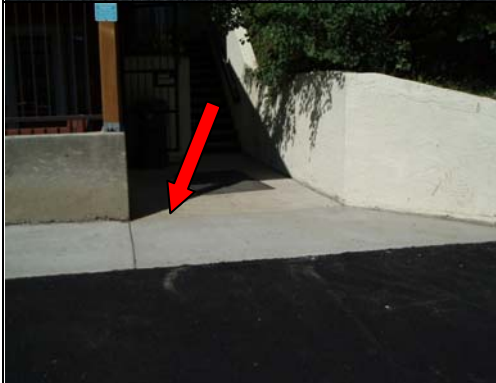
<p>7/19/11 – Photo 17 Upper Level Service Area</p> <p>New concrete sidewalk does not drain properly. Recommend removing and reinstalling the concrete to an appropriate pitch.</p>	<p>LC</p>

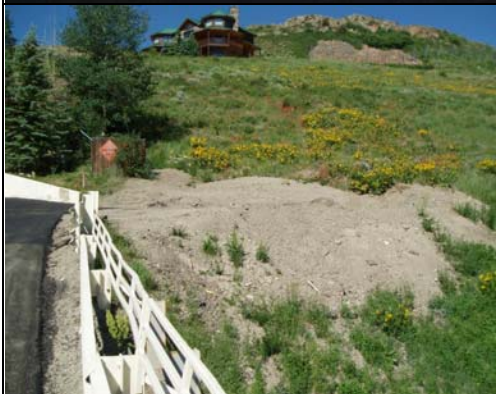
<p>7/19/11 – Photo 18 Upper Level North Snow Storage</p> <p>Additional road base has been piled here beyond the property line. Recommend removing the road base.</p>	<p>LC</p>

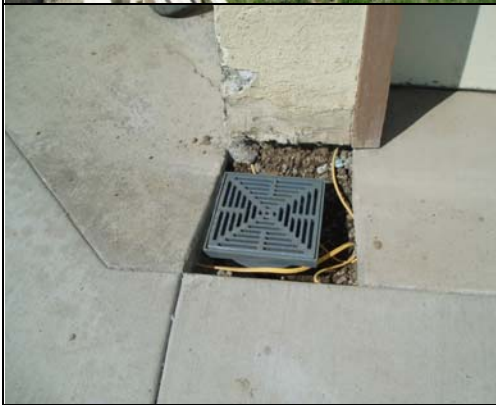
<p>7/19/11 – Photo 19 Upper Level Area Drains</p> <p>General Note: Install concrete around area drains at all locations.</p>	<p>LC</p>

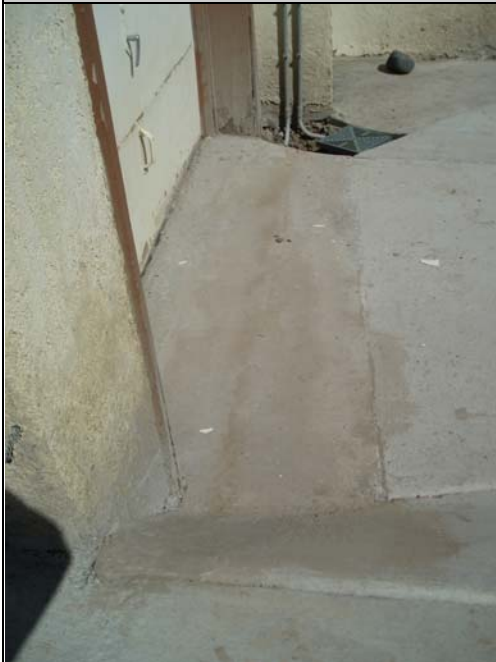
<p>7/19/11 – Photo 20 Unit 13</p> <p>Flow fill has been used to patch areas of the valley pan that were exposed to rain during the pour.</p>	<p>Note</p>

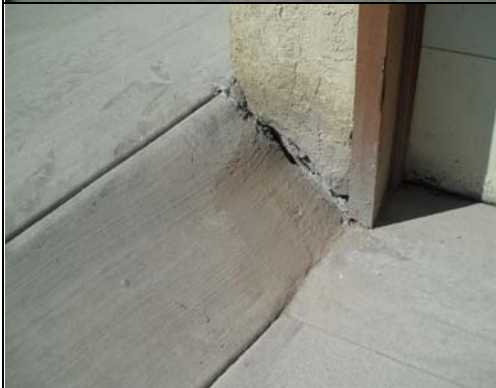
<p>7/19/11 – Photo 21 Unit 12</p> <p>Flow fill has been used to patch areas of the valley pan that were exposed to rain during the pour.</p>	<p>Note</p>

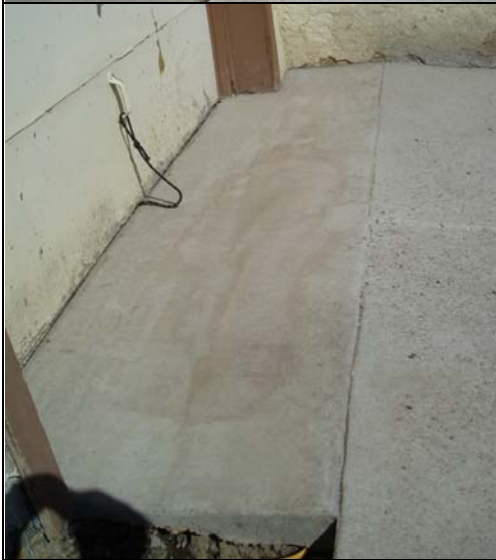
<p>7/19/11 – Photo 22 Unit 14</p> <p>Flow fill has been used to patch areas of the valley pan that were exposed to rain during the pour.</p>	<p>Note</p>

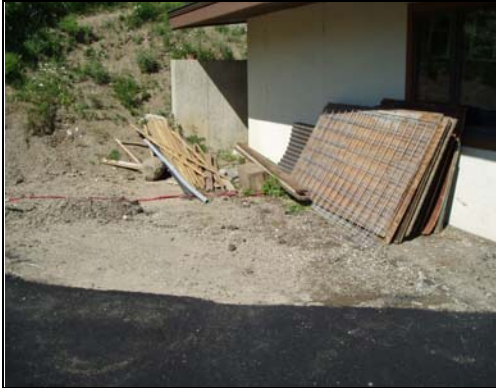
<p>7/19/11 – Photo 25 Upper Level Maintenance Shed</p> <p>Some woven wire mesh remains. The plywood belongs to CBL. Remnants of Phase I construction materials have yet to be removed or stored.</p>	<p>LC MHC</p>
