ARCHITECT'S FIELD REPORT

027

PROJECT	Eagle's Nest Townhouses 11 Morning Glory Way & 31 Marcellina Lane Mt. Crested Butte, CO 81225	DATE	12/22/10
----------------	--	-------------	----------

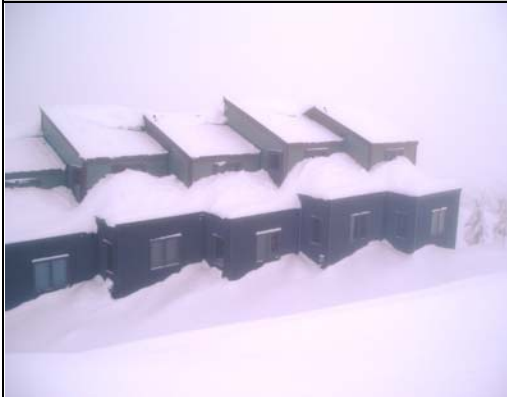
<p>12/22/10 – Photo 1 Units 1 through 4</p> <p>Parapet caps have been installed. Rear of units 100% complete.</p>	None

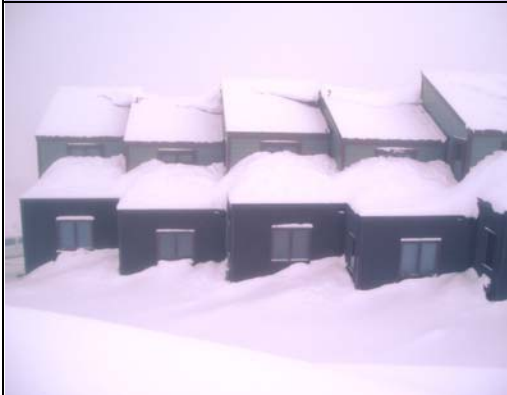
<p>12/22/10 – Photo 2 Units 5 through 8</p> <p>Parapet caps have been installed. Rear of units 100% complete.</p>	None

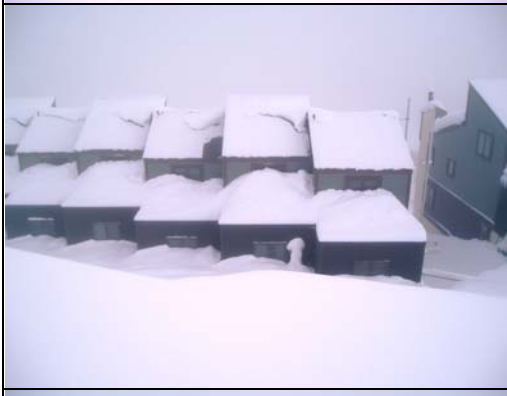
<p>12/22/10 – Photo 3 Units 9 through 12</p> <p>Parapet caps have been installed. Rear of units 100% complete.</p>	None

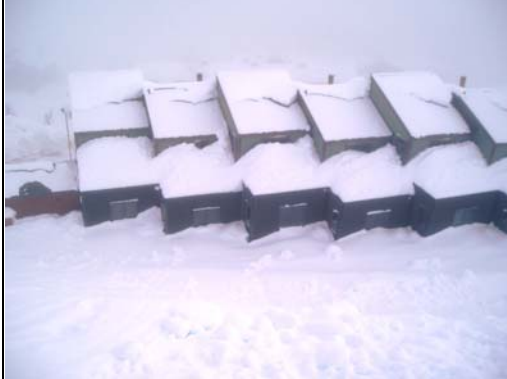
<p>12/22/10 – Photo 4 Units 13 through 16</p> <p>Parapet caps have been installed on all units except for Unit 16 (sloped cap).</p>	None

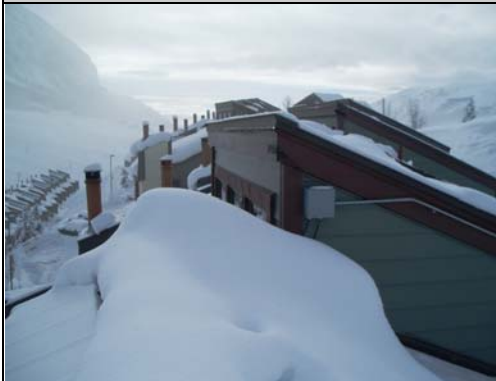
<p>12/22/10 – Photo 13 Unit 13 Roof</p> <p>Attempted inspection of Loft Window and Siding on Building ‘B’.</p> <p>Siding and windows visible appear to be in accordance with the plans.</p>	<p>BWA</p>

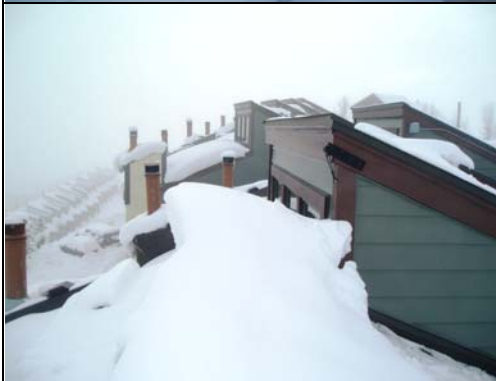
<p>12/22/10 – Photo 14 Unit 15 Roof</p> <p>Attempted inspection of Loft Window and Siding on Building ‘B’.</p> <p>Siding and windows visible appear to be in accordance with the plans.</p>	<p>BWA</p>

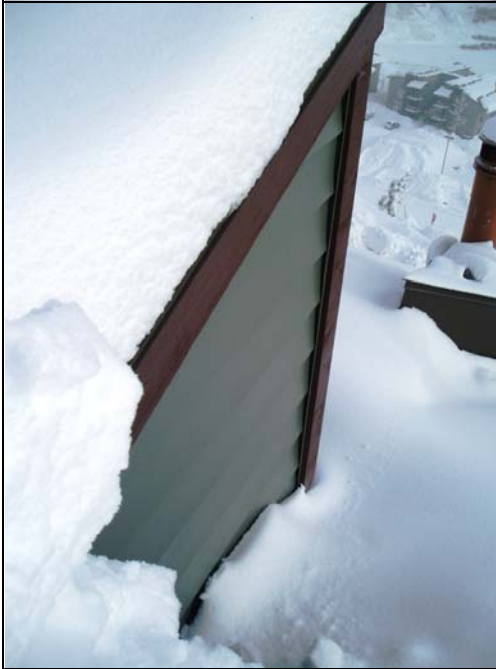
<p>12/22/10 – Photo 15 Unit 16</p> <p>Siding installation on Unit 16, south.</p>	<p>BWA</p>

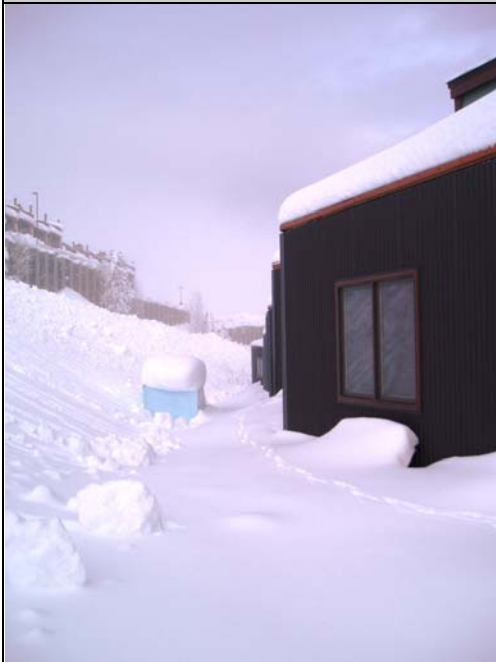
<p>12/22/10 – Photo 24 Lower Level Units looking North</p> <p>Snow is approximately 3 feet deep behind the Lower Level Units.</p> <p>Rigid Insulation stored behind Unit 30 may be damaged by falling snow debris from the road above.</p>	<p>MHC</p>

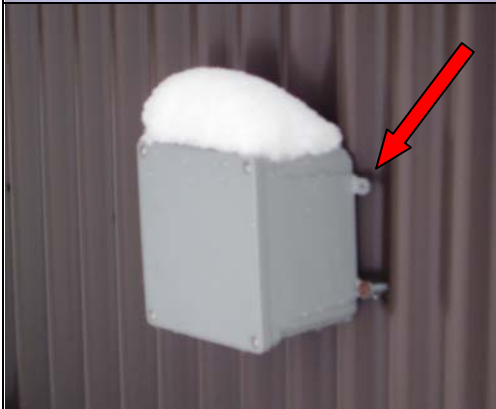
<p>12/22/10 – Photo 25 Typical Lower Level Cable Junction Box</p> <p>Junction boxes are not currently secured at the top connection point.</p>	<p>CBL MHC</p>

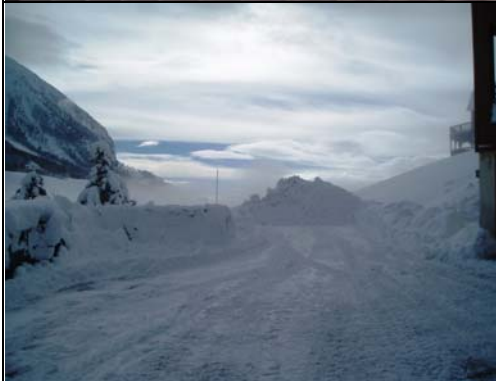
<p>12/22/10 – Photo 26 Lower Level Driveway Looking South</p> <p>Dumpster has been removed. Snow removal is complete.</p>	<p>None</p>
