**ARCHITECT'S FIELD REPORT****013**

**PROJECT**      **Eagle's Nest Townhouses**      **DATE**      8/17/10  
11 Morning Glory Way & 31 Marcellina Lane  
Mt. Crested Butte, CO 81225

WORK OBSERVED	
Phase I – Construction Field Report 05	
TRADES PRESENT	
None

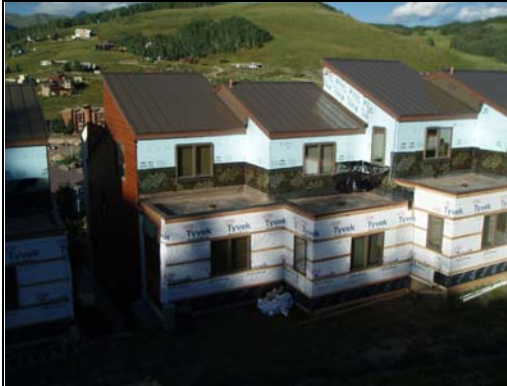
<p>8/17/10 – Photo 1 Rear Insulation &amp; Furring Completed</p> <p>Rear of Upper Units 100% demolition, installation of rigid insulation, window flashing &amp; foam, and waterproofing membrane at 4<sup>th</sup> floor perimeter.</p>	None

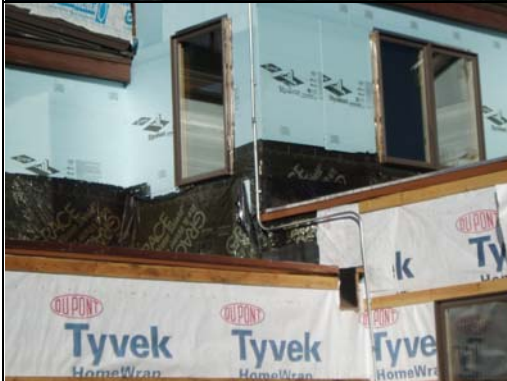
<p>8/17/10 – Photo 2 Unit 7 – Waterproof Membrane</p> <p>Note new waterproofing membrane at 4<sup>th</sup> floor perimeter. Grace Ice &amp; Water Shield has come loose.</p>	MHC

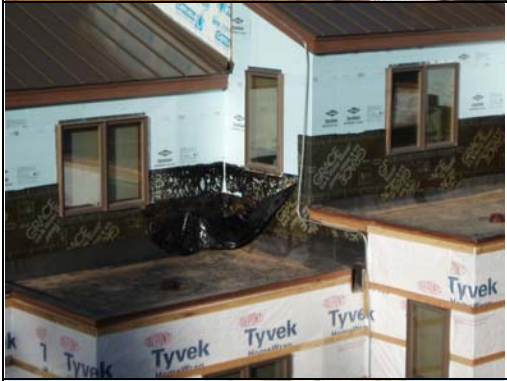
<p>8/17/10 – Photo 3 Unit 33 – Waterproof Membrane</p> <p>Note new waterproofing membrane at 4<sup>th</sup> floor perimeter. Grace Ice &amp; Water Shield has come loose.</p>	MHC

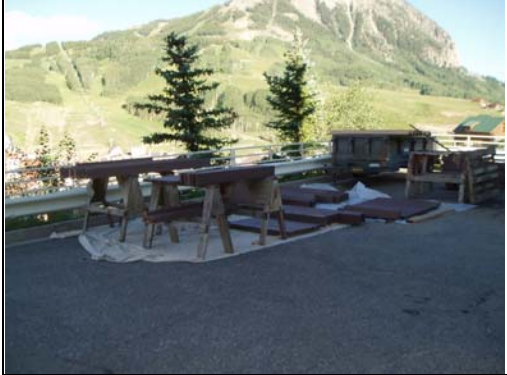
<p>8/17/10 – Photo 4 Window Trim at Upper Unit Area</p> <p>Milled lumber is painted and drying on site.</p>	None
