# ARCHITECT'S FIELD REPORT

043

<b>PROJECT</b>	<b>Eagle's Nest Townhouses</b> 11 Morning Glory Way & 31 Marcellina Lane Mt. Crested Butte, CO 81225	<b>DATE</b>	4/13/11
----------------	--	-------------	---------

WORK OBSERVED	
Phase II – Retaining Wall Repairs	
TRADES PRESENT	
None

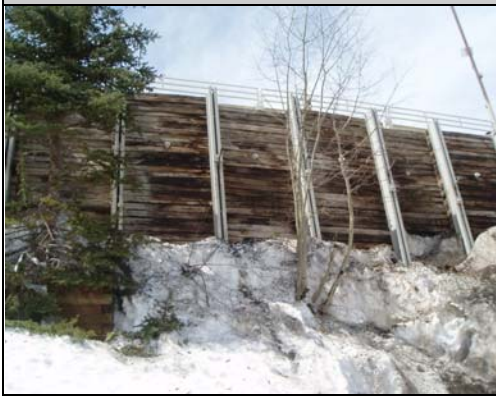
<p>4/13/11 – Photo 2 Upper Level Retaining Wall Repair</p> <p>The drill arm on the excavator is in place and rods are positioned with the boom lift from below. Rods are 10' in length and are coupled together and inserted 30' back into the bedrock.</p>	<p>Note</p>
 	<p>4/13/11 – Photo 3 Upper Level Retaining Wall Repair</p> <p>Pylons 1 through 3 have not been completed due to the snow.</p>	<p>Note</p>

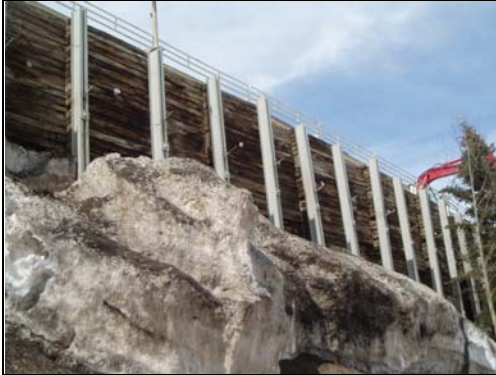
<p>4/13/11 – Photo 4 Upper Level Retaining Wall Repair</p> <p>Pylons 6 through 10 have been drilled. Once the grout injection sets, bolts will secure the rods to the soldier beams.</p>	<p>Note</p>

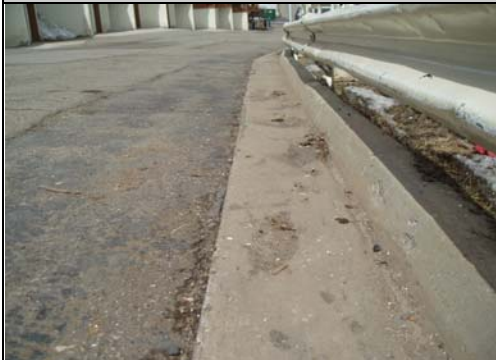
<p>4/13/11 – Photo 15 Lower Level Curb &amp; Gutter Condition Mid-way looking North.</p> <p>Curb is in fair condition.</p>	<p>Note</p>

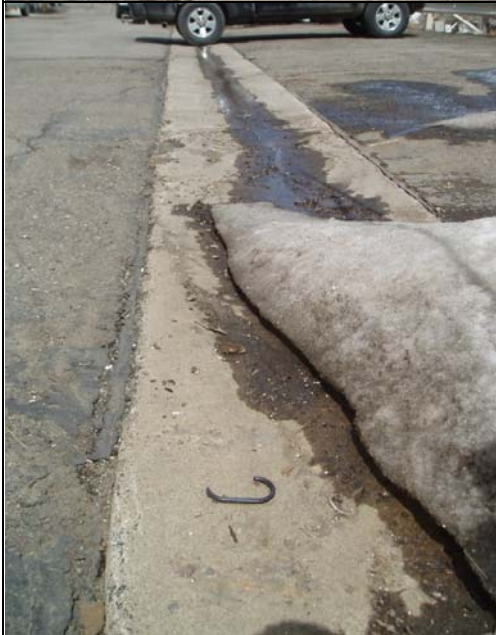
<p>4/13/11 – Photo 16 Lower Level Curb &amp; Gutter Condition</p> <p>Valley pan located along parking area is slated to be removed and replaced. The valley pan is in poor condition.</p>	<p>Note</p>

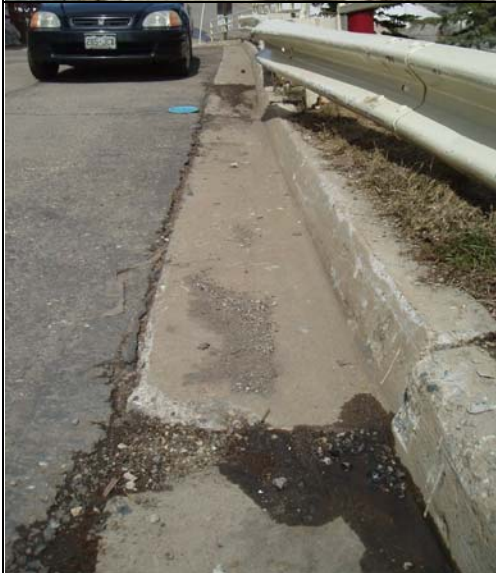
<p>4/13/11 – Photo 17 Lower Level Curb &amp; Gutter Condition</p> <p>Note the slight dip approximately 5' north of the parking area.</p>	<p>Note</p>

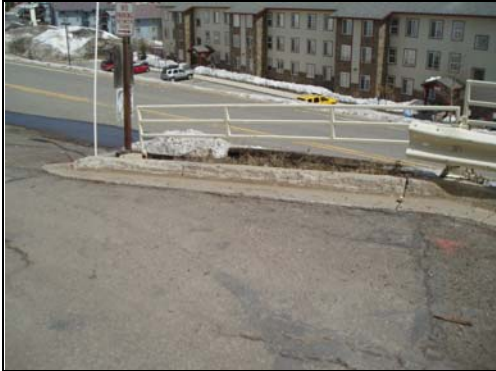
<p>4/13/11 – Photo 18 Lower Level Curb &amp; Gutter Condition</p> <p>Final northern portion of curb is in serviceable condition but has been damaged by snow removal.</p>	<p>Note</p>

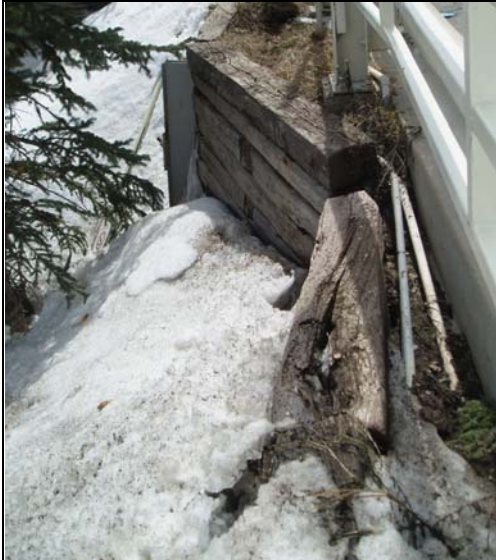
<p>4/13/11 – Photo 19 Lower Level Retaining Wall</p> <p>Photo of Lower Level retaining wall slated for repair.</p>	<p>Note</p>

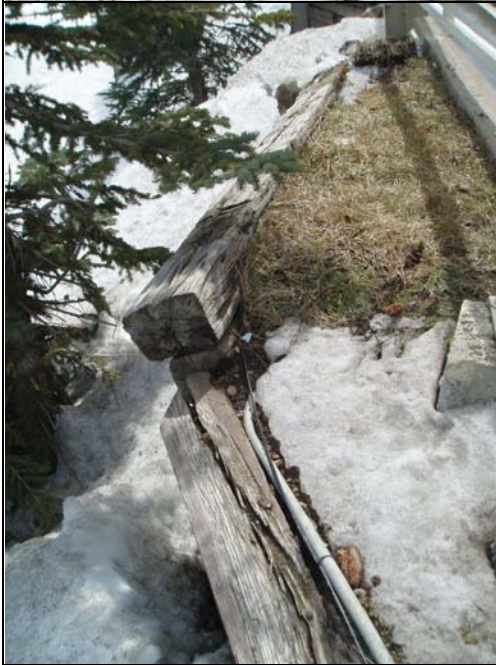
<p>4/13/11 – Photo 20 Lower Level Retaining Wall</p> <p>Photo of Lower Level retaining wall slated for repair.</p>	<p>Note</p>

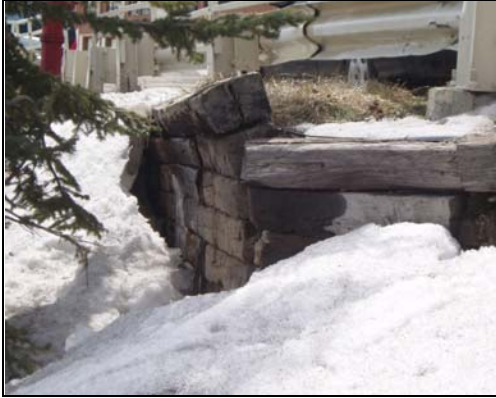
<p>4/13/11 – Photo 21 Lower Level Retaining Wall</p> <p>Photo of Lower Level retaining wall slated for repair.</p>	<p>Note</p>
