# ARCHITECT'S FIELD REPORT

064

<b>PROJECT</b>	<b>Eagle's Nest Townhouses</b> 11 Morning Glory Way & 31 Marcellina Lane Mt. Crested Butte, CO 81225	<b>DATE</b>	10/26/11
----------------	--	-------------	----------

WORK OBSERVED	
Water Test on Vinyl Garage Sill at Unit 32	
TRADES PRESENT	
None

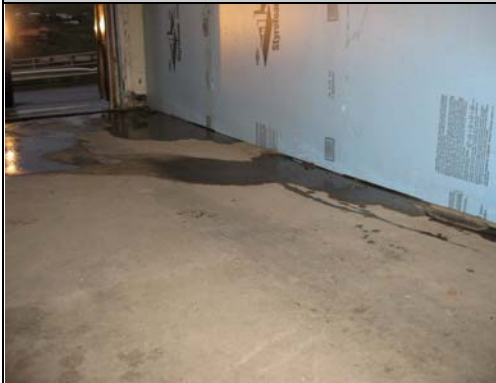
<p>Date Unknown, Summer 2011</p> <p>Example photo from the Home Owner's showing water infiltration and ponding in the garage.</p>	<p>Note</p>

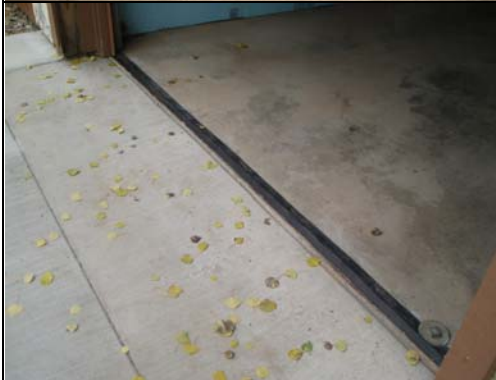
<p>10/25/11 – Photo 1 Unit 32 Garage Threshold</p> <p>Conditions before water test.</p>	<p>Note</p>

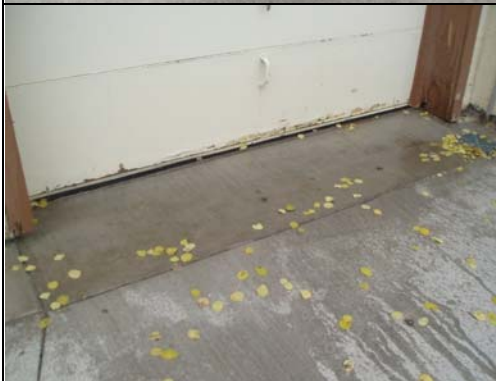
<p>10/25/11 – Photo 3 Unit 32 Garage Threshold</p> <p>Exterior conditions after the water test.</p>	<p>Note</p>
