ARCHITECT'S FIELD REPORT

019

PROJECT	Eagle's Nest Townhouses 11 Morning Glory Way & 31 Marcellina Lane Mt. Crested Butte, CO 81225	DATE	10/07/10
----------------	--	-------------	----------

WORK OBSERVED	
Phase I – Construction	
TRADES PRESENT	
Holgate Construction Company

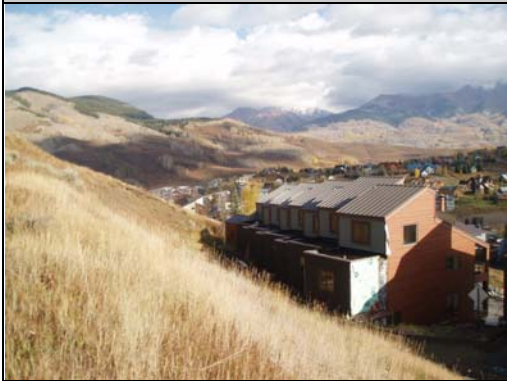
<p>10/06/10 – Photo 1 Upper Units</p> <p>Fall weather and recent rain brought the first dusting of snow at about 10,000 feet.</p>	<p>None</p>

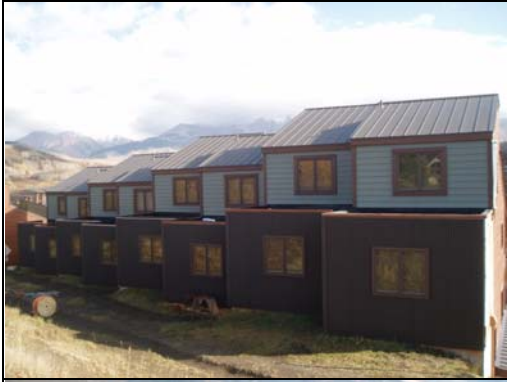
<p>10/06/10 – Photo 2 Units 1 through 8</p> <p>Rear elevations complete and awaiting installation of the metal parapet cap.</p>	<p>None</p>

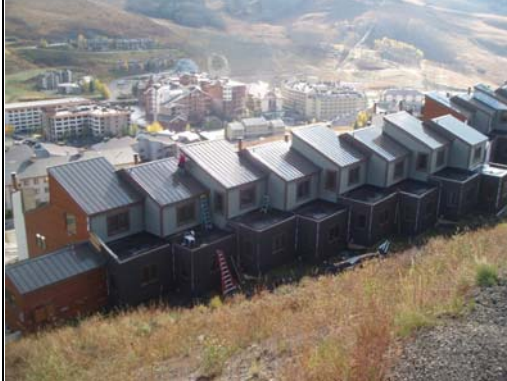
<p>10/06/10 – Photo 3 Units 9 through 16</p> <p>Mick is finishing up the last 2 gable ends completing the metal siding installation on the rear elevations of the Upper Units.</p>	<p>None</p>

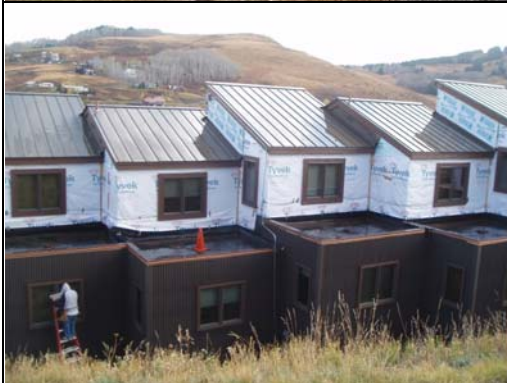
<p>10/06/10 – Photo 4 Units 17 through 20</p> <p>Corrugated metal installation nearing completion. Corner trim is being installed.</p>	<p>None</p>

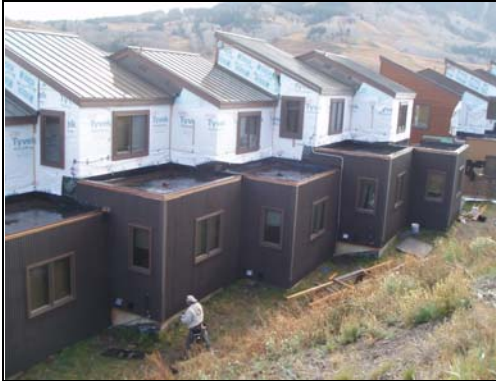
<p>10/06/10 – Photo 5 Units 21 through 24</p> <p>Corner trim installation underway.</p>	<p>None</p>

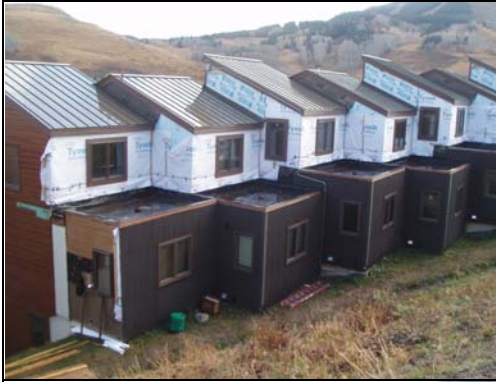
<p>10/06/10 – Photo 6 Units 25 through 28</p> <p>Corrugated metal and corner trim complete. Units are awaiting horizontal metal installation.</p>	<p>None</p>

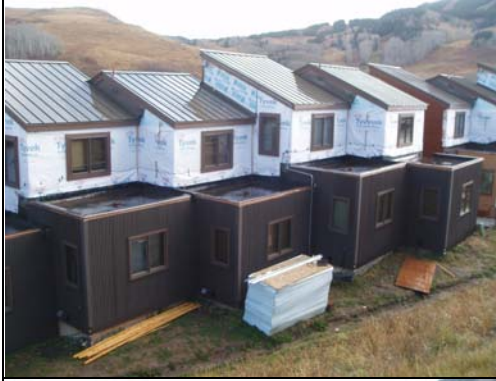
<p>10/06/10 – Photo 7 Units 29 through 32</p> <p>Corrugated metal and corner trim installation complete. Crews working here will move to window installation in the next 2 weeks.</p>	<p>None</p>

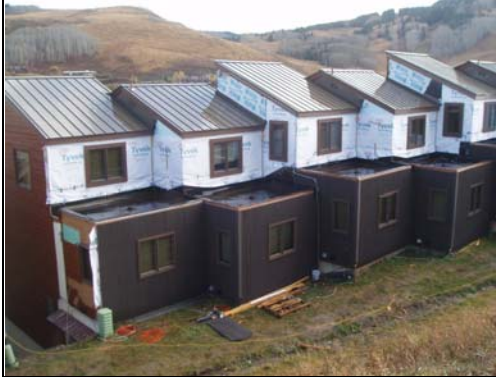
<p>10/06/10 – Photo 8 Units 33 through 36</p> <p>Installation of corrugated metal siding and corner trim is complete on the rear elevations.</p>	<p>None</p>

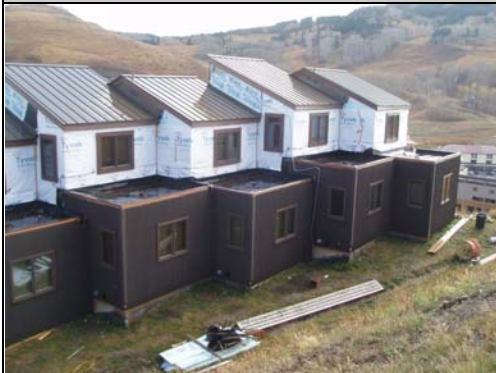
<p>10/06/10 – Photo 9 Units 37 through 40</p> <p>Corrugated metal siding and corner trim is complete.</p>	<p>None</p>

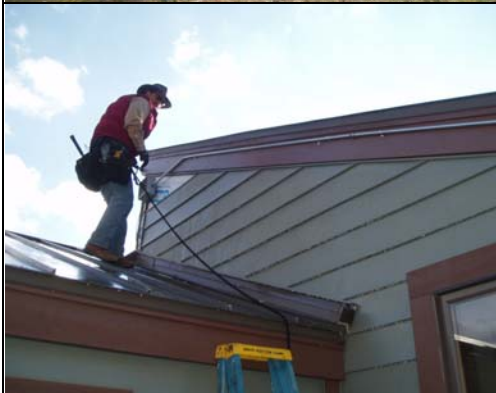
<p>10/06/10 – Photo 10 Unit 14</p> <p>Mick is finishing the last of the horizontal metal siding on the north walls of Units 14 and 6. Installation of siding on the rear of the Upper Units will be complete by the end of the day.</p>	<p>None</p>

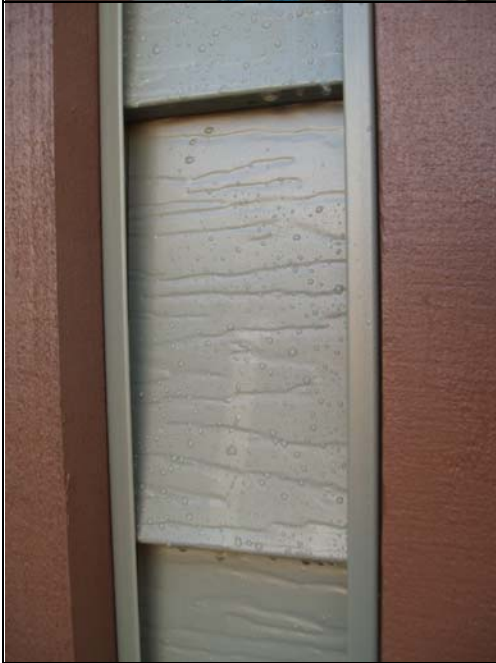
<p>10/06/10 – Photo 11 Detail, Unit 14</p> <p>Siding installed between the window trim and corner trim measures about 8”.</p>	<p>None</p>

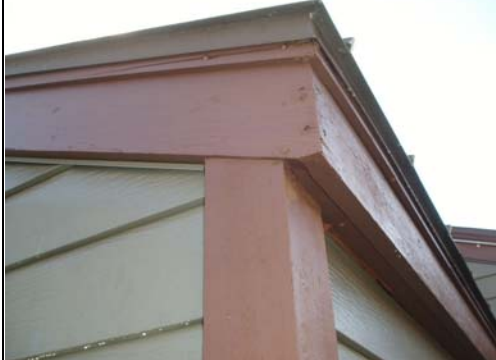
<p>10/06/10 – Photo 12 Unit 14</p> <p>Note the new corner trim next to the existing fascia. The fascia has been repainted but is weathered.</p>	<p>None</p>

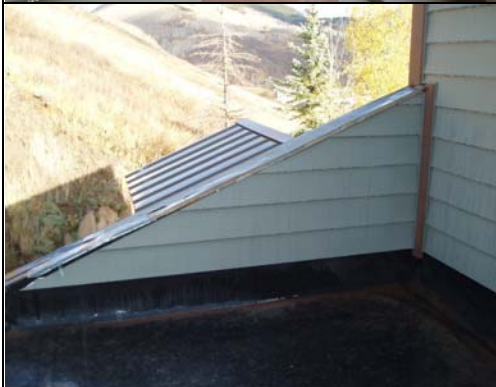
<p>10/06/10 – Photo 13 Unit 16 End Wall</p> <p>Note unique parapet wall at Unit 16. Sloped wall will receive a metal parapet cap.</p>	<p>None</p>

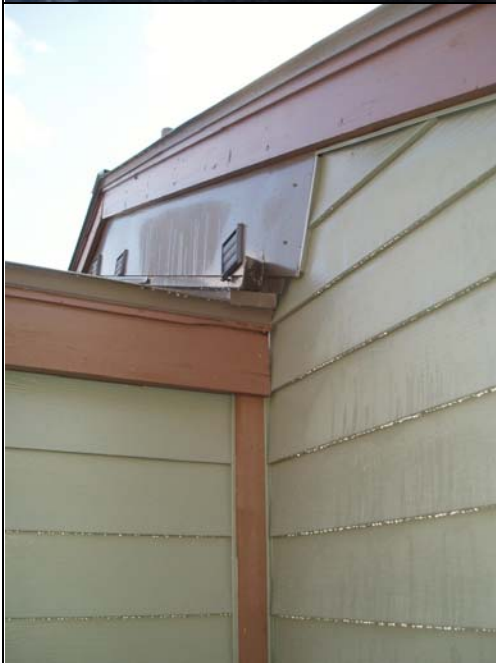
<p>10/06/10 – Photo 14 Unit 13 North Gable End</p> <p>Note the tie-in to new horizontal siding. J-channel is lapped underneath the existing solid metal flashing installed by the roofers last year.</p> <p>Note moisture from recent rain.</p>	<p>None</p>

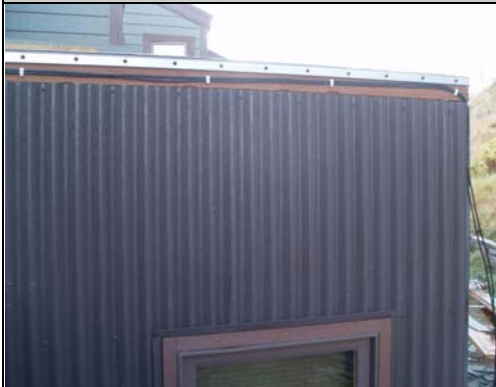
<p>10/06/10 – Photo 15 Unit 14, Coax Run</p> <p>Units are ready for metal parapet cap. Note the coax cable installed above the corrugated metal siding and running down the corner.</p>	<p>None</p>

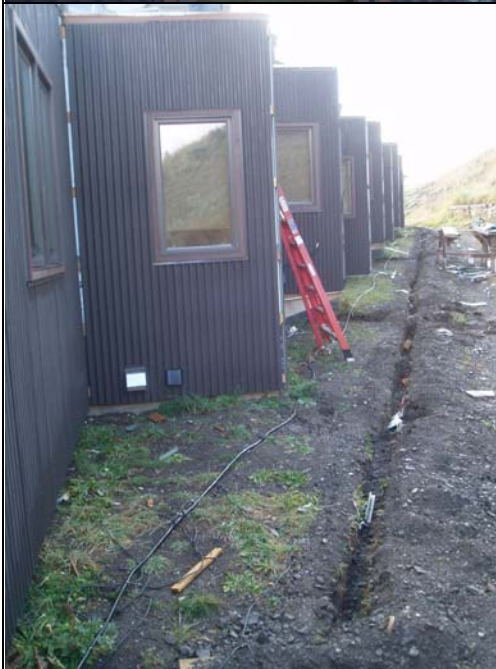
<p>10/06/10 – Photo 16 Coax Trench from Unit 16</p> <p>Trench is approximately 6” wide and 12” deep.</p>	<p>None</p>

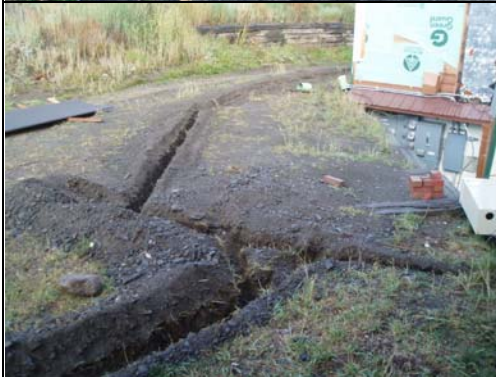
<p>10/06/10 – Photo 17 Coax Trench between Units 8 & 9</p> <p>Note connection trench to existing cable television pedestal.</p>	<p>None</p>

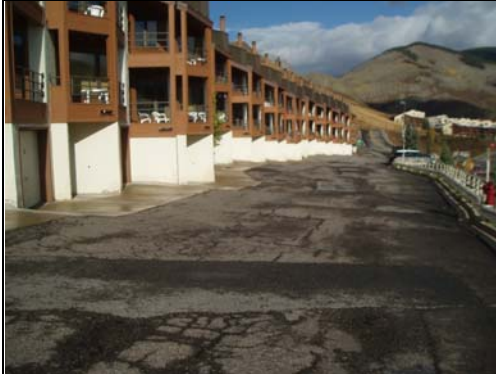
<p>10/06/10 – Photo 19</p> <p>Lower Level drive and parking. Area is completely clean with no visible construction activity.</p>	<p>None</p>

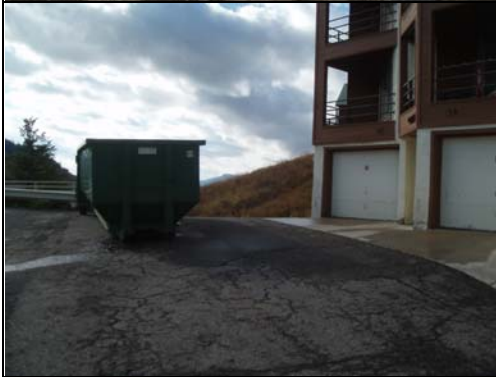
<p>10/06/10 – Photo 20</p> <p>Lower Level construction zone. Dumpster is about 75% full. Front parking area is clean.</p> <p>Debris not related to construction has been deposited on the south side of Unit 40. It appears to be old firewood bark.</p>	<p>None</p>
