ARCHITECT'S FIELD REPORT

093

| PROJECT | Eagle's Nest Townhouses 11 Morning Glory Way & 31 Marcellina Lane Mt. Crested Butte, CO 81225 | DATE | 10/23/12 |

| WORK OBSERVED | |
|--|--|
| Phase III Construction – Stone Installation; Stone Sealant, Chinking, Thresholds | |

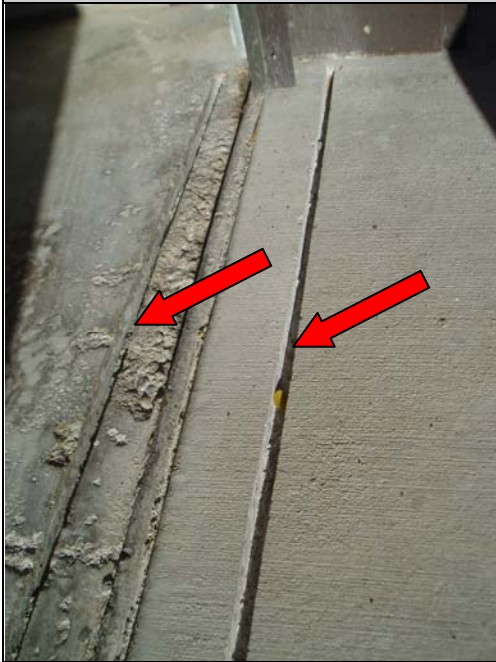
| PHOTO -WORK ITEM | DESCRIPTION | ACTION |
|--|--|---|
| | <p>10/23/12 – Photo 20 Unit 1 Threshold</p> <p>Grooves have been cut in the garage slab and valley pan to receive the new steel garage door threshold.</p> | <p>Note</p> |

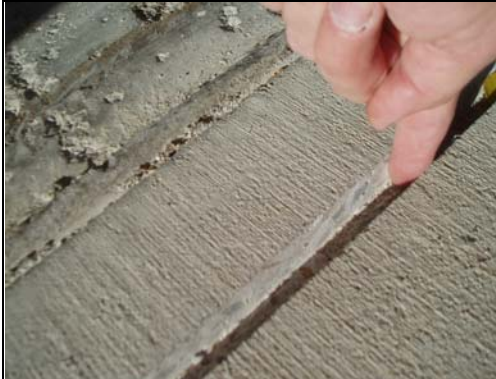
| PHOTO -WORK ITEM | DESCRIPTION | ACTION |
|--|--|---|
| | <p>10/23/12 – Photo 21 Unit 1 Threshold</p> <p>Groove is approximately 1/2" wide or the width of a finger.</p> | <p>Note</p> |
