ARCHITECT'S FIELD REPORT

061

PROJECT	Eagle's Nest Townhouses 11 Morning Glory Way & 31 Marcellina Lane Mt. Crested Butte, CO 81225	DATE	9/16/11
----------------	--	-------------	---------

WORK OBSERVED	
Phase II – Sewer and Asphalt; BWA Punch List Walk #3	
TRADES PRESENT	
None

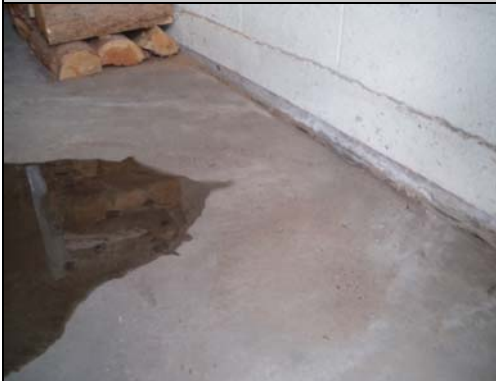
<p>9/15/11 – Photo 11 Unit 27</p> <p>Water is pooling due to slab settlement. Note paint line on right indicating original slab elevation.</p>	<p>Note</p>

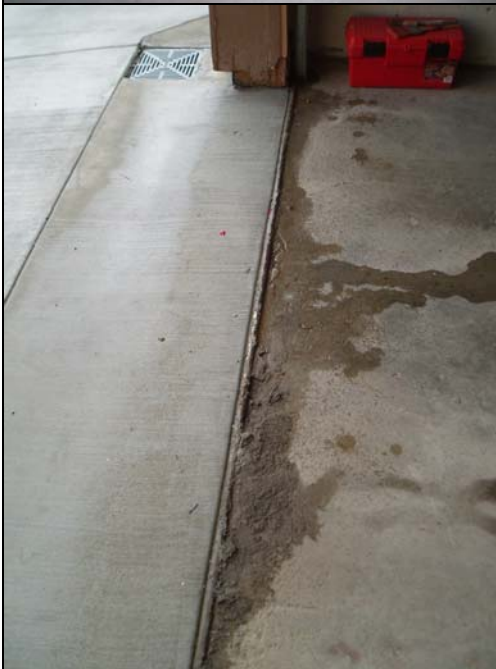
<p>9/15/11 – Photo 12 Unit 27</p> <p>Threshold looking south.</p>	<p>Note</p>

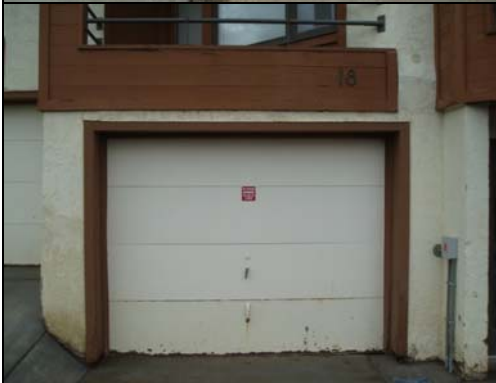
<p>9/15/11 – Photo 13 Unit 18</p> <p>Example Photo – Not on Punch List</p>	<p>Note</p>

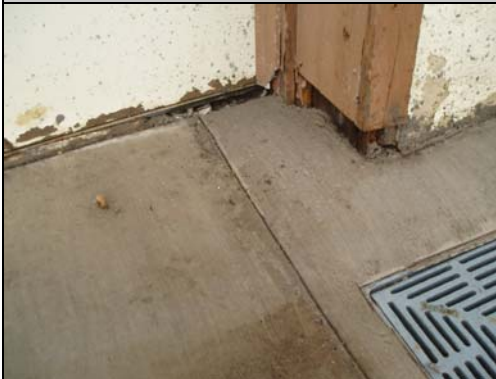
<p>9/15/11 – Photo 14 Unit 18 - Detail</p> <p>Example Photo – Not on Punch List</p>	<p>Note</p>

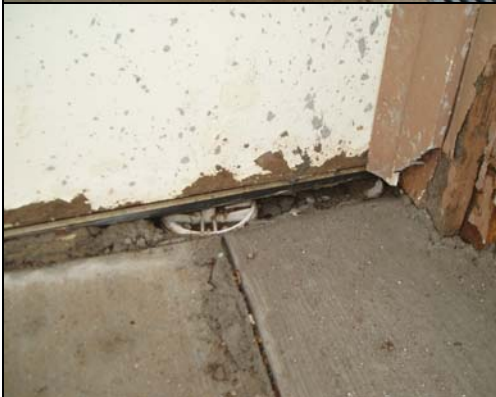
<p>9/15/11 – Photo 15 Unit 18 - Detail</p> <p>Example Photo – Not on Punch List</p> <p>Note Clean-Out directly underneath garage door. A neoprene seal might be appropriate in these instances.</p>	<p>Note</p>

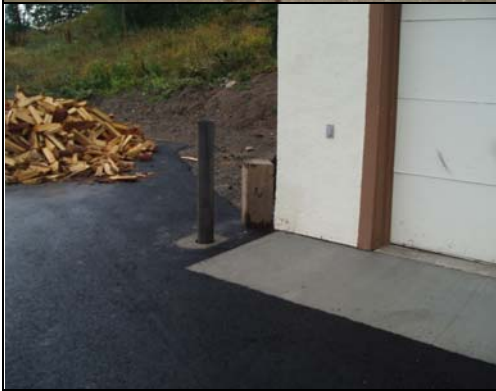
<p>9/15/11 – Photo 16 Upper Level Maintenance Shed</p> <p>Bollard is installed.</p>	<p>Note</p>
