ARCHITECT'S FIELD REPORT

PROJECT	<b>Eagle's Nest Townhouses</b> 11 Morning Glory Way & 31 Marcellina Lane Mt. Crested Butte, CO 81225	DATE	9/18/13
---------	--	------	---------

WORK OBSERVED	
Phase IV Construction – Completion of Lower Level Units	
TRADES PRESENT	
Holgate Construction Co.

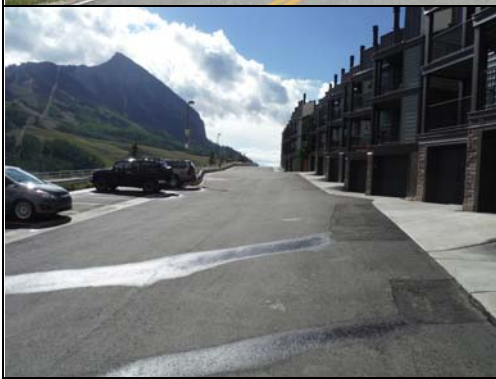
<p>9/18/13 – Photo 4 Lower Level Parking Lot</p> <p>Looking south. Holgate Construction has removed all materials and construction equipment from the parking lot.</p>	<p>Note</p>

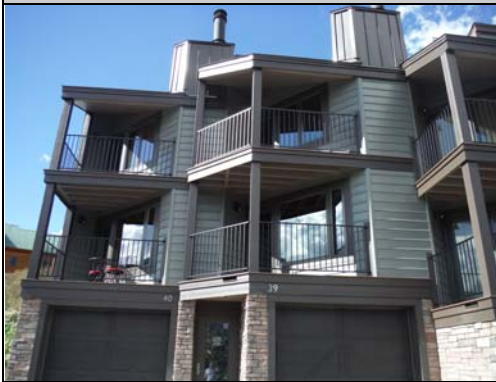
<p>9/18/13 – Photo 9 Units 40 &amp; 39</p> <p>Construction complete.</p>	<p>Note</p>

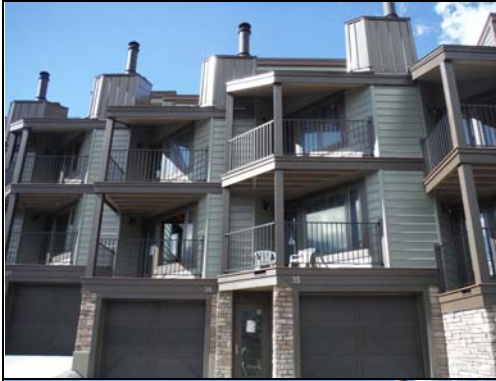
<p>9/18/13 – Photo 10 Units 38 &amp; 37</p> <p>Construction complete.</p>	<p>Note</p>

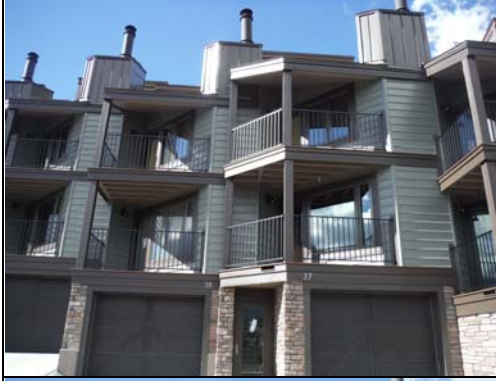
<p>9/18/13 – Photo 11 Units 36 &amp; 35</p> <p>Construction complete.</p>	<p>Note</p>

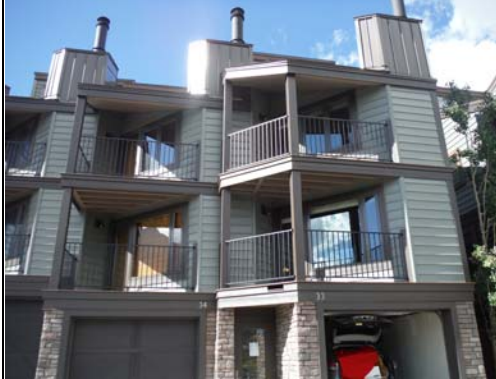
<p>9/18/13 – Photo 12 Units 34 &amp; 33</p> <p>Punch list inspection complete. Metal Chimney siding remaining.</p>	<p>Note</p>
