ARCHITECT'S FIELD REPORT

PROJECT	Eagle's Nest Townhouses 11 Morning Glory Way & 31 Marcellina Lane Mt. Crested Butte, CO 81225	DATE	6/12/13
---------	--	------	---------

WORK OBSERVED	
Phase IV Construction	
TRADES PRESENT	
Holgate Construction Co.

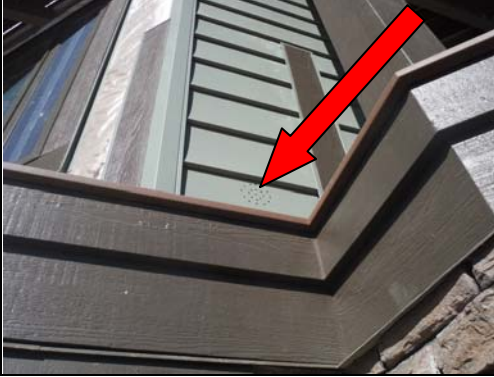
6/12/13 – Photo 12 Detail of Fireplace Combustion Air Vent Template was used to drill holes in the siding to accommodate the combustion air vents.	Note

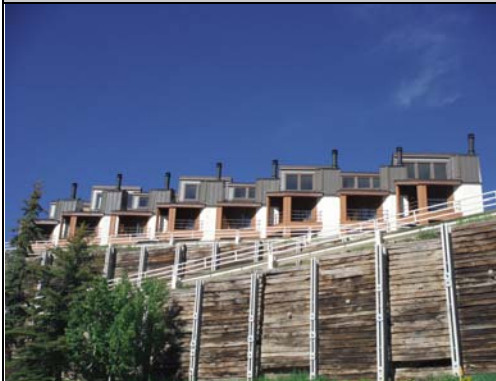
<p>6/12/13 – Photo 21 Upper Level Building B</p> <p>Chimney flues have been painted.</p>	Note

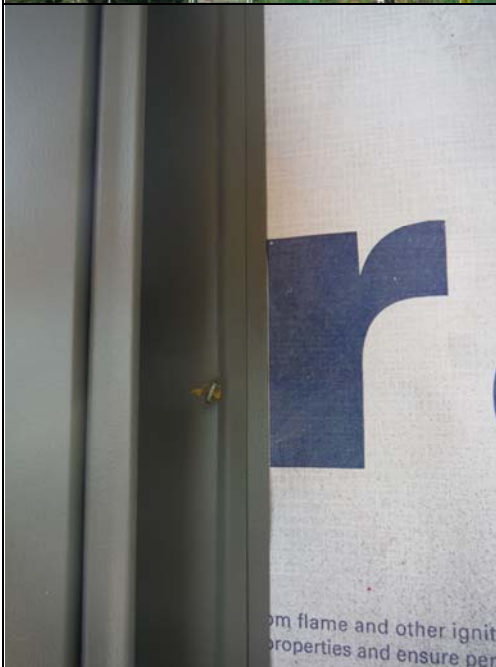
<p>6/12/13 – Photo 22 Detail of Corner Trim Attachment</p> <p>Note 1" staple. BW to coordinate attachment types with MH.</p>	Note
