ARCHITECT'S FIELD REPORT

122

PROJECT	Eagle's Nest Townhouses 11 Morning Glory Way & 31 Marcellina Lane Mt. Crested Butte, CO 81225	DATE	9/11/13
----------------	--	-------------	---------

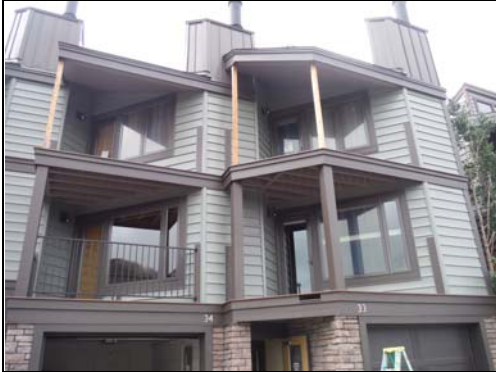
<p>9/11/13 – Photo 2 Units 33 & 34</p> <p>2nd Floor Post Wraps are complete. Guardrail installation underway.</p>	<p>Note</p>

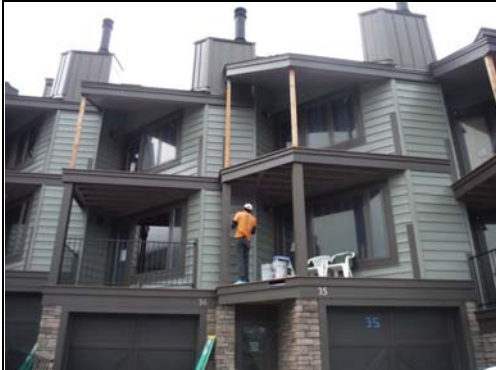
<p>9/11/13 – Photo 3 Units 35 & 36</p> <p>2nd Floor Post Wraps are complete. Guardrail installation underway.</p>	<p>Note</p>

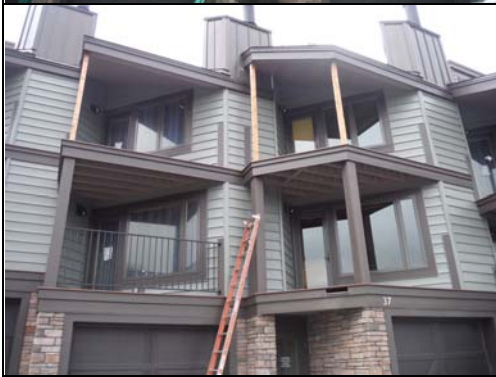
<p>9/11/13 – Photo 4 Units 37 & 38</p> <p>2nd Floor Post Wraps are complete. Guardrail installation underway.</p>	<p>Note</p>

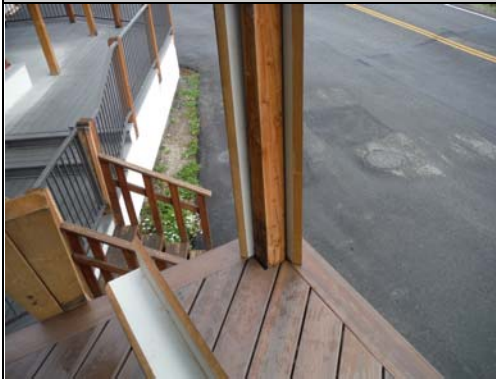
<p>9/11/13 – Photo 9 Unit 17 Balcony 2nd Floor</p> <p>Photo of wood post wrap installation.</p>	<p>Note</p>
 	<p>9/11/13 – Photo 10 Unit 17 Balcony 2nd Floor</p> <p>Completed Fiberon Deck installation.</p>	<p>Note</p>

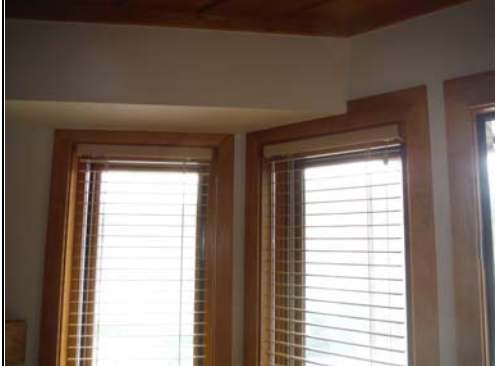
<p>9/11/13 – Photo 11 Unit 17 2nd Floor Interior Trim</p> <p>Completed interior trim. Minor touch-up still needed.</p>	<p>Note</p>
 	<p>9/11/13 – Photo 12 Unit 17 2nd Floor Interior Trim</p> <p>Completed interior trim. Minor touch-up still needed.</p>	<p>Note</p>
