**ARCHITECT'S FIELD REPORT**

**097**

<b>PROJECT</b>	<b>Eagle's Nest Townhouses</b> 11 Morning Glory Way & 31 Marcellina Lane Mt. Crested Butte, CO 81225	<b>DATE</b>	1/25/13
----------------	--	-------------	---------

<b>WORK OBSERVED</b>	
Phase III Construction – Garage Door Operation and Threshold Conditions	
<b>TRADES PRESENT</b>

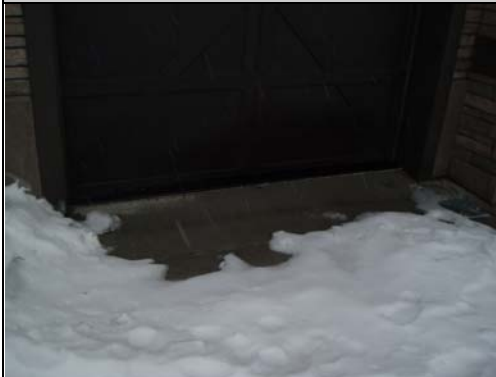
<p>1/24/13 – Photo 5 Unit #5</p> <p>Garage Door Operation: No opener; door opens; bottom track of door loose. Garage Threshold: Dry</p>	<p><b>MH</b></p>

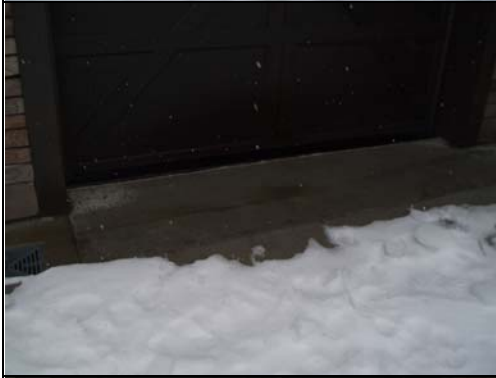
<p>1/24/13 – Photo 6 Unit #6</p> <p>Garage Door Operation: No opener; door track on north side high is loose. Garage Threshold: Dry</p>	<p><b>MH</b></p>

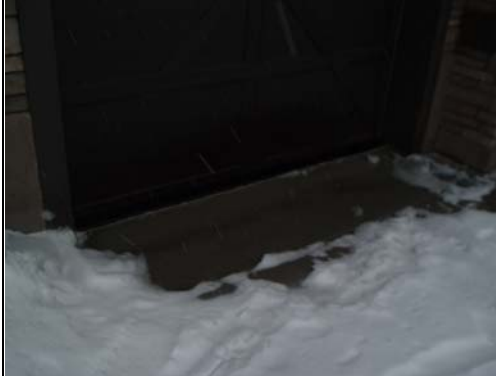
<p>1/24/13 – Photo 7 Unit #7</p> <p>Garage Door Operation: Okay Garage Threshold: Slightly damp on north side, not a significant amount of water.</p>	<p>Note</p>

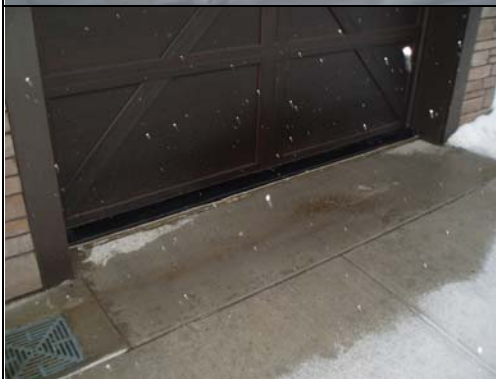
<p>1/24/13 – Photo 8 Unit #8</p> <p>Garage Door Operation: Okay Garage Threshold: Dry</p>	<p>Note</p>

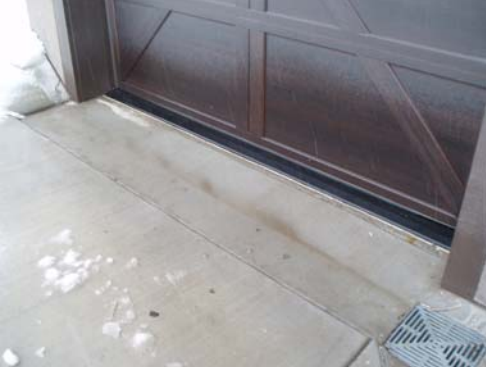
<p>1/24/13 – Photo 29 Unit #28</p> <p>Garage Door Operation: Okay Garage Threshold: Dry</p>	<p>Note</p>

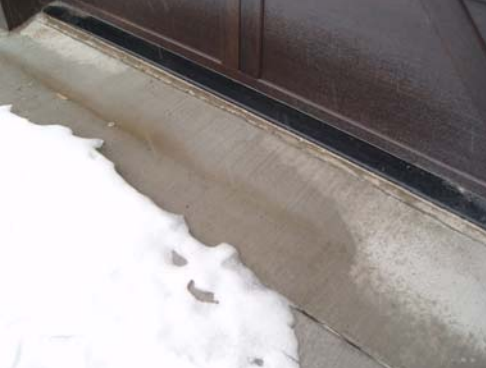
<p>1/24/13 – Photo 30 Unit #29</p> <p>Garage Door Operation: Okay Garage Threshold: Dry</p>	<p>Note</p>
 	<p>1/24/13 – Photo 31 Unit #30</p> <p>Garage Door Operation: Garage door opener stuck in up position. Likely due to faulty eye. Garage Threshold: Dry</p>	<p>Home Owner?</p>

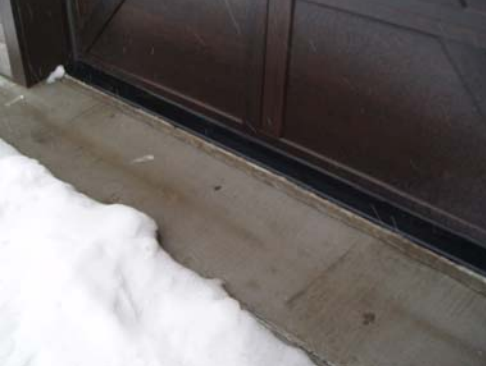
<p>1/24/13 – Photo 32 Unit #31</p> <p>Garage Door Operation: Okay; did not fully open door as one eye was red. Garage Threshold: Dry</p>	<p>Note</p>

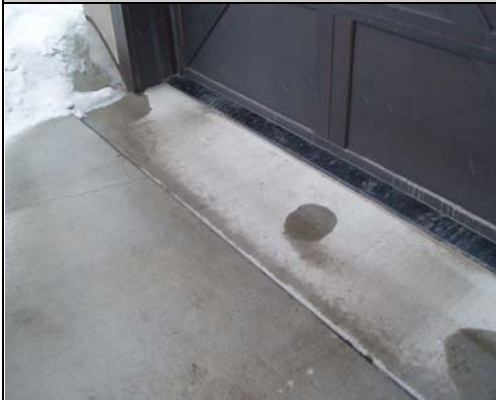
<p>1/24/13 – Photo 37 Unit #36</p> <p>Garage Door Operation: Okay Garage Threshold: Dry</p>	<p>Note</p>

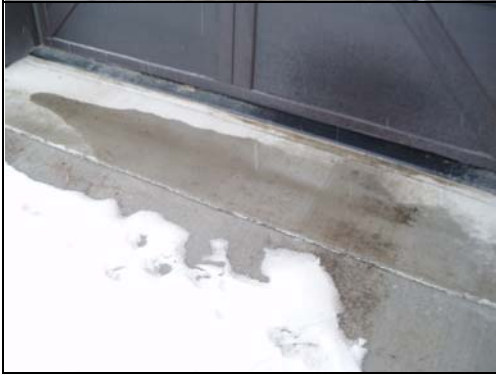
<p>1/24/13 – Photo 38 Unit #37</p> <p>Garage Door Operation: Okay; Door rubs on garage door track. Garage Threshold: Dry</p>	<p>Note</p>

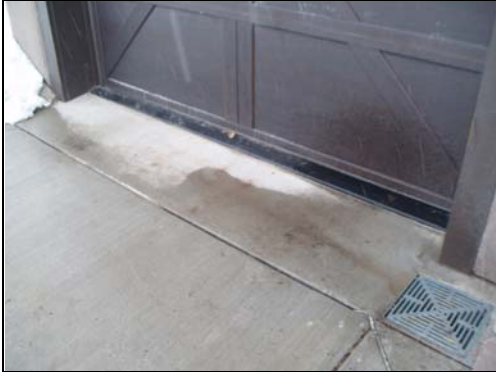
<p>1/24/13 – Photo 39 Unit #38</p> <p>Garage Door Operation: Okay Garage Threshold: Dry</p>	<p>Note</p>
 	<p>1/24/13 – Photo 40 Unit #39</p> <p>Garage Door Operation: Okay Garage Threshold: Dry</p>	<p>Note</p>

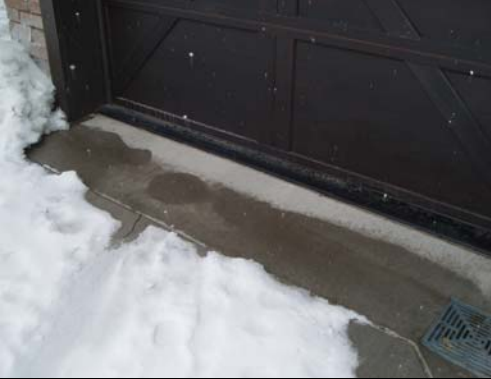
<p>1/24/13 – Photo 41 Unit #40</p> <p>Garage Door Operation: No Opener; disconnected bolt but could not open door. Garage Threshold: Dry</p>	<p>MH</p>
