ARCHITECT'S FIELD REPORT

075

PROJECT	Eagle's Nest Townhouses 11 Morning Glory Way & 31 Marcellina Lane Mt. Crested Butte, CO 81225	DATE	6/5/12
----------------	--	-------------	--------

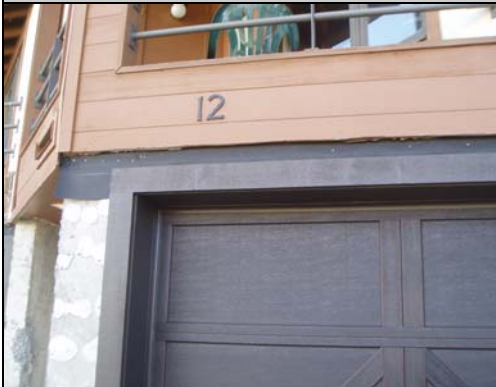
<p>6/5/12 – Photo 5 Unit 12</p> <p>Completed trim and door.</p>	<p>Note</p>
 	<p>6/5/12 – Photo 6 Unit 12</p> <p>Door trim. Note split on northern trim piece.</p>	<p>Note</p>
 	<p>6/5/12 – Photo 7 Upper Level Work Area</p> <p>Area is clean and well organized.</p>	<p>Note</p>

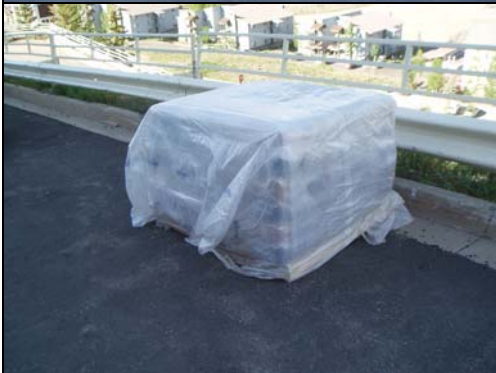
PHOTO –WORK ITEM	DESCRIPTION	ACTION
 	<p>6/5/12 – Photo 8 Upper Level Work Area</p> <p>Note trailer with old garage doors and mortar mix.</p>	<p>Note</p>
