# ARCHITECT'S FIELD REPORT

071

<b>PROJECT</b>	<b>Eagle's Nest Townhouses</b> 11 Morning Glory Way & 31 Marcellina Lane Mt. Crested Butte, CO 81225	<b>DATE</b>	5/8/12
----------------	--	-------------	--------

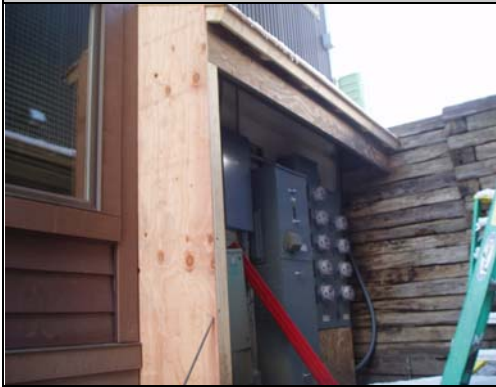
<p>5/08/12 – Photo 1 Unit 33 Electrical Meter Shed</p> <p>Framing is in place.</p>	<p>Note</p>

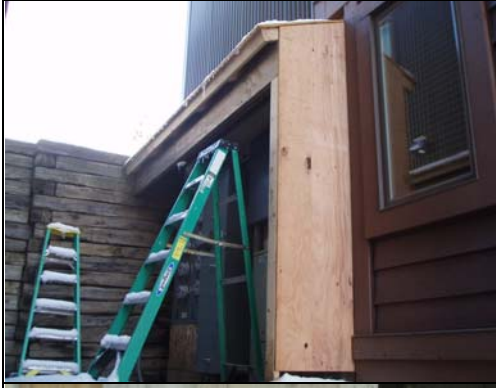
<p>5/08/12 – Photo 2 Unit 32 Electrical Meter Shed</p> <p>Framing is in place.</p>	<p>Note</p>

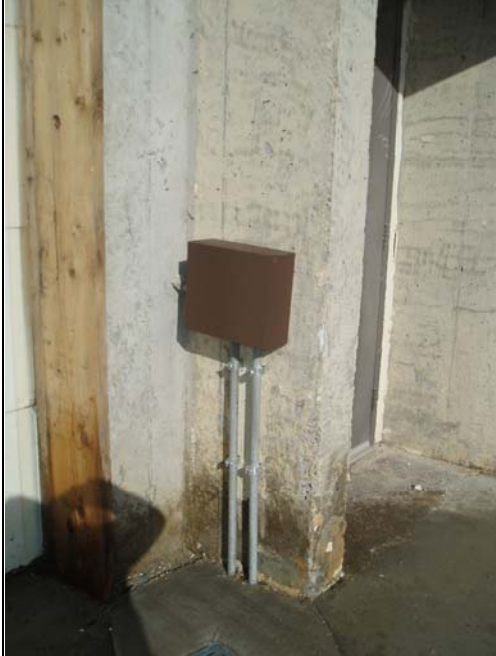
<p>5/08/12 – Photo 3 Example Snow Melt Control Box Cover</p> <p>Mick will cut approximately 1-1/2" diameter holes adjacent to the thermostat (lower left hand corner.)</p>	<p>Note</p>

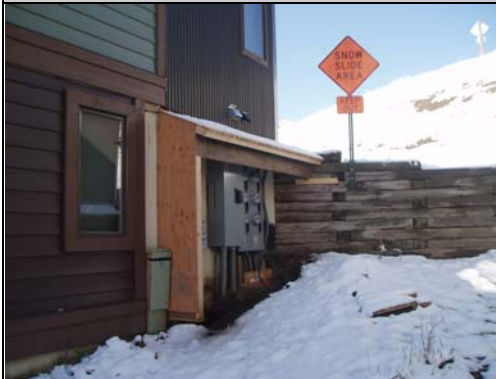
<p>A photograph showing the exterior of a building with dark wood siding. A wooden frame for an electrical meter shed is visible. A snow-covered path leads to the shed. In the background, a red diamond-shaped sign reads 'SNOW SLIDE AREA'.</p>	<p>5/08/12 – Photo 4 Unit 8 Electrical Meter Shed</p> <p>Framing is in place.</p>	<p>Note</p>

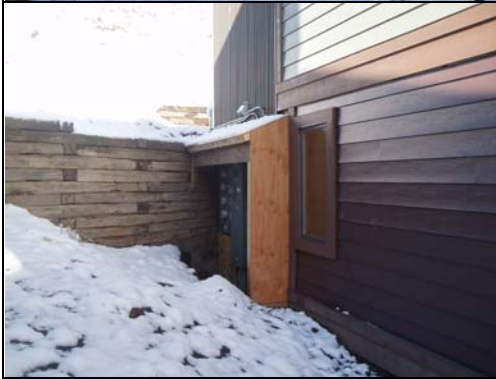
<p>A photograph showing the exterior of a building with dark wood siding. A wooden frame for an electrical meter shed is visible. A snow-covered path leads to the shed.</p>	<p>5/08/12 – Photo 5 Unit 9 Electrical Meter Shed</p> <p>Framing is in place.</p>	<p>Note</p>

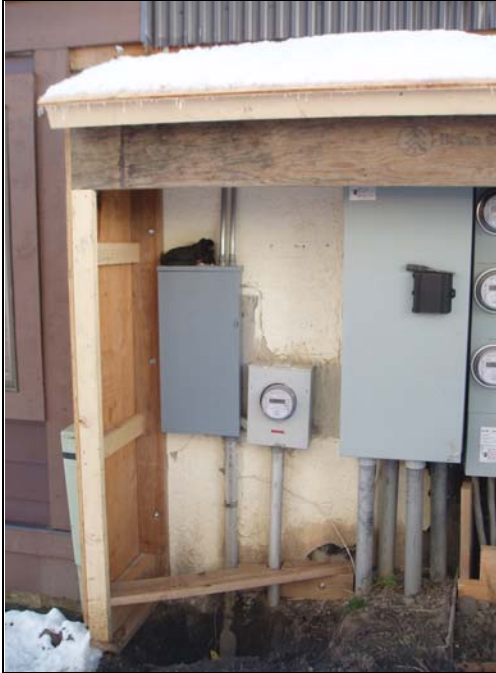
<p>A close-up photograph of the electrical meter shed. It shows a wooden frame with a corrugated metal roof. Two electrical meters are mounted on the wall. The structure is supported by a wooden LVL header and bracing at the lower corner. The end wall is held off the ground.</p>	<p>5/08/12 – Photo 6 Unit 8 Electrical Meter Shed Detail</p> <p>Note LVL Header and bracing at lower corner. End wall is held off the ground.</p>	<p>Note</p>

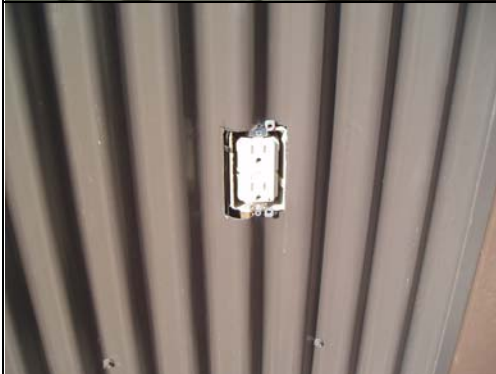
<p>5/08/12 – Photo 11 Maintenance Shed Exterior Outlet</p> <p>GFCI outlet has been installed.</p>	<p>Note</p>

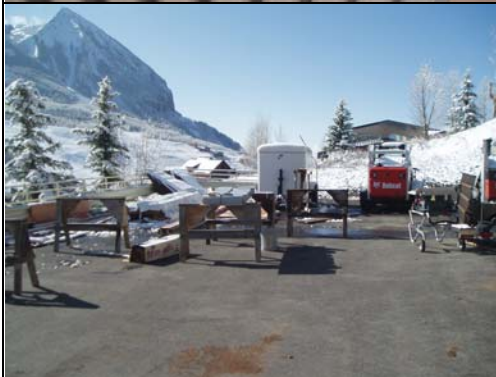
<p>5/08/12 – Photo 12 Upper Level Work Area</p> <p>Site is in good order.</p>	<p>Note</p>

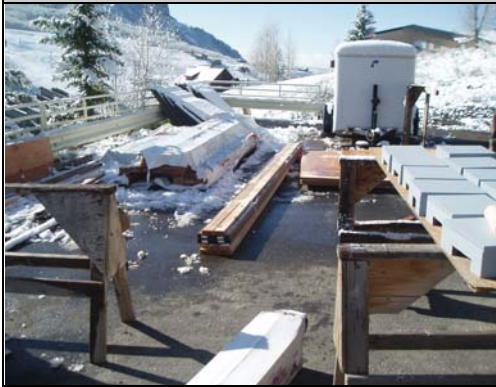
<p>5/08/12 – Photo 13 Upper Level Work Area</p> <p>Note wood trim is on site.</p>	<p>Note</p>

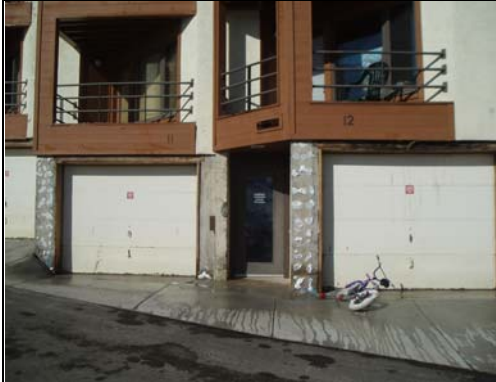
<p>5/08/12 – Photo 14 Unit 12 – Extent of Entry Door Trim</p> <p>Entry door trim installation is underway.</p>	<p>Note</p>
