ARCHITECT'S FIELD REPORT

133

PROJECT	Eagle's Nest Townhouses 11 Morning Glory Way & 31 Marcellina Lane Mt. Crested Butte, CO 81225	DATE	11/27/13
---------	--	------	----------

WORK OBSERVED	
Phase IV Construction – Upper Level Renovations	
TRADES PRESENT	
Holgate Construction Co.

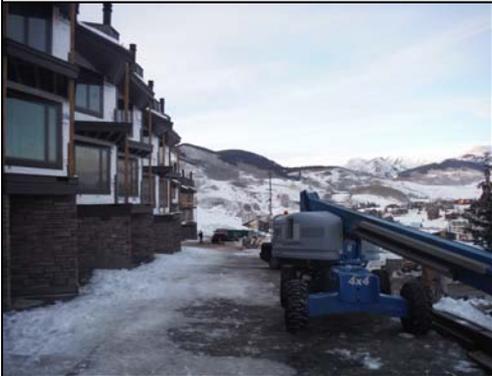
<p>11/27/13 – Photo 1 Upper Level Looking North</p> <p>Work area conditions.</p>	<p>Note</p>

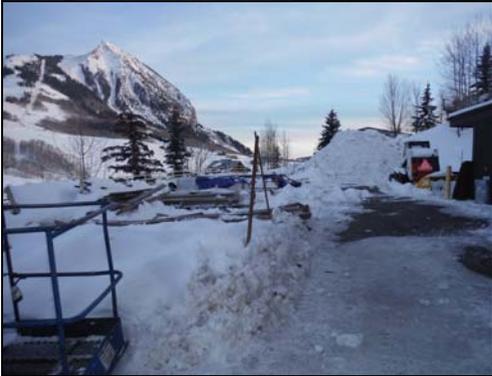
<p>11/27/13 – Photo 2 Upper Level Looking South</p> <p>Materials are stored close enough to the guardrail to allow for snow removal.</p>	<p>Note</p>

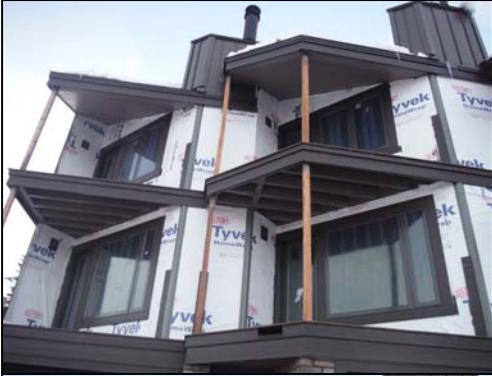
<p>11/27/13 – Photo 3 Units 1 & 2</p> <p>Exterior trim work is complete. Awaiting siding installation.</p>	<p>Note</p>

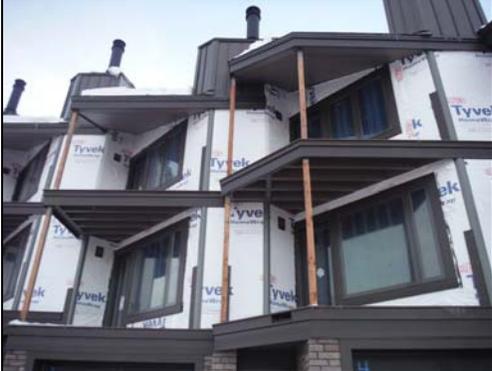
<p>11/27/13 – Photo 4 Units 3 & 4</p> <p>Exterior trim work is complete. Awaiting siding installation.</p>	<p>Note</p>

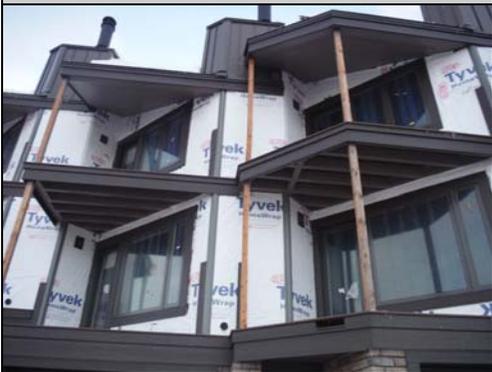
<p>11/27/13 – Photo 5 Units 5 & 6</p> <p>Exterior trim work is complete. Awaiting siding installation.</p>	<p>Note</p>

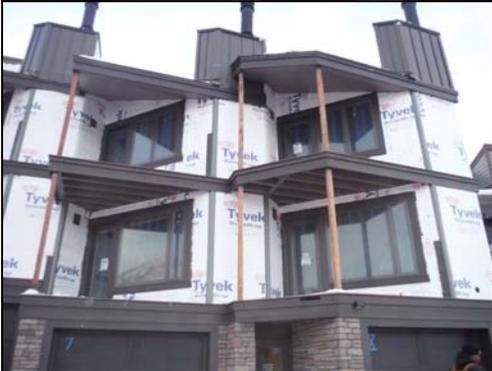
<p>11/27/13 – Photo 6 Units 7 & 8</p> <p>Exterior trim work is complete. Awaiting siding installation.</p>	<p>Note</p>

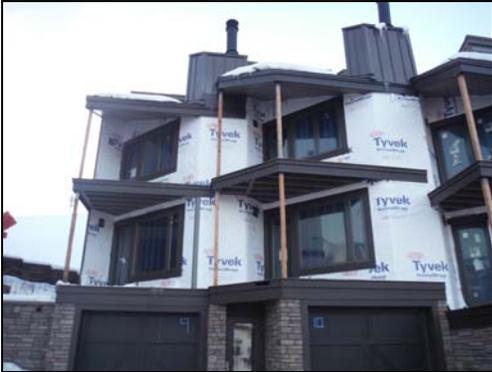
<p>11/27/13 – Photo 7 Units 9 & 10</p> <p>Exterior trim work is complete. Awaiting siding installation.</p>	<p>Note</p>

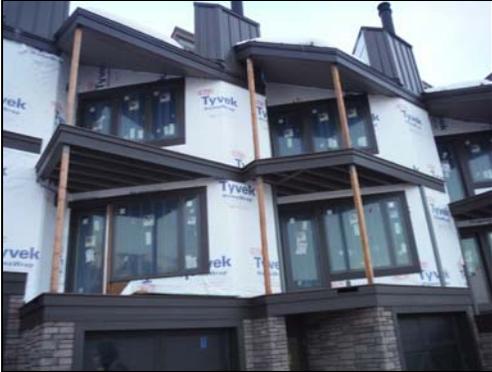
<p>11/27/13 – Photo 8 Units 11 & 12</p> <p>Exterior trim work is complete. Awaiting siding installation.</p>	<p>Note</p>

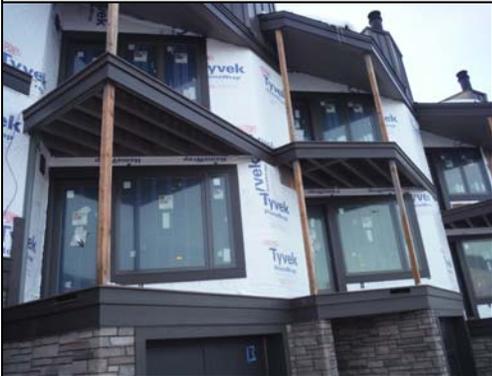
<p>11/27/13 – Photo 9 Units 13 & 14</p> <p>Exterior trim work is complete. Awaiting siding installation.</p>	<p>Note</p>

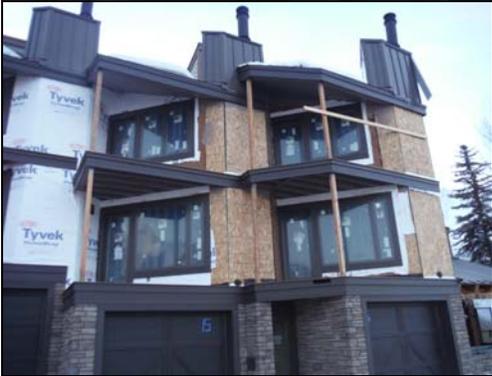
<p>11/27/13 – Photo 10 Units 15 & 16</p> <p>Exterior trim work is complete. A small amount of Tyvek has yet to be installed. Awaiting siding installation.</p>	<p>Note</p>

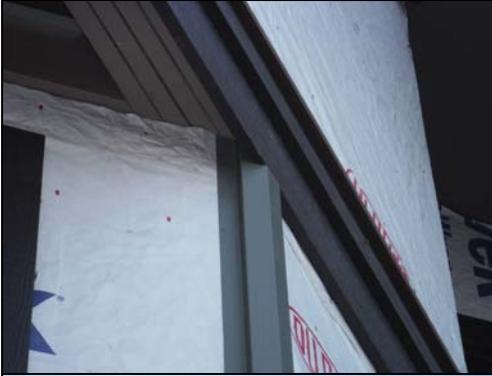
<p>11/27/13 – Photo 11 Typical Corner Trim Installation</p> <p>Detail level has remained consistent despite the cold weather.</p>	<p>Note</p>

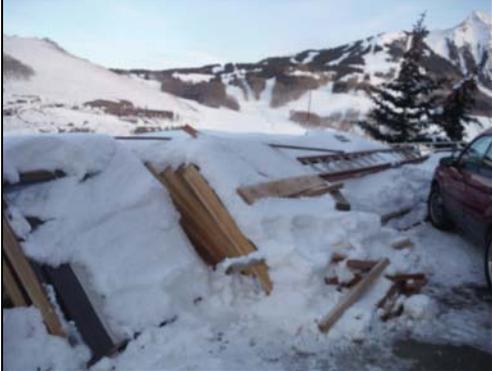
<p>11/27/13 – Photo 12 Stockpiled Windows</p> <p>Old windows have yet to be removed from the site.</p>	<p>Note</p>

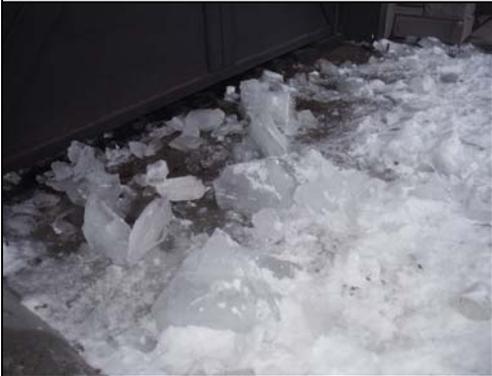
<p>11/27/13 – Photo 13 Building A, Typical Roof Ice</p> <p>Workers have removed ice along the roof eave with the high lift.</p>	<p>Note</p>

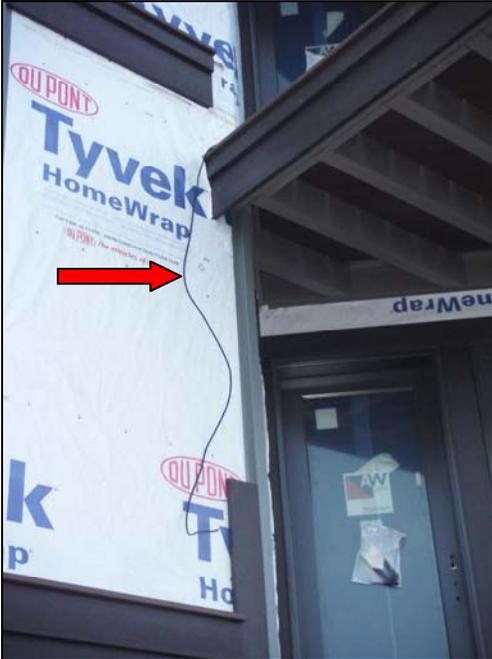
<p>11/27/13 – Photo 14 Unit 13</p> <p>It appears that a cable TV line was severed during demolition.</p>	<p>MHC</p>
