**ARCHITECT'S FIELD REPORT**

**069**

<b>PROJECT</b>	<b>Eagle's Nest Townhouses</b> 11 Morning Glory Way & 31 Marcellina Lane Mt. Crested Butte, CO 81225	<b>DATE</b>	4/24/12
----------------	--	-------------	---------

<b>WORK OBSERVED</b>	
Phase III - Demolition	
<b>TRADES PRESENT</b>	
Holgate Construction

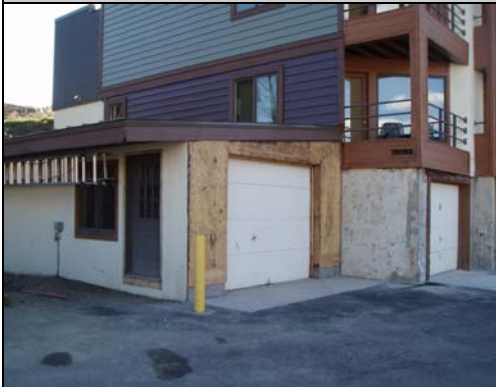
<p>4/24/12 – Photo 1 Upper Level Maintenance Shed</p> <p>Front demolition complete.</p>	<p>Note</p>

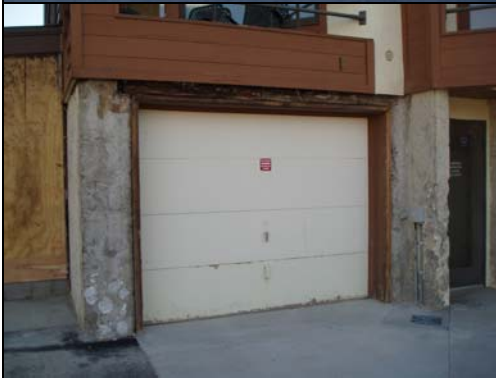
<p>4/24/12 – Photo 2 Unit 1</p> <p>Demolition complete. Awaiting repair of pilaster (column) next to entry door.</p>	<p>Note</p>

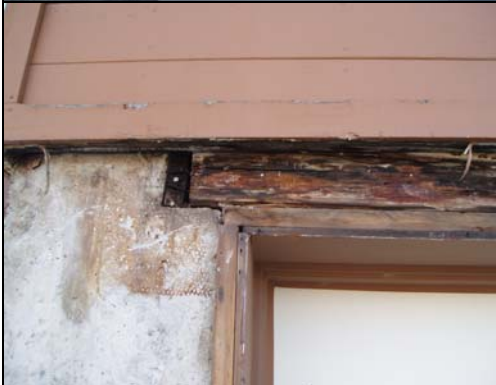
<p>4/24/12 – Photo 3 Unit 1 Detail</p> <p>Degraded condition of garage door header. Recommend replacement of header.</p>	<p>ENT</p>

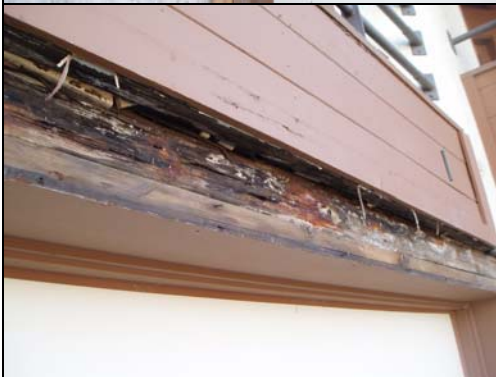
<p>4/24/12 – Photo 4 Unit 1 Detail</p> <p>Degraded condition of garage door header. Note sag and decay.</p>	<p>ENT</p>

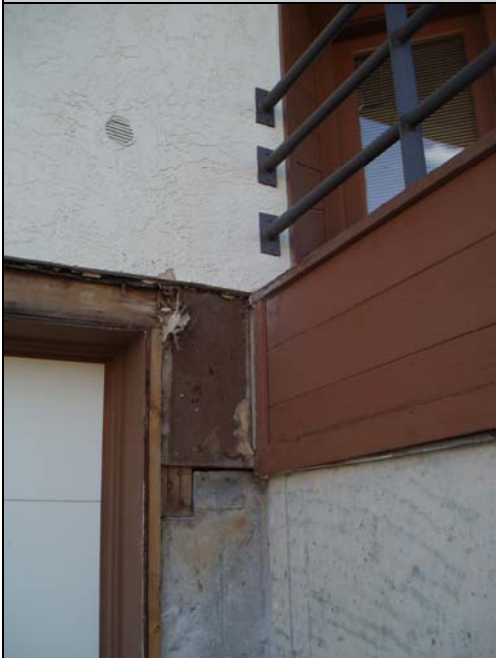
<p>4/24/12 – Photo 9 Unit 6 - Detail</p> <p>Typical condition at step between units. Adhered stone veneer will span over wood frame at these 15 locations.</p>	<p>Note</p>
 	<p>4/24/12 – Photo 10 Unit 7</p> <p>Demolition complete.</p>	<p>Note</p>

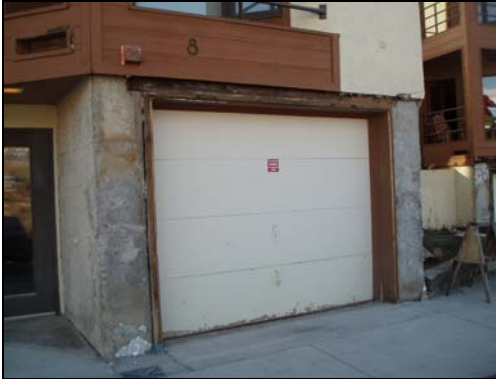
<p>4/24/12 – Photo 11 Unit 8</p> <p>Demolition complete.</p>	<p>Note</p>

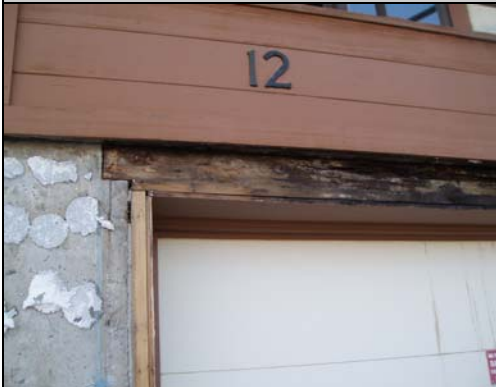
<p>4/24/12 – Photo 16 Unit 12 Detail</p> <p>Degraded condition of garage door header.</p>	<p>ENT</p>
 	<p>4/24/12 – Photo 17 Unit 12 Detail</p> <p>Degraded condition of garage door header. Recommend replacement of header.</p>	<p>ENT</p>
 	<p>4/24/12 – Photo 18 Units 14 &amp; 15</p> <p>Demolition complete.</p>	<p>Note</p>
 	<p>4/24/12 – Photo 19 Unit 16</p> <p>Demolition complete.</p>	<p>Note</p>

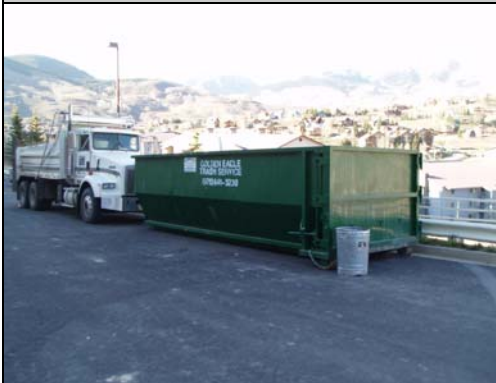
<p>4/24/12 – Photo 20 Lower Level Dumpster</p> <p>Dumpster is on-site and approximately 1/3 full.</p>	<p>Note</p>

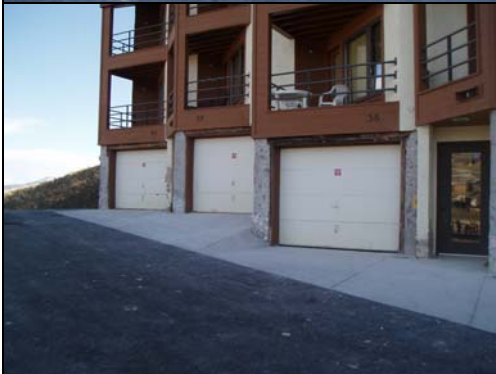
<p>4/24/12 – Photo 21 Units 40, 39, and 38</p> <p>Demolition underway.</p>	<p>Note</p>

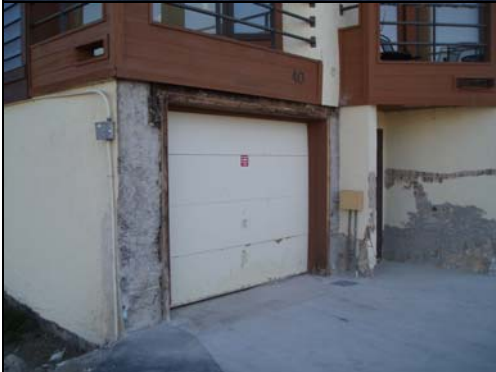
<p>4/24/12 – Photo 22 Unit 40</p> <p>Demolition underway.</p>	<p>Note</p>

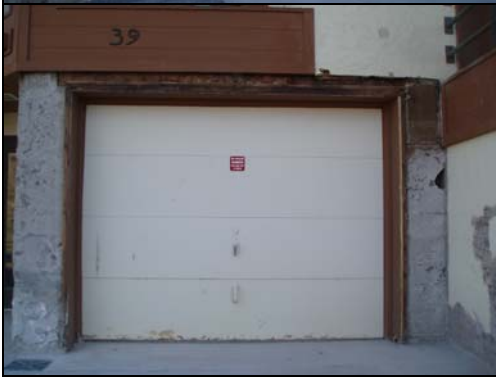
<p>4/24/12 – Photo 23 Unit 39</p> <p>Demolition underway.</p>	<p>Note</p>

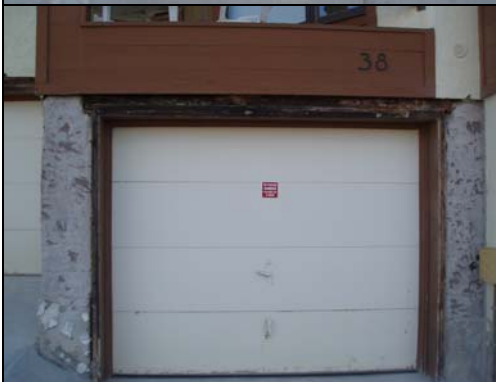
<p>4/24/12 – Photo 25 Unit 38</p> <p>Demolition underway.</p>	<p>Note</p>

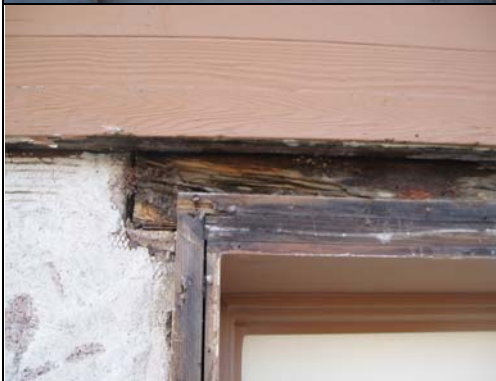
<p>4/24/12 – Photo 26 Unit 38 Detail</p> <p>Degraded condition of garage door header. Recommend replacement of header.</p>	<p>ENT</p>

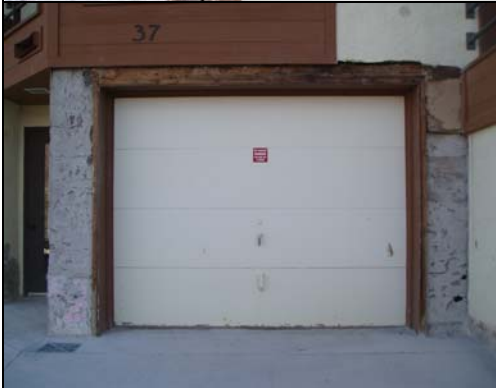
<p>4/24/12 – Photo 27 Unit 37</p> <p>Demolition underway.</p>	<p>Note</p>

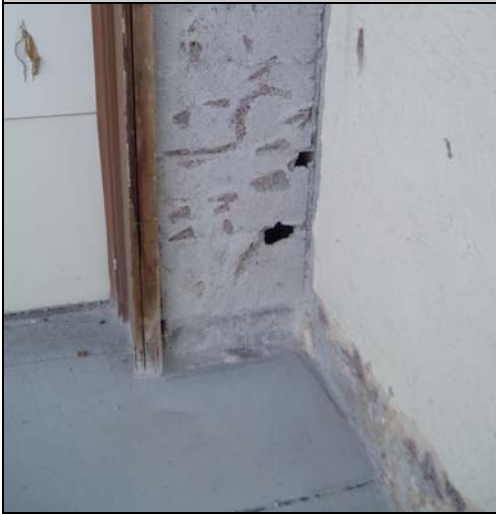
<p>4/24/12 – Photo 28 Unit 37 Detail</p> <p>Note damage to CMU basement walls. Recommend repairs to wall prior to stone installation.</p>	<p>Note</p>

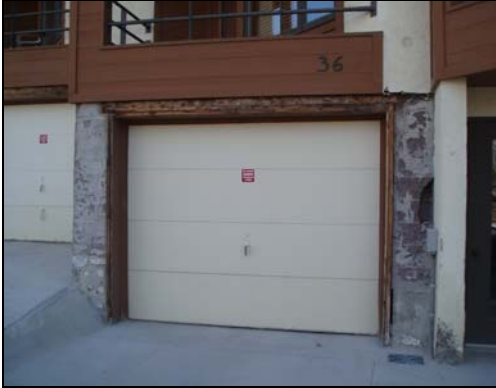
<p>4/24/12 – Photo 29 Unit 36</p> <p>Demolition underway.</p>	<p>Note</p>

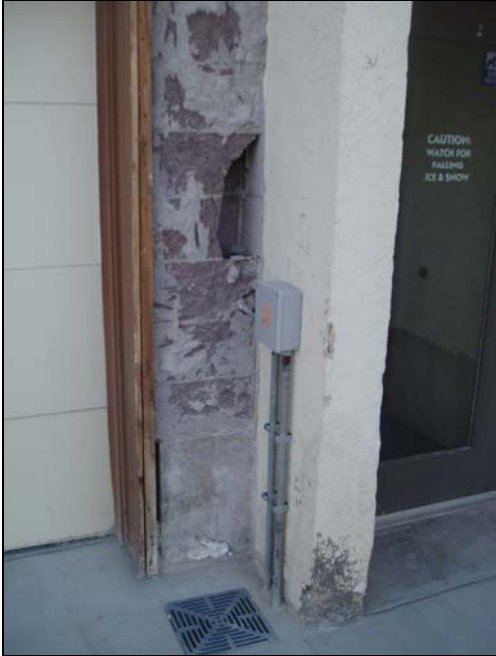
<p>4/24/12 – Photo 30 Unit 36 Detail</p> <p>Note damage to CMU basement walls. Recommend repairs to wall prior to stone installation.</p>	<p>Note</p>

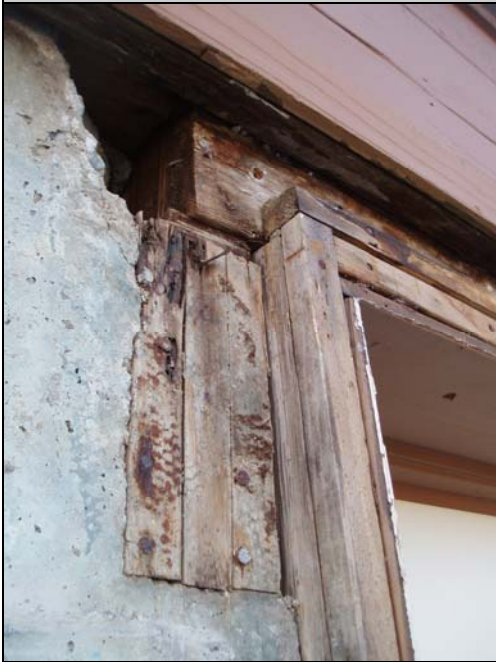
<p>4/24/12 – Photo 35 Unit 32 Detail</p> <p>Infill blocking appears to be in a serviceable condition.</p>	<p>Note</p>

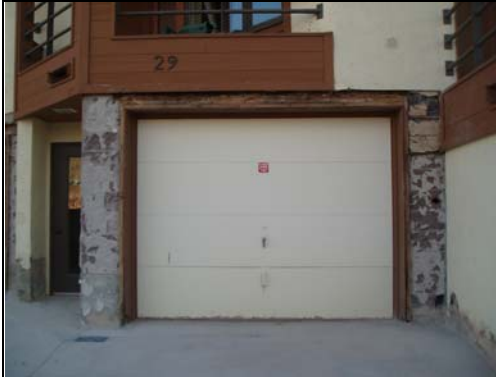
<p>4/24/12 – Photo 36 Unit 29</p> <p>Demolition underway.</p>	<p>Note</p>

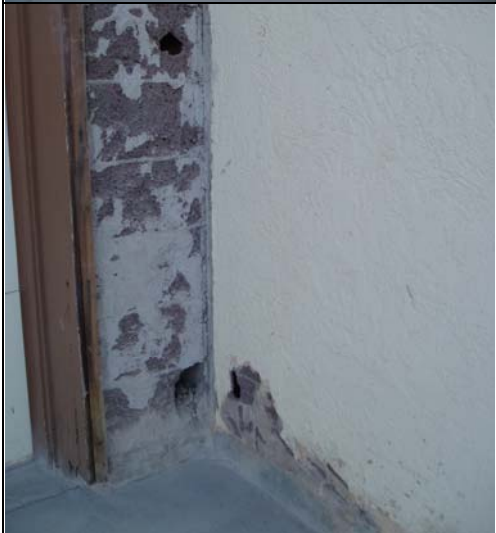
<p>4/24/12 – Photo 37 Unit 29 Detail</p> <p>Note damage to CMU basement walls. Recommend repairs to wall prior to stone installation.</p>	<p>Note</p>

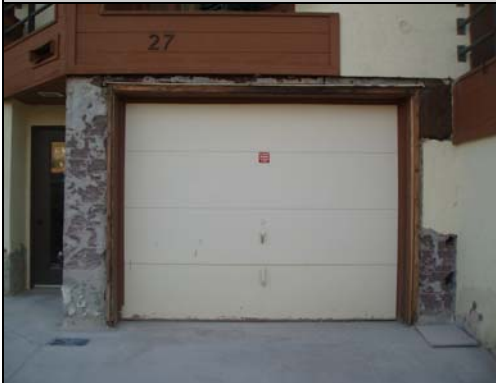
<p>4/24/12 – Photo 38 Unit 27</p> <p>Demolition underway. Note damage to CMU basement walls. Recommend repairs to wall prior to stone installation.</p>	<p>Note</p>

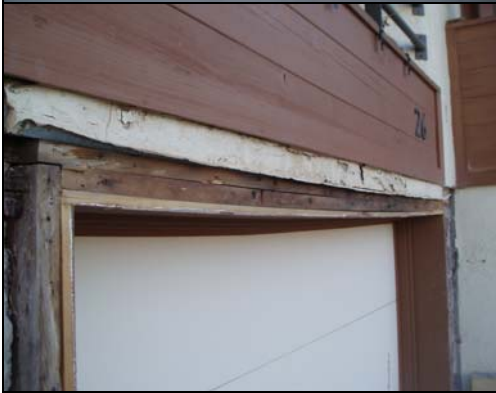
<p>4/24/12 – Photo 39 Unit 26 Detail</p> <p>Note sag in garage door header. Recommend replacement.</p>	<p>ENT</p>

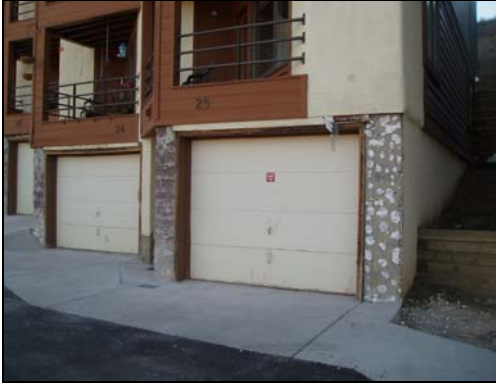
<p>4/24/12 – Photo 40 Units 26 &amp; 25</p> <p>Demolition underway.</p>	<p>Note</p>
