ARCHITECT'S FIELD REPORT

055

PROJECT	Eagle's Nest Townhouses 11 Morning Glory Way & 31 Marcellina Lane Mt. Crested Butte, CO 81225	DATE	6/22/11
----------------	--	-------------	---------

WORK OBSERVED	
Phase II – Sewer and Asphalt	
TRADES PRESENT	
Lacy Construction

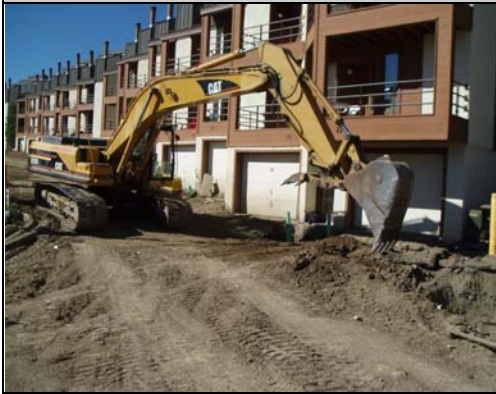
<p>6/22/11 – Photo 1 Lower Level Parking</p> <p>Backfill at Unit 17 is nearing completion. Underground drain lines are installed.</p>	<p>Note</p>

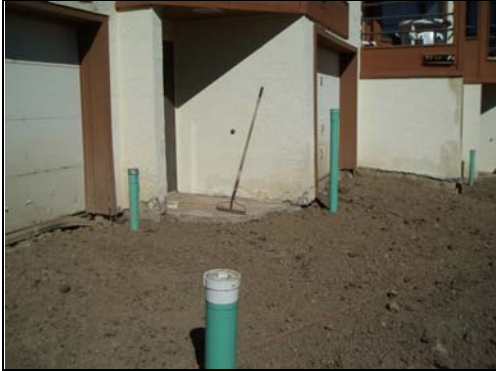
<p>6/22/11 – Photo 2 Lower Level Area Drains</p> <p>Detail at Units 40 & 39 of area drain connections. Note the string line barely visible in the lower right corner marking the concrete apron edge.</p>	<p>Note</p>

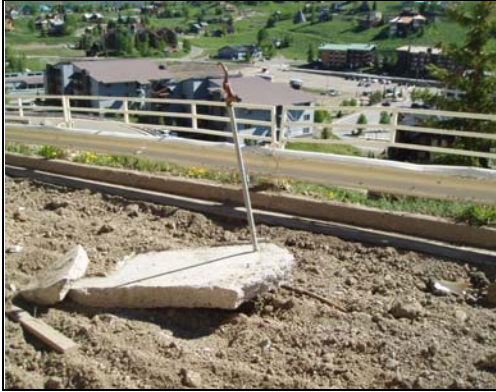
<p>6/22/11 – Photo 3 Lower Level Water Spigot</p> <p>Water spigot adjacent to Unit 39 was apparently abandoned. The spigot was removed and the line capped.</p>	<p>Note</p>
