ARCHITECT'S FIELD REPORT

044

PROJECT	Eagle's Nest Townhouses 11 Morning Glory Way & 31 Marcellina Lane Mt. Crested Butte, CO 81225	DATE	4/20/11
----------------	--	-------------	---------

WORK OBSERVED	
Phase II – Retaining Wall Repairs	
TRADES PRESENT	
None

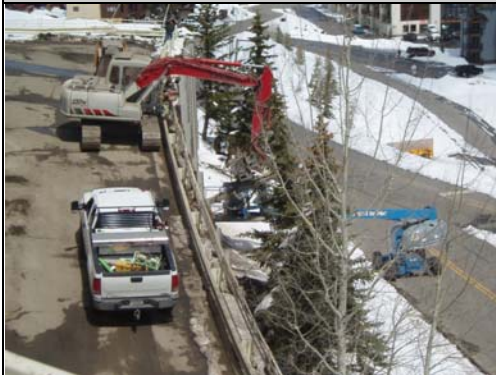
<p>4/20/11 – Photo 1</p> <p>Work is progressing on Pylon #51. Access to the Upper Level is not restricted.</p>	<p>Note</p>

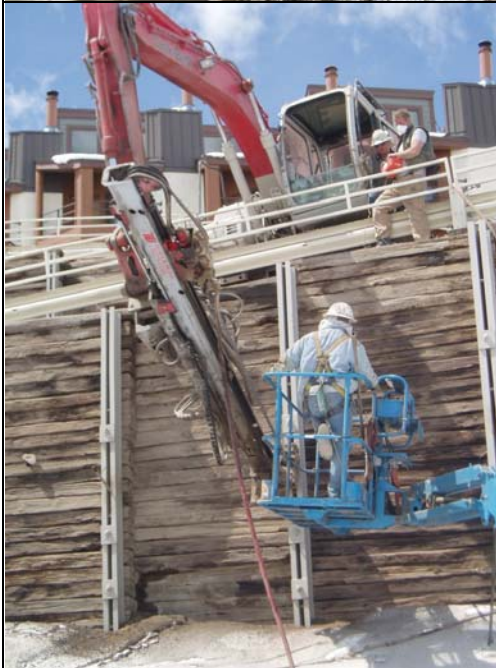
<p>4/20/11 – Photo 2</p> <p>Drill rig is inserting a 10' section of anchor.</p>	<p>Note</p>

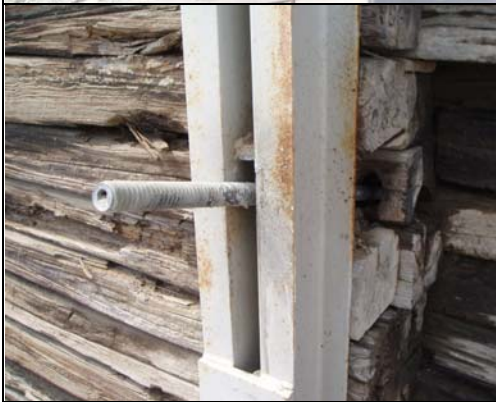
<p>4/20/11 – Photo 3</p> <p>Completed anchor on Pylon #41. A plate and bolt will be installed to connect the anchor to the existing soldier beam.</p>	<p>Note</p>

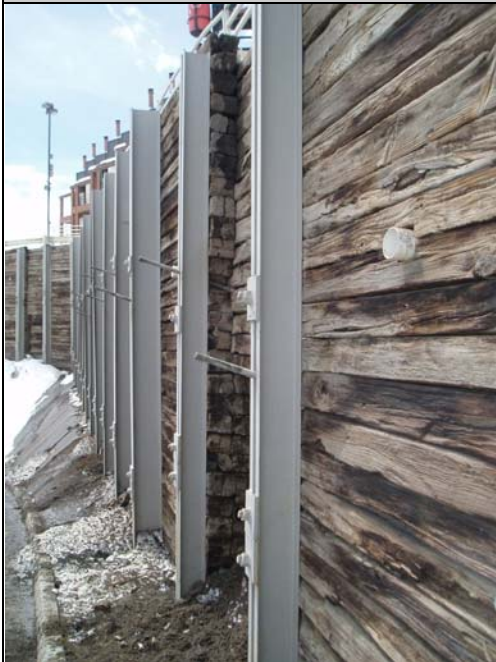
<p>4/20/11 – Photo 8 Upper Level Retaining Wall</p> <p>Detail of installed anchors.</p>	<p>Note</p>

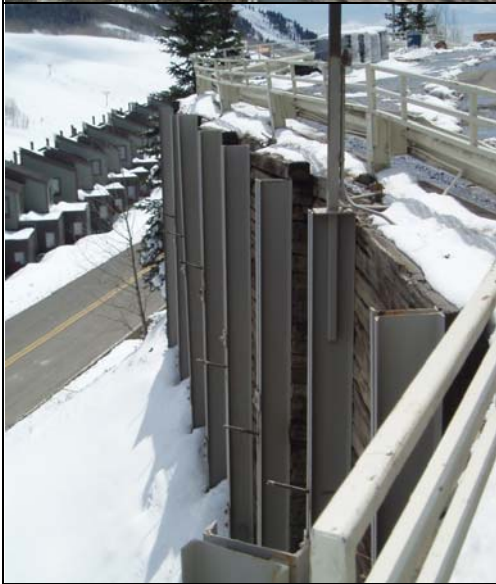
<p>4/20/11 – Photo 9 Upper Level Retaining Wall</p> <p>Detail of installed anchors.</p>	<p>Note</p>

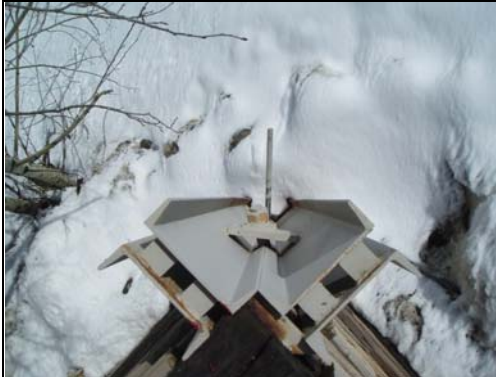
<p>4/20/11 – Photo 10 Upper Level Retaining Wall</p> <p>Pylon #1 – Anchor rod has been installed. This anchor was not installed in the previous Field Report.</p>	<p>Note</p>

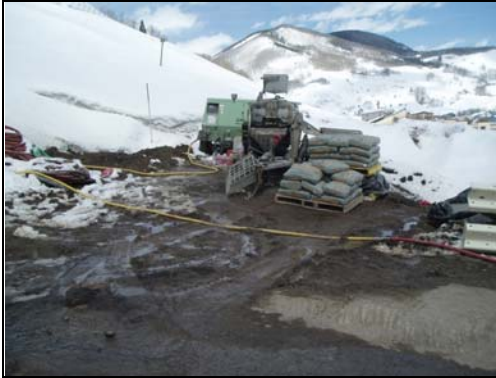
<p>4/20/11 – Photo 11</p> <p>Grout injection was not performed today. The mixer and supplies are set up at the north end of the parking lot.</p>	<p>Note</p>

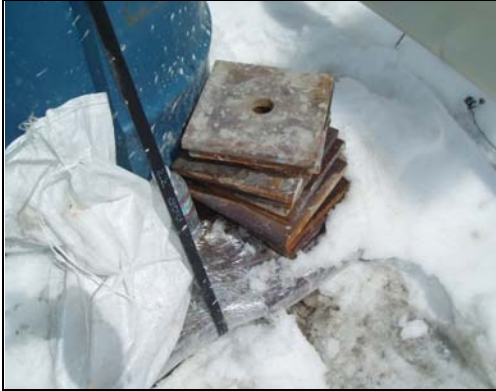
<p>4/20/11 – Photo 12</p> <p>Example of base plates.</p>	<p>Note</p>

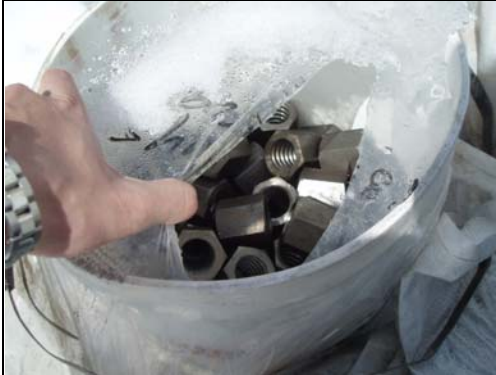
<p>4/20/11 – Photo 13</p> <p>Example of bolts on site.</p>	<p>Note</p>

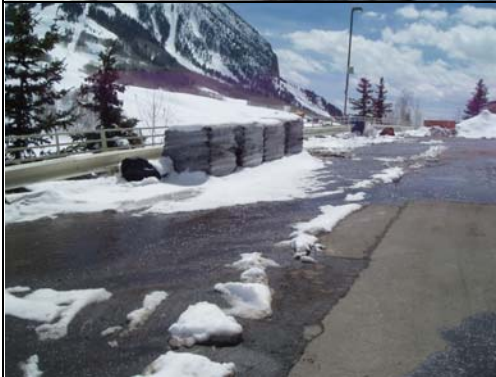
<p>4/20/11 – Photo 14</p> <p>Material stockpile at the Upper Level parking area. No guest or owner vehicles were present.</p>	<p>Note</p>
