ARCHITECT'S FIELD REPORT

094

PROJECT	Eagle's Nest Townhouses 11 Morning Glory Way & 31 Marcellina Lane Mt. Crested Butte, CO 81225	DATE	11/7/12
----------------	--	-------------	---------

WORK OBSERVED	
Phase III Construction – Garage Door Thresholds	
TRADES PRESENT

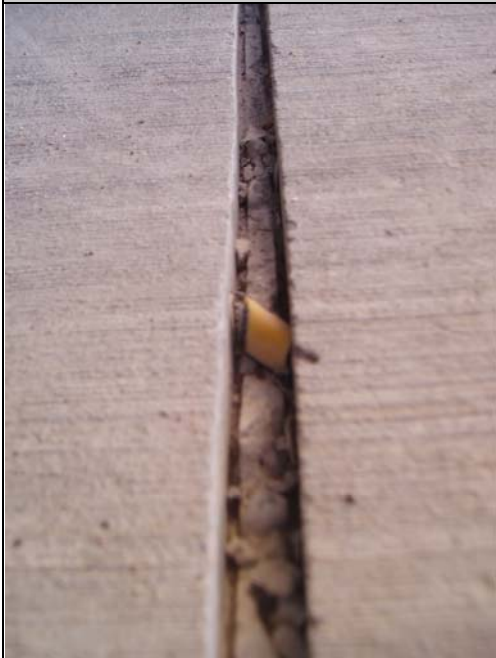
<p>11/07/12 – Photo 1 Unit 21 Garage Apron</p> <p>Threshold Groove Detail</p> <p>Note: Embedded heat trace line was severed while cutting the concrete groove.</p>	<p>MHC</p>

COMMENTS & OBSERVATIONS
<ol style="list-style-type: none"> 1. Observed completed saw-cut grooves in the concrete at all thresholds. 2. Noted severed heat tape lines at Units 21 & 22. Heat tape was apparently installed approximately 1/2" below the top surface of the concrete valley pan. CB Electric will need to be retained to splice the heat line and the concrete patched. Heat tape was not installed per the specifications – embed depth of 1" to 2" and 4-1/2" from the edge of concrete. 3. Garage Door Thresholds are set to arrive today and installation begins tomorrow. 4. We are still awaiting the delivery and installation of the entry door hardware. Grant relayed that the shipping date will be 11/9/12. 5. Weather Delays to Date – 3 days

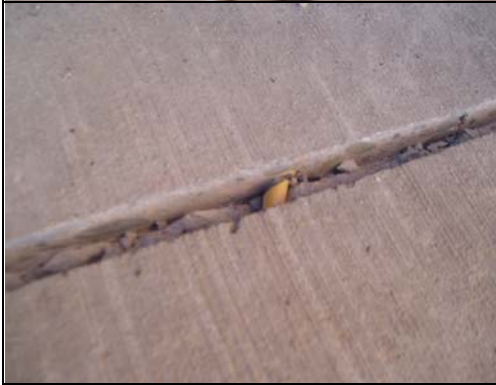
<p>11/07/12 – Photo 2 Unit 21 Garage Apron</p> <p>Concrete groove detail</p> <p>Overhead view of severed heat trace line.</p>	<p>MHC</p>

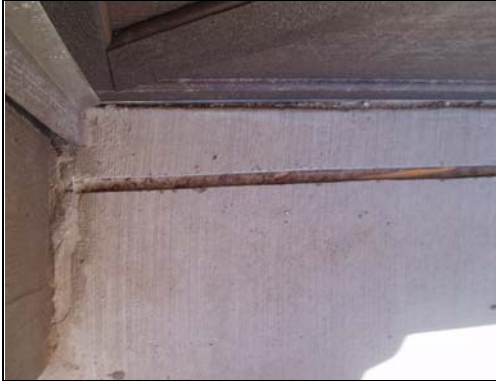
<p>11/07/12 – Photo 3 Unit 22 Garage Apron</p> <p>Concrete groove detail.</p> <p>Overhead view of severed heat trace line.</p>	<p>MHC</p>
