**ARCHITECT'S FIELD REPORT**

**022**

**PROJECT**      **Eagle's Nest Townhouses**      **DATE**      11/05/10  
 11 Morning Glory Way & 31 Marcellina Lane  
 Mt. Crested Butte, CO 81225

WORK OBSERVED
Phase I – Construction
TRADES PRESENT
Holgate Construction Company

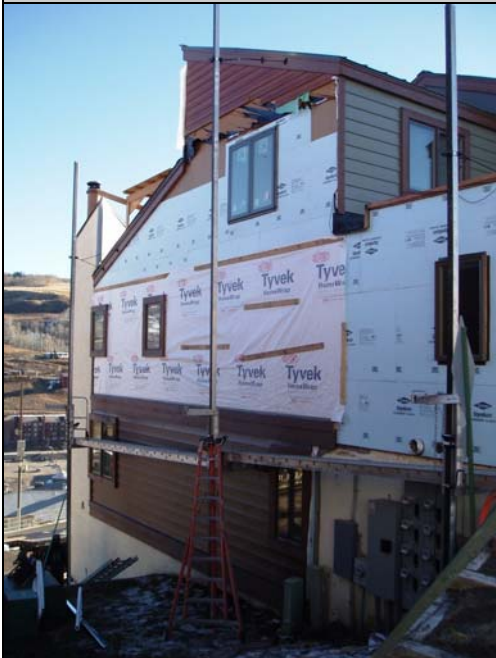
<p>11/3/10 – Photo 9 Unit 8 End Wall</p> <p>Belly bands are installed and brown horizontal siding is in place. Tyvek house wrap extends to the 4<sup>th</sup> Floor.</p>	<p>None</p>

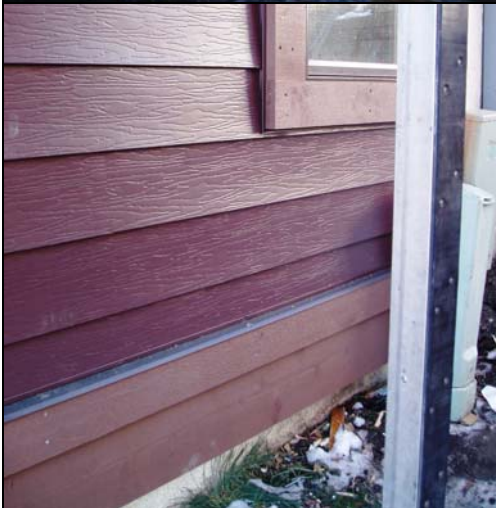
<p>11/3/10 – Photo 10 Unit 8</p> <p>Detail of brown metal siding and cedar belly band. Note small strip of siding underneath the window trim on the 4<sup>th</sup> course from the bottom. Mick plans to adjust the bottom course to eliminate this condition on subsequent elevations.</p>	<p>MHC</p>

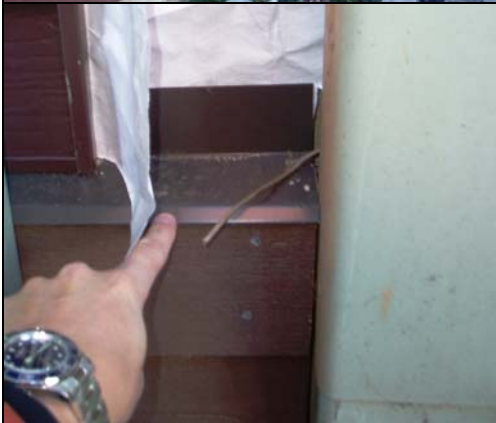
<p>11/3/10 – Photo 11 Unit 8</p> <p>Detail of belly band termination. Note the metal siding stops (on left) at a J-Channel. Vertical trim will sit in this location on top of metal flashing. Mick is to be commended on a very high level of detail work.</p>	<p>None</p>

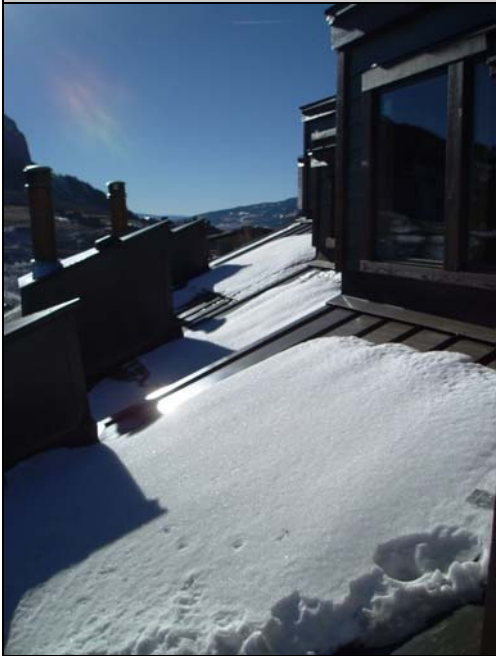
<p>11/3/10 – Photo 12 Units 4 through 1 Looking South</p> <p>Note snow coverage from early storm on November 2<sup>nd</sup>. Mt. Crested Butte reported 16 inches of snow.</p>	<p>None</p>

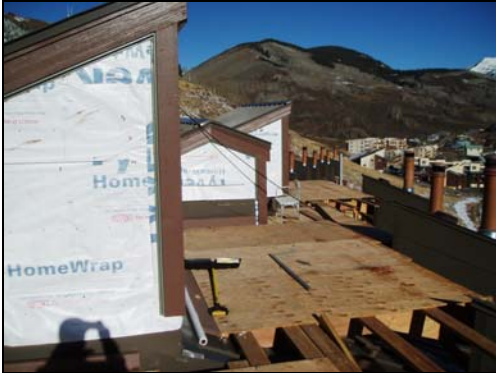
<p>11/3/10 – Photo 13 From Unit 4 Looking North</p> <p>Temporary scaffold is in place at Units 5, 6, 7 &amp; 8.</p>	<p>None</p>

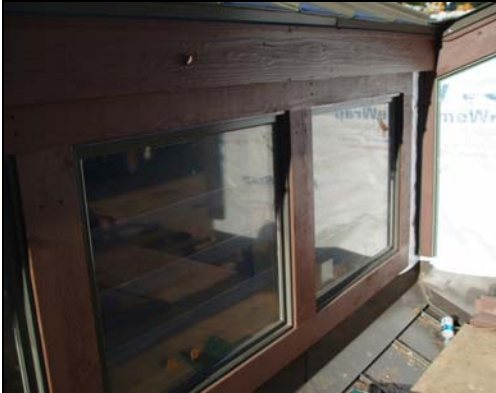
<p>11/3/10 – Photo 14 Unit 4</p> <p>Completed loft window installation and Tyvek house wrap.</p>	<p>None</p>

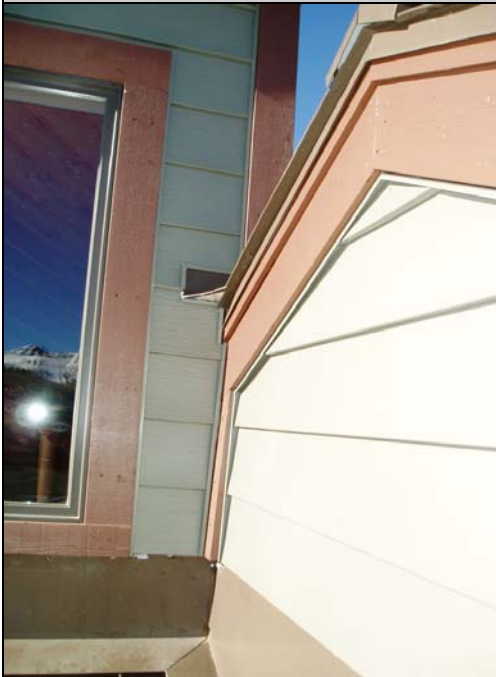
<p>11/3/10 – Photo 15 Units 4 &amp; 5</p> <p>Completed window, window trim, siding and repainted fascia at junction of Units 4&amp; 5.</p>	<p>None</p>

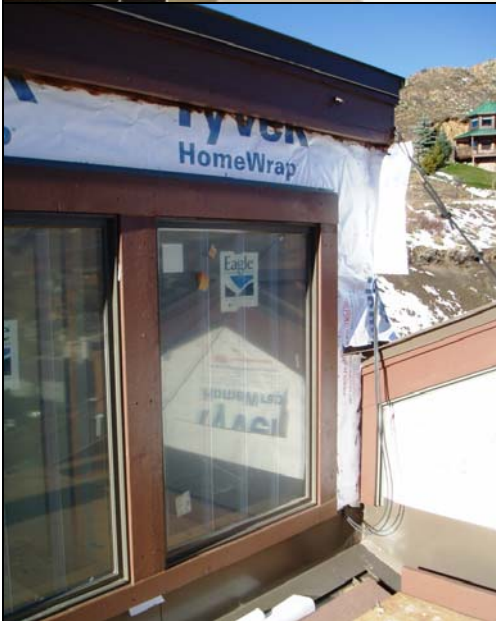
<p>11/3/10 – Photo 16 Junction of Units 5 &amp; 6</p> <p>Loft windows installed. Wood trim painted and in place. Existing fascia boards have been repainted.</p>	<p>None</p>

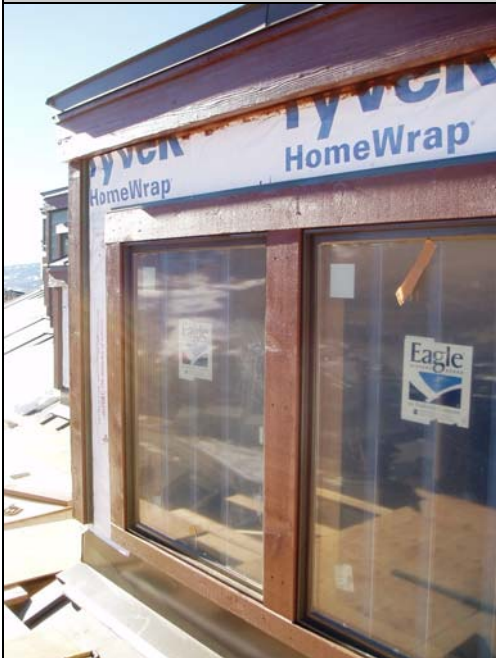
<p>11/3/10 – Photo 17 Unit 6</p> <p>Loft windows &amp; trim installed. Fascia repainted.</p>	<p>None</p>

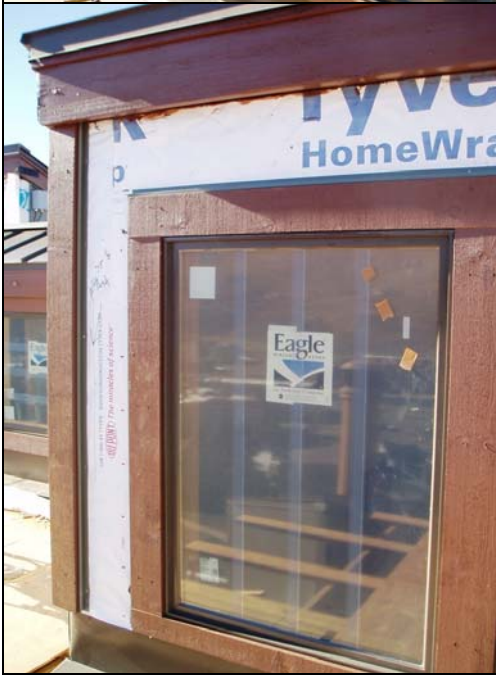
<p>11/3/10 – Photo 18 Unit 8</p> <p>Loft windows installed at Unit 8. Note J-Channel in place ready for metal siding.</p>	<p>None</p>

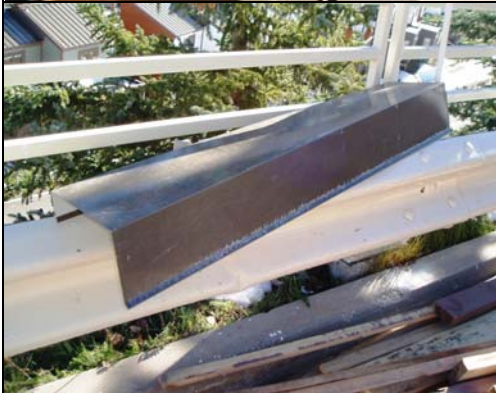
<p>11/3/10 – Photo 20 Parapet Cap</p> <p>Parapet caps have been delivered and are on site. Metal is protected in shrink wrap.</p> <p>Discussed with Mick installation techniques with roof membrane replacements in mind.</p>	<p>None</p>

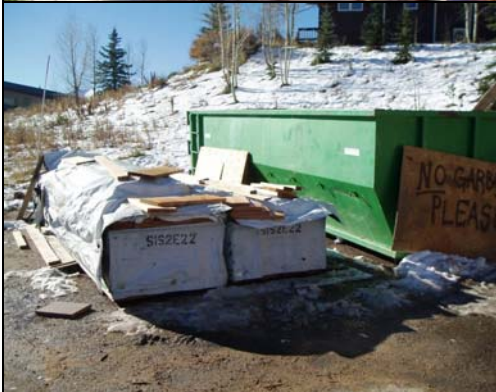
<p>11/3/10 – Photo 21 Upper Level Construction Area</p> <p>Cedar 2x12s have been delivered to the site and are protected under tarps.</p>	<p>None</p>

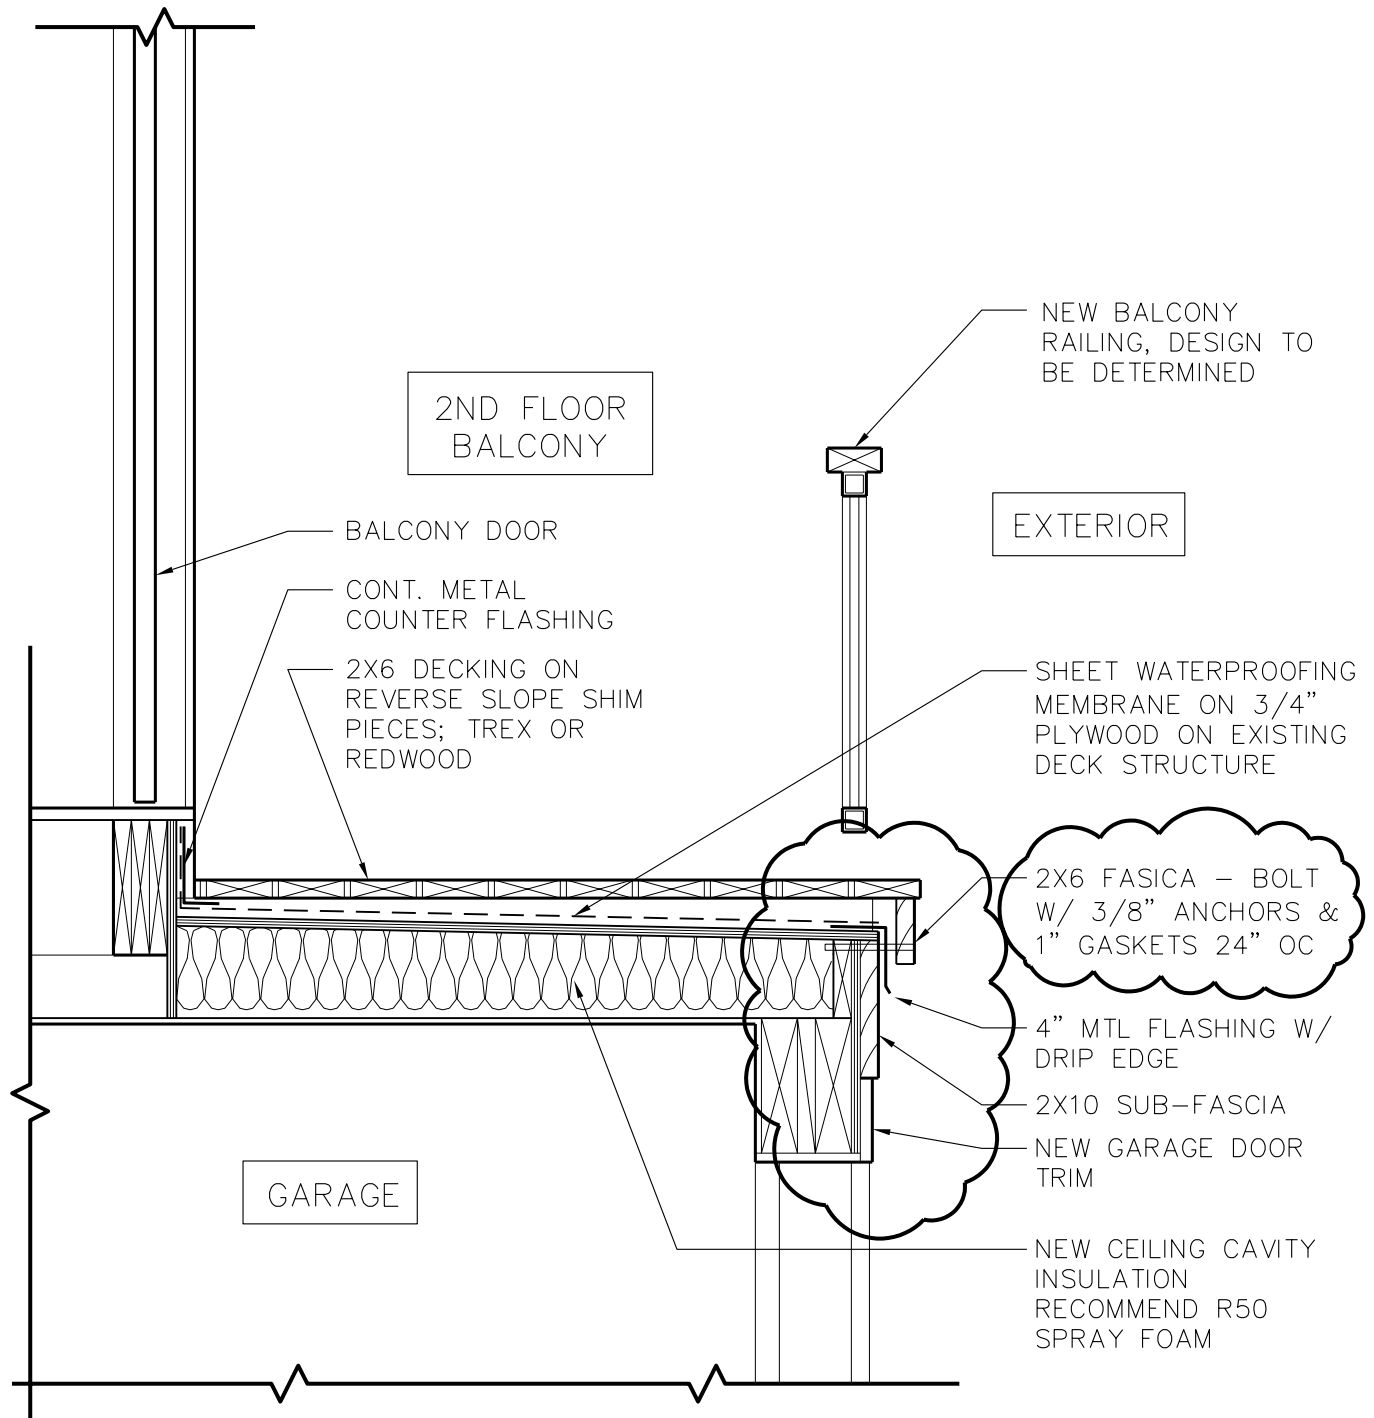
1 BALCONY DECK SECTION  
 $\frac{3}{4}" = 1'-0"$

DRIP THRU DECK OVER  
 CONDITIONED SPACE WITH  
 CONCEALED EDGE DRAIN

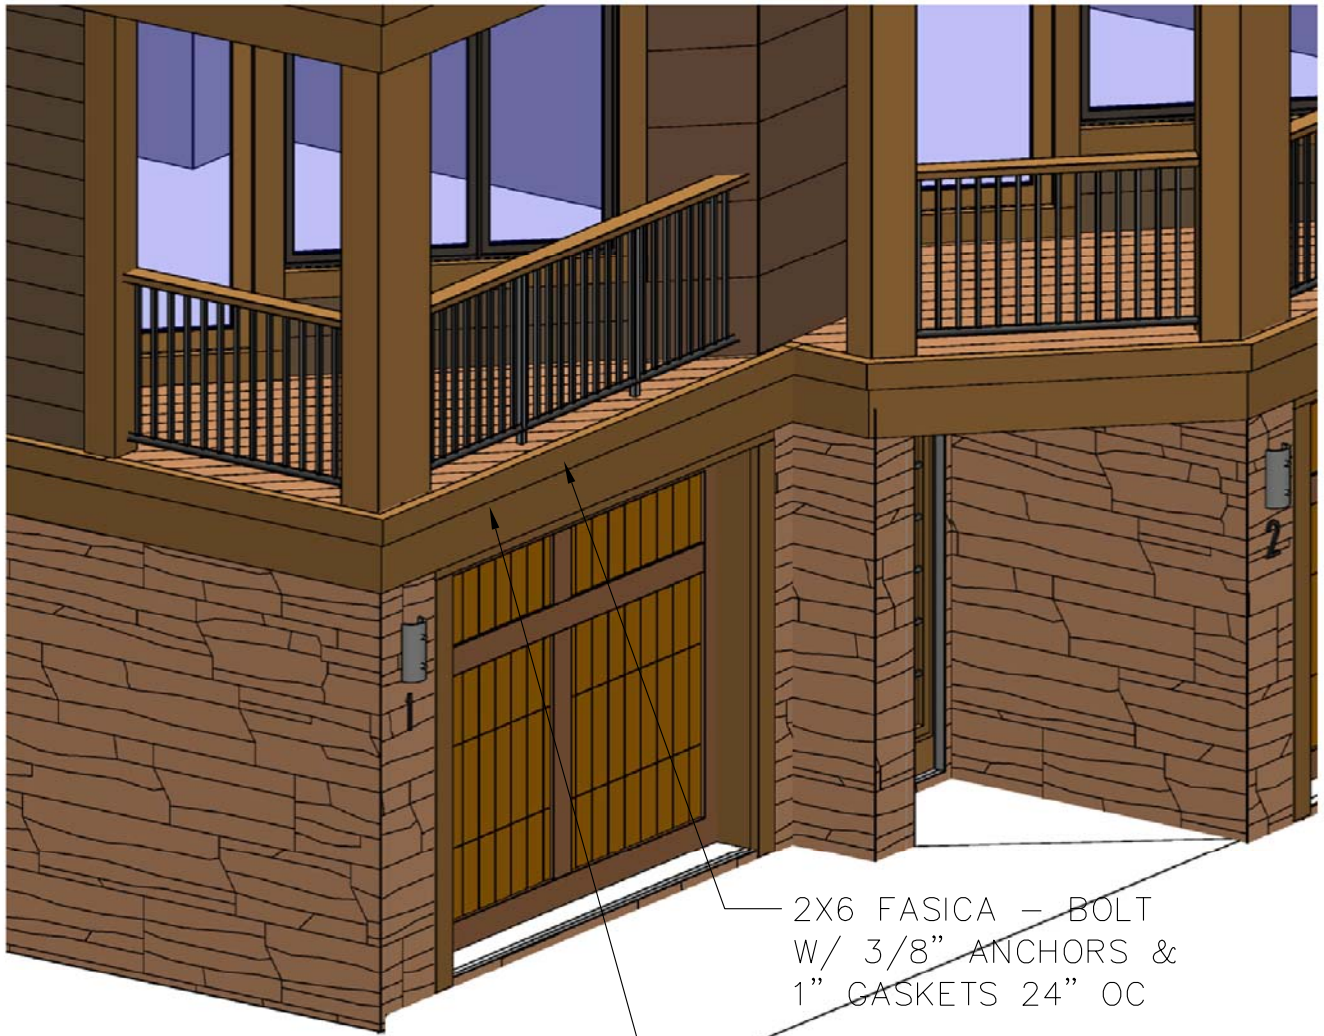
BALCONY DECK DETAIL

2X6 FASICA - BOLT  
W/ 3/8" ANCHORS &  
1" GASKETS 24" OC

DECK WATER DRAINS BEHIND  
2x6 FASCIA AND OVER 2x12  
SUB-FASCIA. (METAL DRAINS  
WILL BE REMOVED IN PHASE III)
