ARCHITECT'S FIELD REPORT

052

PROJECT	Eagle's Nest Townhouses 11 Morning Glory Way & 31 Marcellina Lane Mt. Crested Butte, CO 81225	DATE	6/01/11
----------------	--	-------------	---------

WORK OBSERVED	
Phase II – Sewer and Asphalt Pre-Construction	
TRADES PRESENT	
Lacy Construction

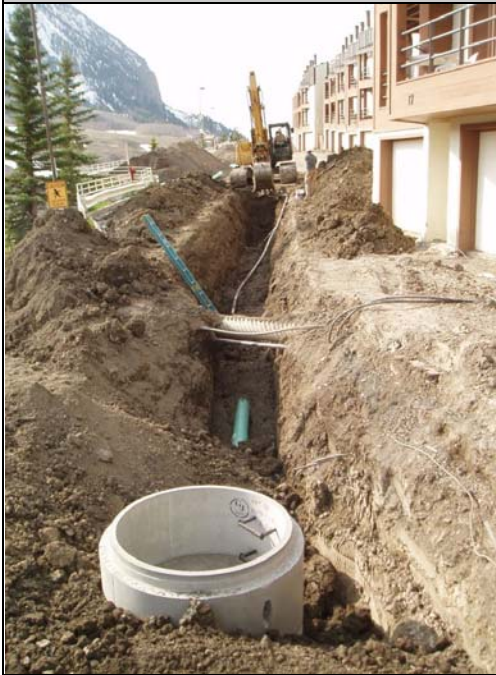
<p>6/01/11 – Photo 1 Lower Level Sewer Trench</p> <p>Manhole #7 is in place. New sewer line is being installed. Existing telephone line (visible to the right of the trench) is slowing excavation work.</p> <p>Culvert traversing the trench is from the Lower Level area drain behind the units.</p>	<p>Note</p>

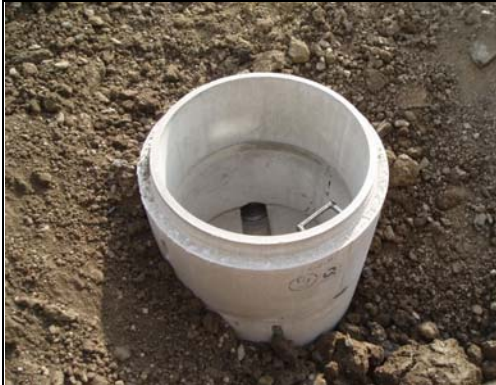
<p>6/01/11 – Photo 2 Detail of Manhole #7</p>	<p>Note</p>

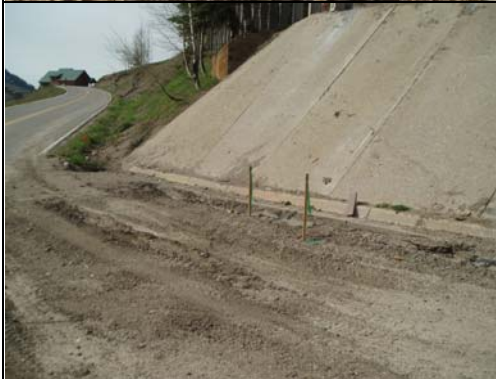
<p>6/01/11 – Photo 3 Upper Level Driveway Entrance</p> <p>Ponding water from previous Field Report is no longer present.</p> <p>Note survey stakes for Manhole #4.</p>	<p>Note</p>

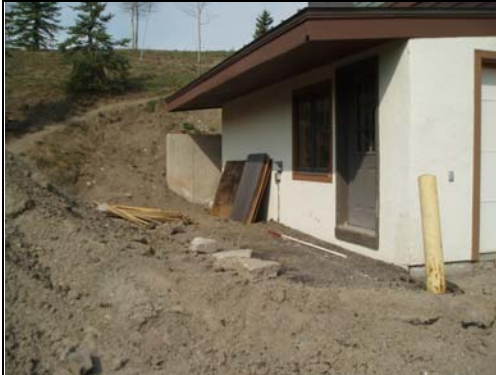
<p>6/01/11 – Photo 8 Upper Level Maintenance</p> <p>Building materials have been removed.</p>	<p>Note</p>

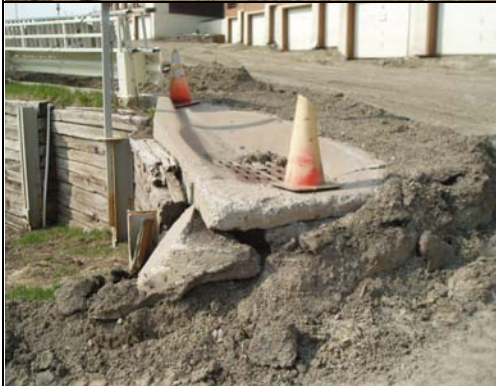
<p>6/01/11 – Photo 9 Upper Level Area Drain</p> <p>Note displaced corner - area drain catch basin is in need of replacement. This addition is currently being priced.</p>	<p>Note</p>

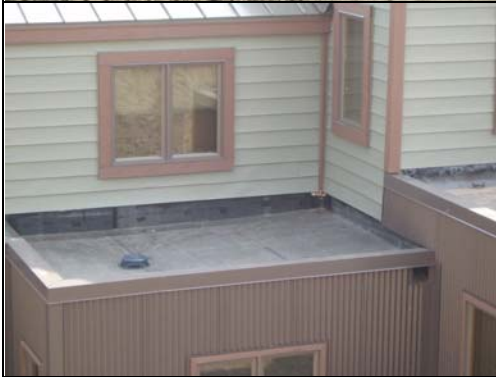
<p>6/01/11 – Photo 10 Lower Level Roof Repair Unit 28</p> <p>New roof noted.</p>	<p>Note</p>
