ARCHITECT'S FIELD REPORT

PROJECT	Eagle's Nest Townhouses 11 Morning Glory Way & 31 Marcellina Lane Mt. Crested Butte, CO 81225	DATE	9/12/14
----------------	--	-------------	---------

WORK OBSERVED	
Sloped Roof	
TRADES PRESENT	
Roofmasters Roofing & Sheet Metal

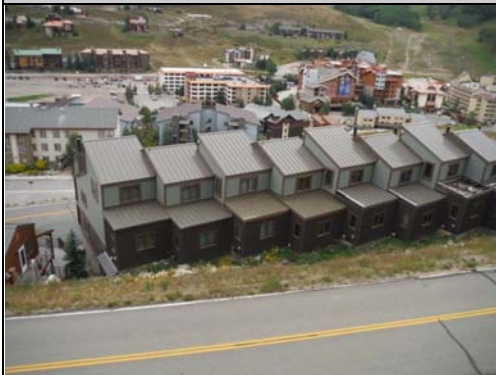
<p>9/12/14 – Photo 1 View of Lower Level Building C</p> <p>Units 17, 18, 19 & 20 are roofs from previous projects.</p>	<p>Note</p>

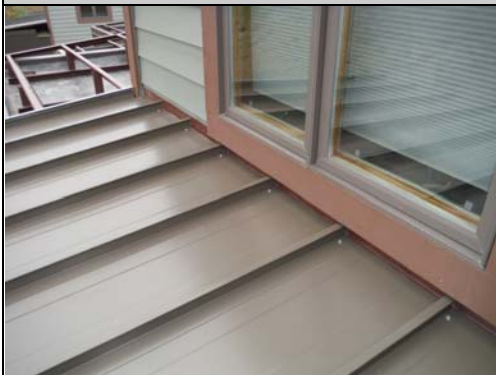
<p>9/12/14 – Photo 13 Detail of Roof at Window Sill</p> <p>Counter-flashing will be installed at the roof to wall connection.</p>	<p>Note</p>

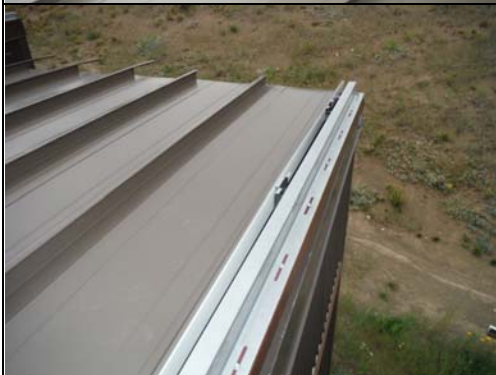
<p>9/12/14 – Photo 14 Detail of Outside Roof Edge</p> <p>C-shaped trim piece will cover the end seam and connect to the side wall flashing.</p>	<p>Note</p>

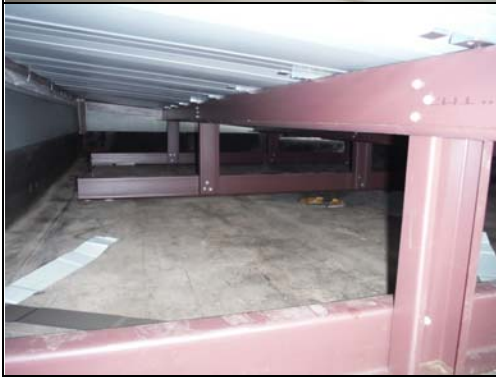
<p>9/12/14 – Photo 16 View of Framing Below</p> <p>Z-Channels have been installed perpendicular to the existing roof joists. Purlins span less than 30" per the design drawings.</p>	<p>Note</p>

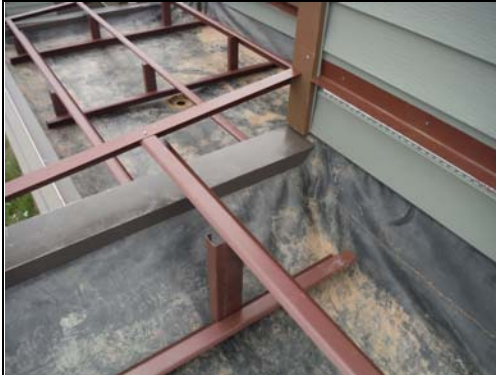
<p>9/12/14 – Photo 17 Exposed Framing on Unit 6</p> <p>Edge detail connection.</p>	<p>Note</p>

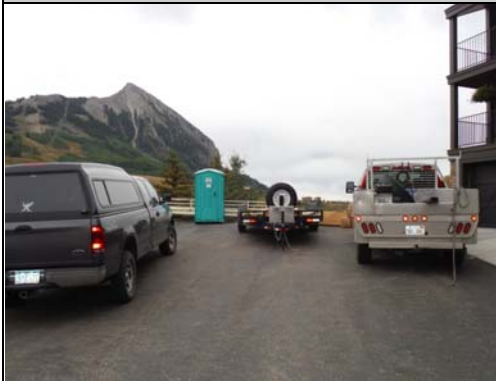
<p>9/12/14 – Photo 25 Lower Level Work Area</p> <p>Temporary Facilities and work truck parking.</p>	<p>Note</p>

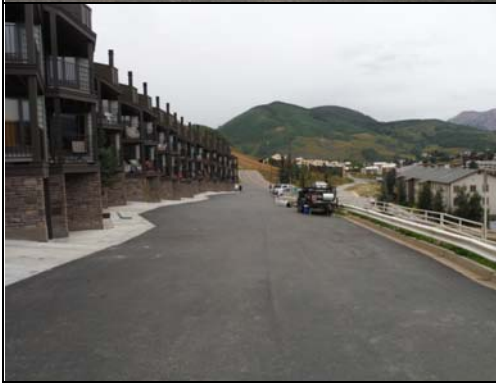
<p>9/12/14 – Photo 26 Looking North at the Lower Level Parking Lot</p> <p>Coil machine is located in front of Building D. Machine does produce noise but does not operate continuously.</p>	<p>Note</p>
