ARCHITECT'S FIELD REPORT

045

PROJECT	Eagle's Nest Townhouses 11 Morning Glory Way & 31 Marcellina Lane Mt. Crested Butte, CO 81225	DATE	4/25/11
----------------	--	-------------	---------

WORK OBSERVED	
Phase II – Retaining Wall Repairs	
TRADES PRESENT	
None

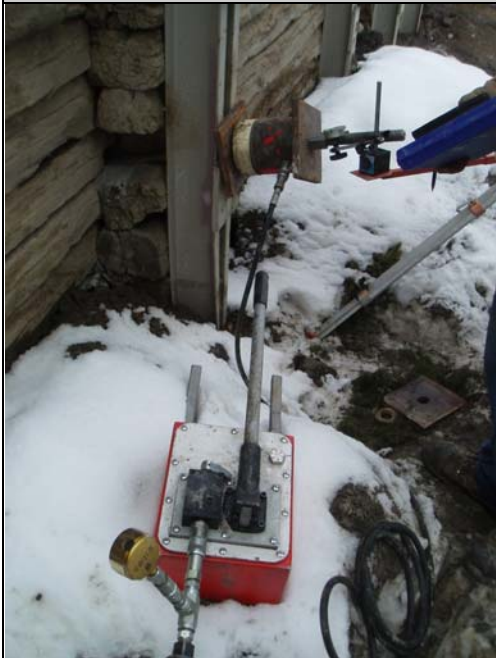
<p>4/25/11 – Photo 1 Mid-Level Retaining Wall</p> <p>Pull Test Equipment on Pylon 45. The compressor feeds an expansion sleeve located on the end of the anchor. A second plate provides resistance. The tripod and arm supports a measurement device to record movement on the anchor head.</p>	<p>Note</p>

COMMENTS & OBSERVATIONS
<ol style="list-style-type: none"> 1. Met with Ben and Kari to witness strength pull test on 2 anchors (#45 & #46 on the Mid-Level Retaining Wall). Kari will submit a final report detailing the results of the test. 2. Work is underway on Mid-Level wall below the entrance drive on the north end of the retaining wall. 3. (43) Calendar Days to complete work. Work was started April 1st and should be completed by May 13th. 4. (67) Pylons total to be repaired. (62) are completed to date leaving (5) to finish. 5. Kari Roberts will collect grout samples on 4/26/11 and issue a report. 6. (4) Workers were on site including Ben.

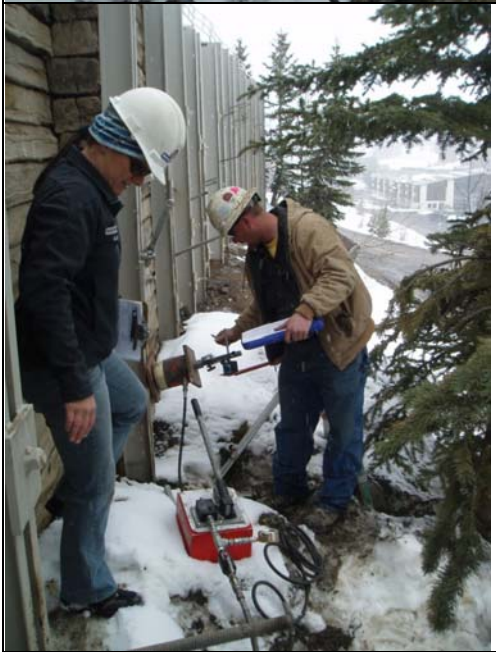
<p>4/25/11 – Photo 2 Mid-Level Retaining Wall</p> <p>Kari Roberts with Buckhorn Geotech and Ben Arnold with Mays Construction.</p>	<p>Note</p>

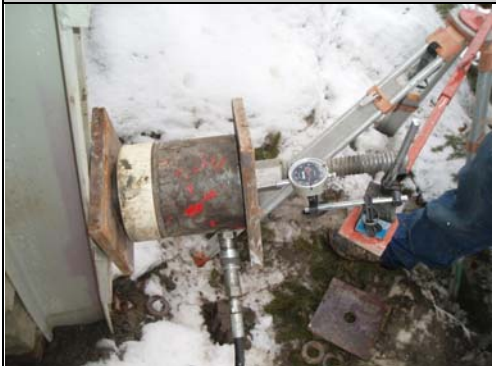
<p>4/25/11 – Photo 3 Mid-Level Retaining Wall</p> <p>Detail of the sleeve and measurement device. Measurements were taken in thousandths of an inch of movement.</p>	<p>Note</p>

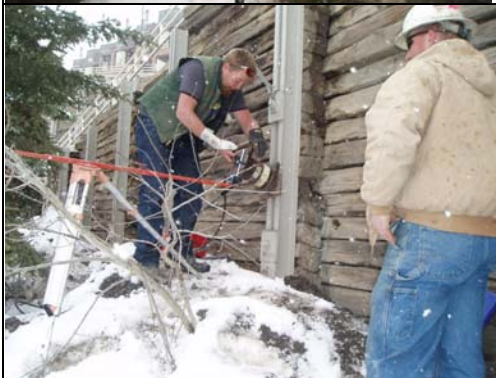
<p>4/25/11 – Photo 4 Mid-Level Retaining Wall</p> <p>Setting up equipment on Pylon #46.</p>	<p>Note</p>

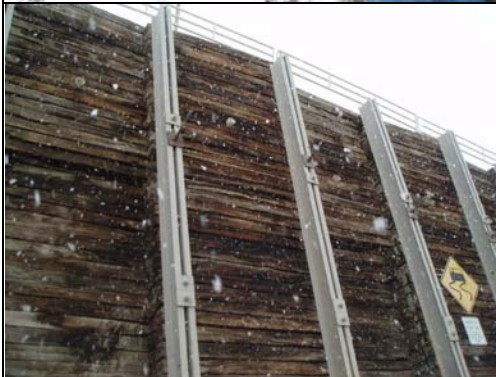
<p>4/25/11 – Photo 5 Upper Level Retaining Wall</p> <p>Note the plates and bolts have been installed on finished anchors.</p> <p>The anchor plates and bolts have not been painted.</p>	<p>ENT</p>

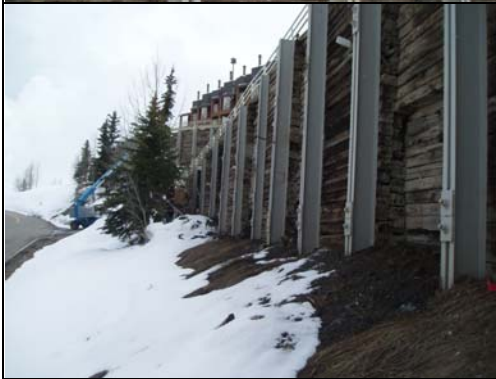
<p>4/25/11 – Photo 6 Mid-Level Retaining Wall</p> <p>Pylons 47 through 56</p>	<p>Note</p>

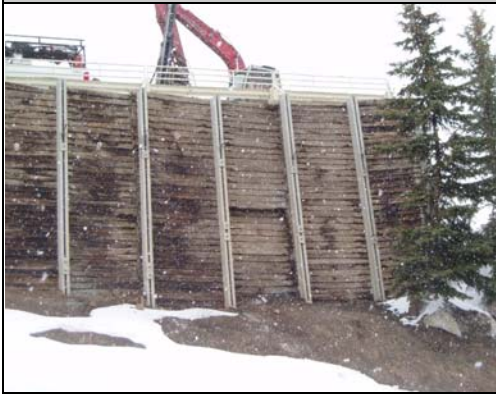
<p>4/25/11 – Photo 7 Mid-Level Retaining Wall</p> <p>Pylons 57 through 62 have anchors installed. The (5) remaining anchors are around the corner to the north (not shown).</p>	<p>Note</p>
