ARCHITECT'S FIELD REPORT

085

PROJECT	Eagle's Nest Townhouses 11 Morning Glory Way & 31 Marcellina Lane Mt. Crested Butte, CO 81225	DATE	8/06/12
----------------	--	-------------	---------

WORK OBSERVED	
Phase III Construction – Garage Door Punch, Garage Threshold Investigation	
TRADES PRESENT	
Holgate Construction

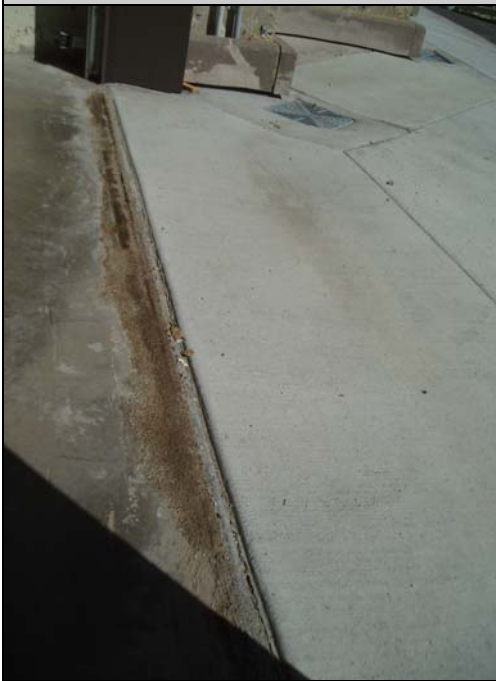
<p>7/26/12 – Photo 1 Unit #1 Threshold</p> <p>Opener Works: Yes Sensors Work: Yes Ceiling Condition: <i>No Stains Present</i> Clean Out Coordination: <i>None Noted</i> Threshold Bar: <i>None</i> Threshold Condition: <i>Fair</i></p>	<p>Note</p>

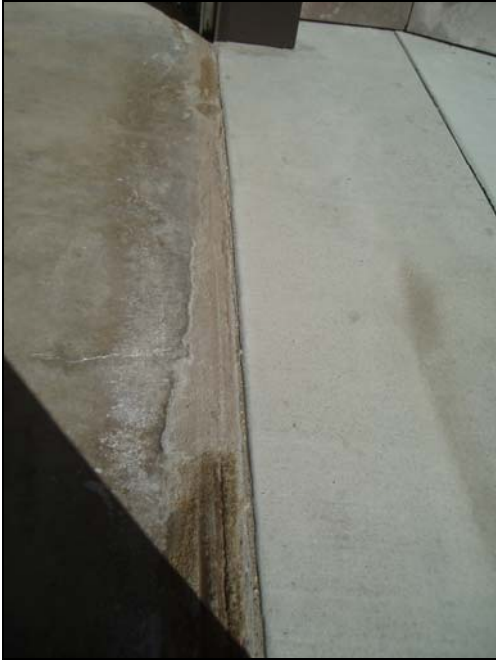
<p>7/26/12 – Photo 2 Unit #2 Threshold</p> <p>Opener Works: <i>Yes, Button Cracked</i> Sensors Work: Yes Ceiling Condition: <i>No Stains Present</i> Clean Out Coordination: <i>None Noted</i> Threshold Bar: <i>None</i> Threshold Condition: <i>Fair</i></p>	<p>Note</p>

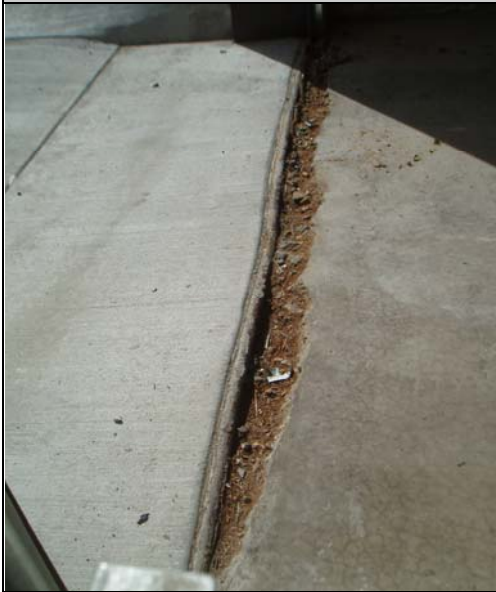
<p>7/26/12 – Photo 3 Unit #3 Threshold</p> <p>Opener Works: Yes Sensors Work: <i>Yes, Mounted Too High</i> Ceiling Condition: <i>No Stains Present</i> Clean Out Coordination: <i>None Noted</i> Threshold Bar: <i>Yes, Poor Condition</i> Threshold Condition: <i>Poor Condition</i></p>	<p>Note</p>

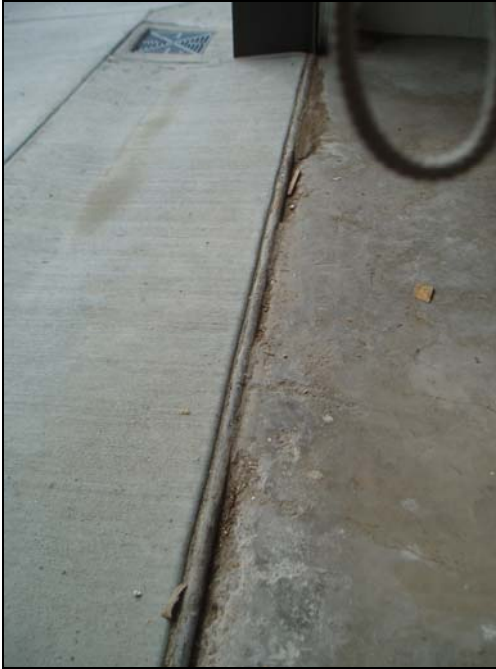
<p>7/26/12 – Photo 4 Unit #4 Threshold</p> <p>Opener Works: Yes Sensors Work: Yes Ceiling Condition: <i>No Stains Present</i> Clean Out Coordination: <i>None Noted</i> Threshold Bar: <i>Yes, Poor (High)</i> Threshold Condition: <i>Poor, Raised on North End</i></p>	<p>Note</p>

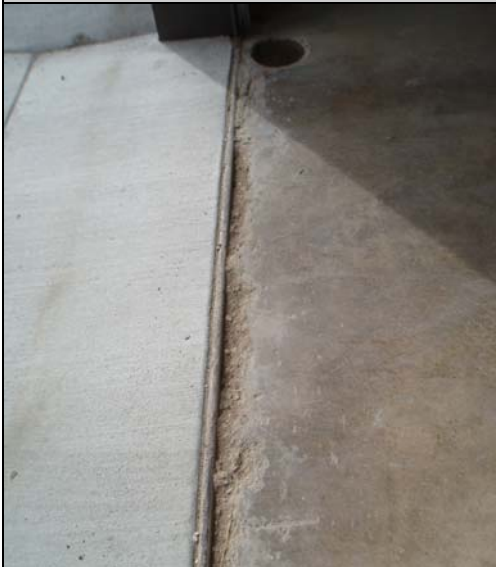
<p>7/26/12 – Photo 5 Unit #5 Threshold</p> <p>Opener Works: <i>Yes</i> Sensors Work: <i>Yes</i> Ceiling Condition: <i>No Stains Present</i> Clean Out Coordination: <i>Yes</i> Threshold Bar: <i>Yes, Poor</i> Threshold Condition: <i>Poor</i></p>	<p>Note</p>

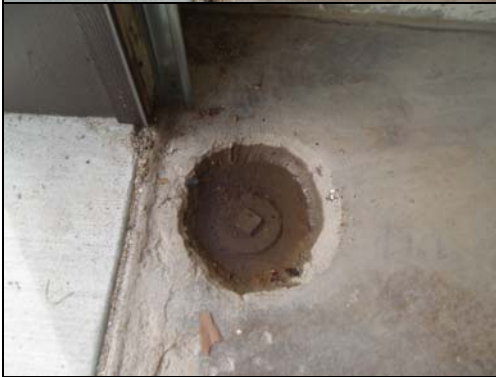
<p>7/26/12 – Photo 6 Unit #5 Clean Out Detail</p> <p>Note clean out at threshold and standing water.</p>	<p>Note</p>

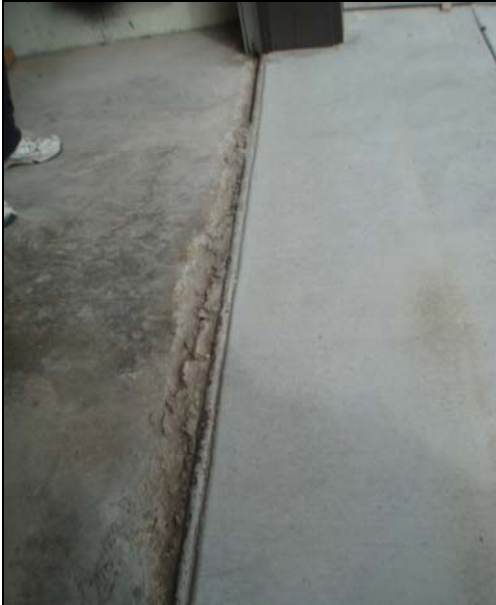
<p>7/26/12 – Photo 7 Unit # 6 Threshold</p> <p>Opener Works: <i>None, Rope Pull</i> Lock Condition: <i>Misaligned</i> Ceiling Condition: <i>No Stains Present</i> Clean Out Coordination: <i>None Noted</i> Threshold Bar: <i>Yes, Poor</i> Threshold Condition: <i>Poor</i></p>	<p>MHC</p>

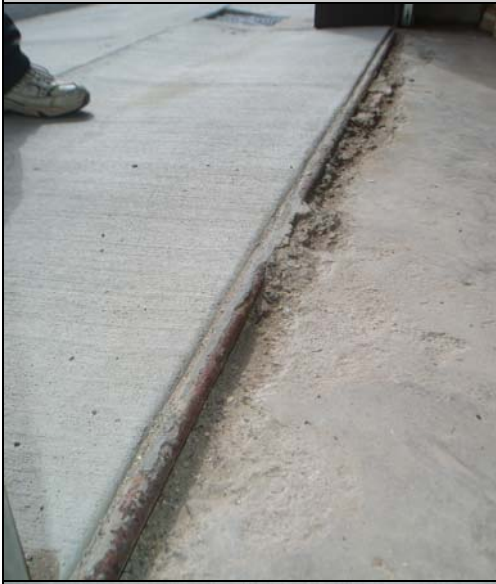
<p>7/26/12 – Photo 8 Unit # 7 Threshold</p> <p>Opener Works: <i>Yes</i> Sensors Work: <i>No Sensors Present</i> Ceiling Condition: <i>No Stains Present</i> Clean Out Coordination: <i>Yes, Low</i> Threshold Bar: <i>Yes, Poor</i> Threshold Condition: <i>Very Poor</i></p>	<p>Note</p>

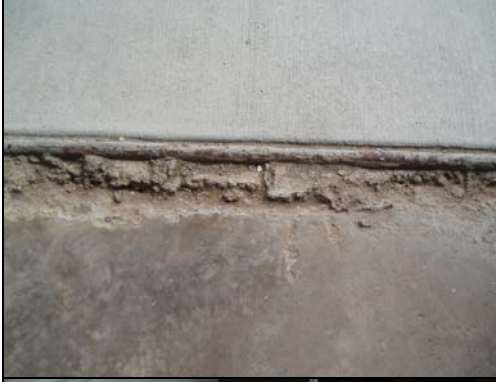
<p>7/26/12 – Photo 9 Unit #7 Threshold Detail</p> <p>Note rebar ties used to embed the threshold bar. Approximately #3 rebar on the interior side at 18” on center.</p>	<p>Note</p>

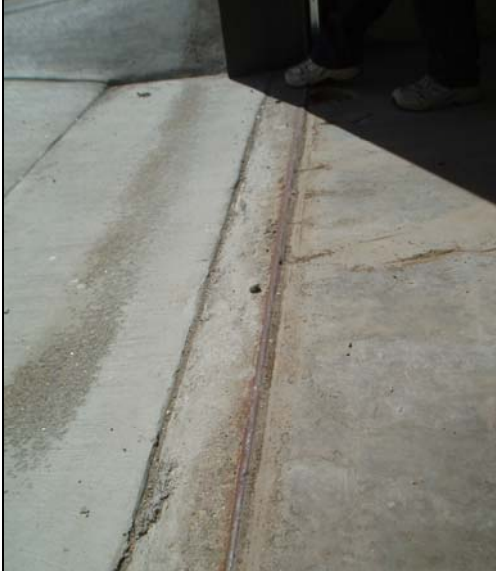
<p>7/26/12 – Photo 10 Unit #8</p> <p>Opener Works: <i>Yes</i> Sensors Work: <i>Yes, Mounted Low</i> Ceiling Condition: <i>No Stains Present</i> Clean Out Coordination: <i>Yes, Poor</i> Threshold Bar: <i>Yes, Fair</i> Threshold Condition: <i>Fair, Seam on Exterior</i></p>	<p>Note</p>

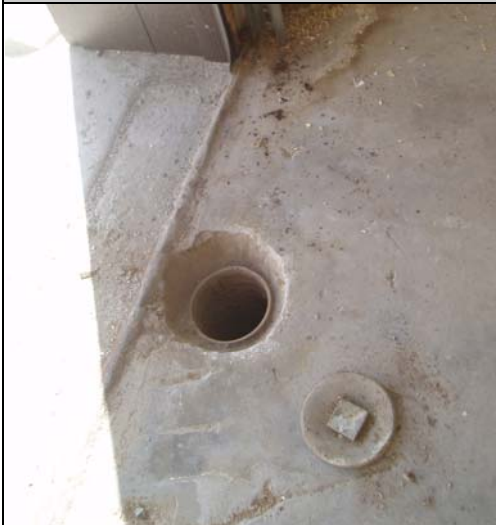
<p>7/26/12 – Photo 11 Unit #8 Clean Out Detail</p> <p>Note clean out location at threshold. Cap will no longer screw back on.</p>	<p>Note</p>

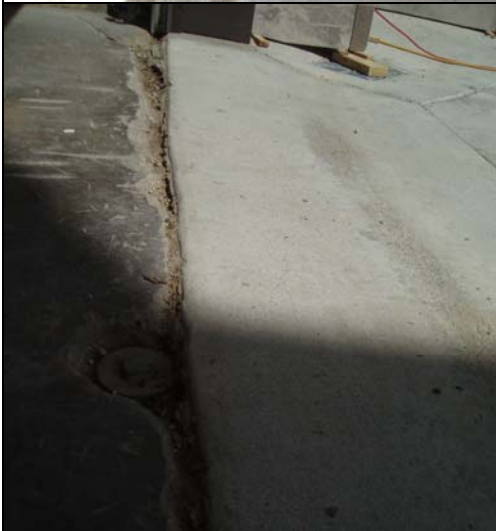
<p>7/26/12 – Photo 12 Unit #9 Threshold</p> <p>Opener Works: <i>Yes</i> Sensors Work: <i>Yes</i> Ceiling Condition: <i>No Stains Present</i> Clean Out Coordination: <i>Yes, Poor</i> Threshold Bar: <i>None</i> Threshold Condition: <i>Very Poor</i></p>	<p>Note</p>

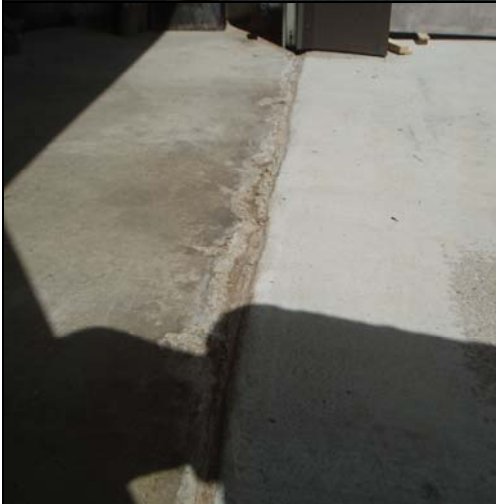
<p>7/26/12 – Photo 13 Unit 10 Threshold</p> <p>Opener Works: <i>Yes</i> Sensors Work: <i>No, Needs Adjusting</i> Ceiling Condition: <i>No Stains Present</i> Clean Out Coordination: <i>None Noted</i> Threshold Bar: <i>None</i> Threshold Condition: <i>Fair</i></p>	<p>Note</p>

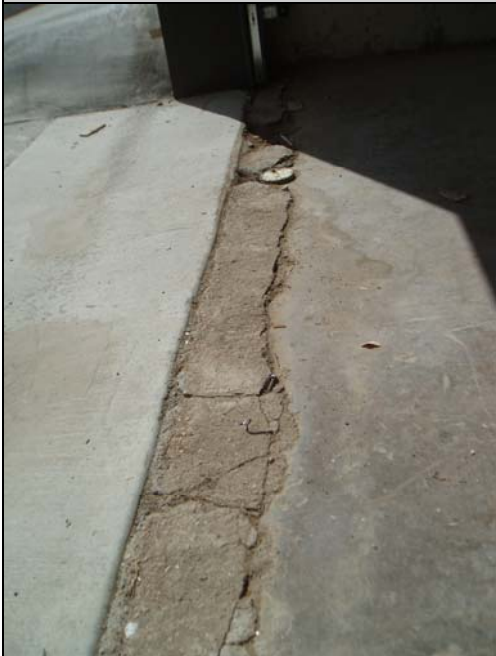
<p>7/26/12 – Photo 14 Unit 11 Threshold</p> <p>Opener Works: <i>Yes</i> Sensors Work: <i>Yes</i> Ceiling Condition: <i>No Stains Present</i> Clean Out Coordination: <i>Yes, Poor</i> Threshold Bar: <i>None</i> Threshold Condition: <i>Very Poor</i></p>	<p>Note</p>

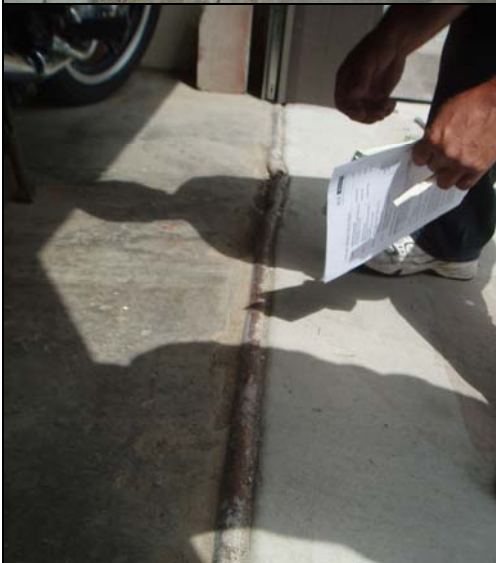
<p>7/26/12 – Photo 15 Unit 12 Threshold</p> <p>Opener Works: <i>Sticks, Needs Adjusting</i> Sensors Work: <i>None Noted</i> Ceiling Condition: <i>No Stains Present</i> Clean Out Coordination: <i>None Noted</i> Threshold Bar: <i>Yes, Very Poor</i> Threshold Condition: <i>Very Poor</i></p>	<p>Note</p>

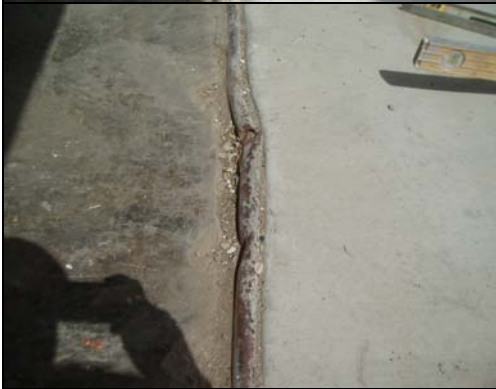
<p>7/26/12 – Photo 16 Unit 12 Threshold Detail</p> <p>Note bent threshold bar.</p>	<p>Note</p>

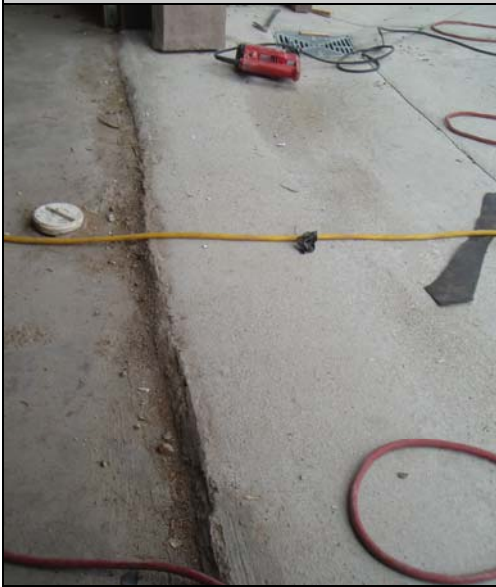
<p>7/26/12 – Photo 17 Unit 13 Threshold</p> <p>Opener Works: <i>No, Needs Attention</i> Sensors Work: <i>None Noted</i> Ceiling Condition: <i>No Stains Present</i> Clean Out Coordination: <i>None</i> Threshold Bar: <i>Yes, Very Poor</i> Threshold Condition: <i>Very Poor, Elevation is off by approximately 1" on the interior.</i></p>	<p>Note</p>

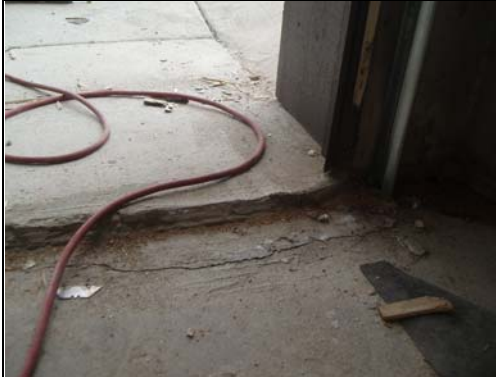
<p>7/26/12 – Photo 18 Unit 13 Threshold Detail</p> <p>Note raised elevation of the garage apron.</p>	<p>Note</p>

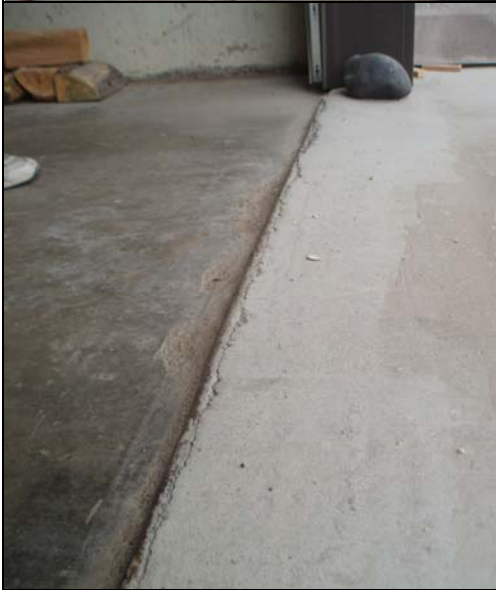
<p>7/26/12 – Photo 19 Unit 14 Threshold</p> <p>Opener Works: <i>None, Rope Installed</i> Lock Condition: <i>Operational, Okay</i> Ceiling Condition: <i>No Stains Present</i> Clean Out Coordination: <i>None Noted</i> Threshold Bar: <i>Yes, Fair</i> Threshold Condition: <i>Fair</i></p>	<p>Note</p>

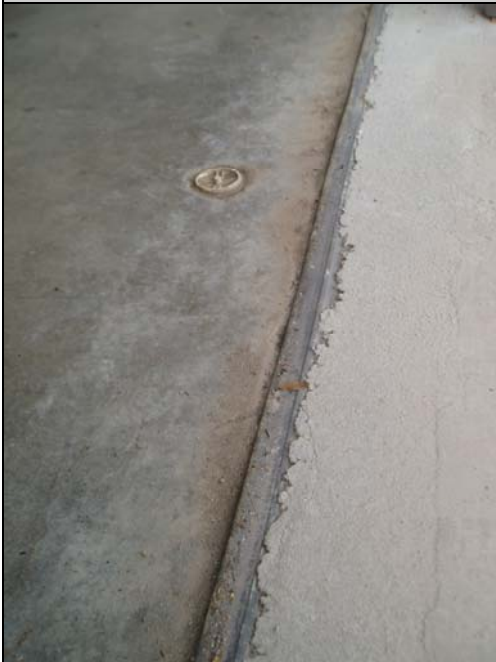
<p>7/26/12 – Photo 20 Unit 15 Threshold</p> <p>Opener Works: <i>None, Rope Installed</i> Lock Condition: <i>Operational, Okay</i> Ceiling Condition: <i>No Stains Present</i> Clean Out Coordination: <i>None</i> Threshold Bar: <i>None</i> Threshold Condition: <i>Fair</i></p>	<p>Note</p>

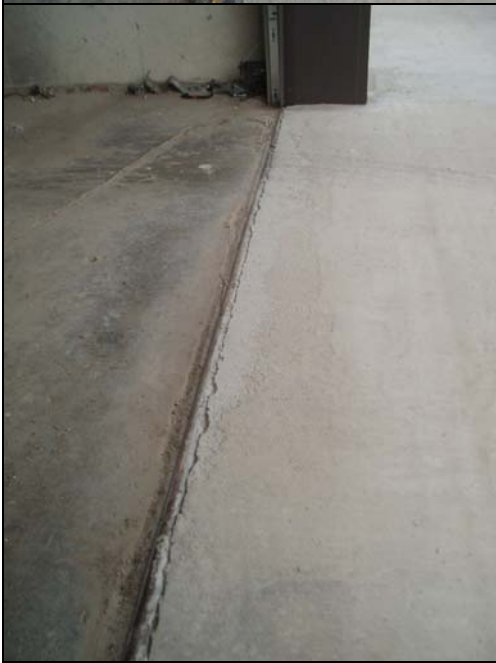
<p>7/26/12 – Photo 21 Unit 16 Threshold</p> <p>Opener Works: <i>Yes</i> Sensors Work: <i>Needs Adjusting</i> Ceiling Condition: <i>No Stains Present</i> Clean Out Coordination: <i>None Noted</i> Threshold Bar: <i>Yes, High On South</i> Threshold Condition: <i>Poor</i></p>	<p>Note</p>

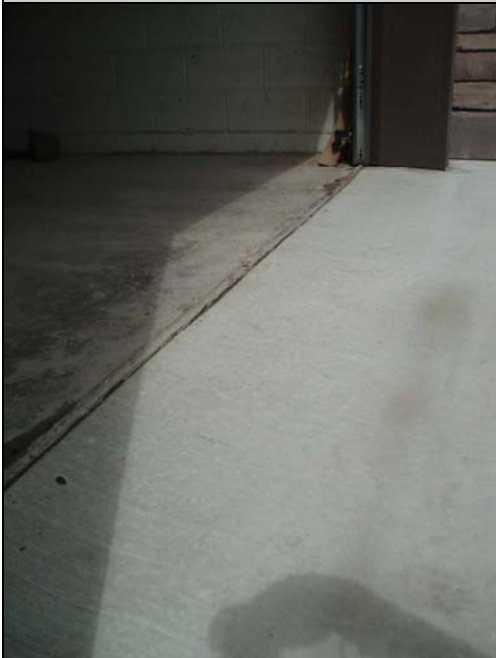
<p>8/02/12 – Photo 24 Unit 19 Threshold</p> <p>Opener Works: <i>Yes</i> Sensors Work: <i>Yes</i> Ceiling Condition: <i>No Stains Present</i> Clean Out Coordination: <i>None Noted</i> Threshold Bar: <i>Yes, Fair</i> Threshold Condition: <i>Poor</i></p>	<p>Note</p>

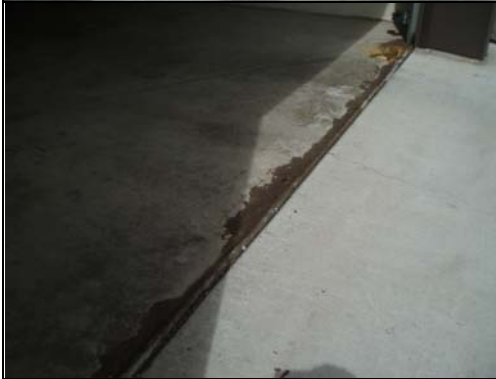
<p>8/02/12 – Photo 25 Unit 20 Threshold</p> <p>Opener Works: <i>Yes</i> Sensors Work: <i>Yes</i> Ceiling Condition: <i>No Stains Present</i> Clean Out Coordination: <i>Yes, Poor</i> Threshold Bar: <i>Yes, Fair</i> Threshold Condition: <i>Poor, Standing Water</i></p>	<p>Note</p>

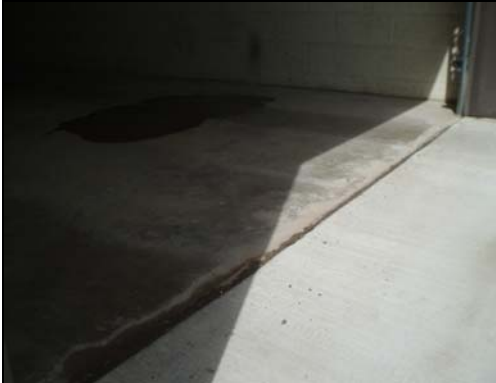
<p>8/02/12 – Photo 26 Unit 21 Threshold</p> <p>Opener Works: <i>Yes</i> Sensors Work: <i>Yes</i> Ceiling Condition: <i>No Stains Present</i> Clean Out Coordination: <i>None Noted</i> Threshold Bar: <i>Yes, Fair</i> Threshold Condition: <i>Poor</i></p>	<p>Note</p>

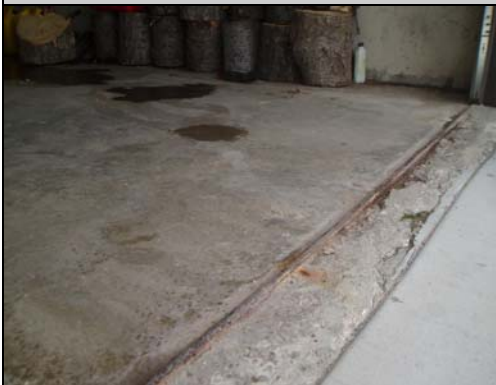
<p>8/02/12 – Photo 31 Unit 25 Threshold</p> <p>Opener Works: <i>None</i> Bolt and Rope: <i>Yes</i> Ceiling Condition: <i>No Stains Present</i> Clean Out Coordination: <i>None Noted</i> Threshold Bar: <i>Yes, Fair</i> Threshold Condition: <i>Poor</i></p>	<p>Note</p>

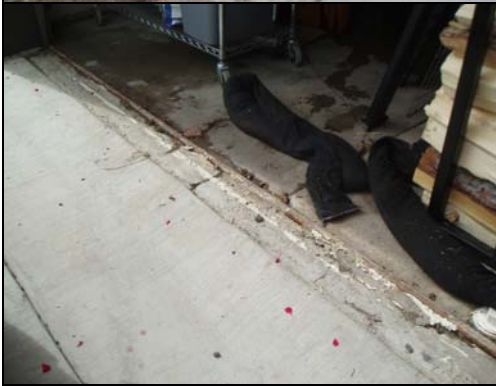
<p>8/02/12 – Photo 32 Unit 26 Threshold</p> <p>Opener Works: <i>Yes</i> Sensors Work: <i>Yes</i> Ceiling Condition: <i>No Stains Present</i> Clean Out Coordination: <i>Yes, Poor</i> Threshold Bar: <i>Yes, Very Poor</i> Threshold Condition: <i>Very Poor</i></p>	<p>Note</p>
 	<p>8/02/12 – Photo 33 Unit 26 Threshold</p> <p>Note cleanout cap plug is directly in the line of the garage door bottom seal, the cap is not vehicle rated, and is a tripping hazard.</p>	<p>Note</p>

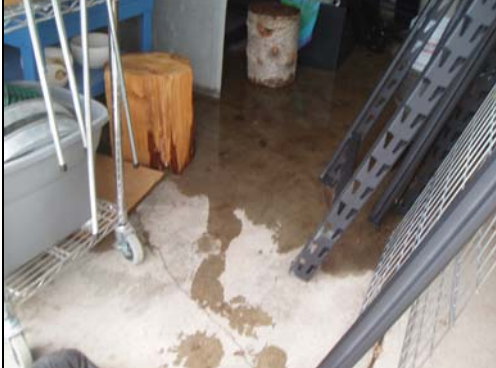
<p>8/02/12 – Photo 34 Unit 26 Standing Water</p> <p>Note large quantity of standing water.</p>	<p>Note</p>

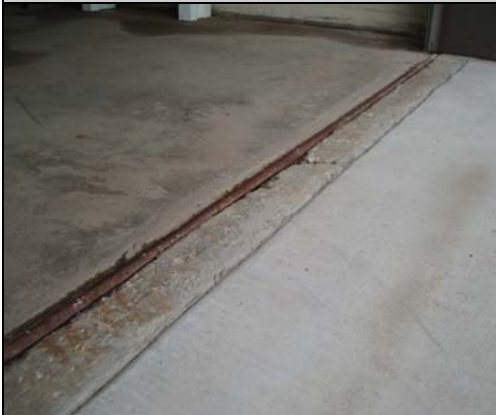
<p>8/02/12 – Photo 39 Unit 31 Threshold</p> <p>Opener Works: Yes Sensors Work: Yes Ceiling Condition: <i>No Stains Present</i> Clean Out Coordination: <i>None Noted</i> Threshold Bar: <i>Yes, Very Poor</i> Threshold Condition: <i>Very Poor, Standing Water</i></p>	<p>Note</p>

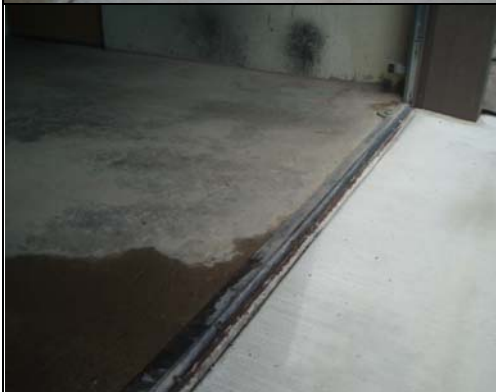
<p>8/02/12 – Photo 40 Unit 32 Threshold North</p> <p>Opener Works: Yes Sensors Work: Yes Ceiling Condition: <i>No Stains Present</i> Clean Out Coordination: <i>Yes, Poor</i> Threshold Bar: <i>Yes, Fair</i> Threshold Condition: <i>Fair, Standing Water</i></p>	<p>Note</p>

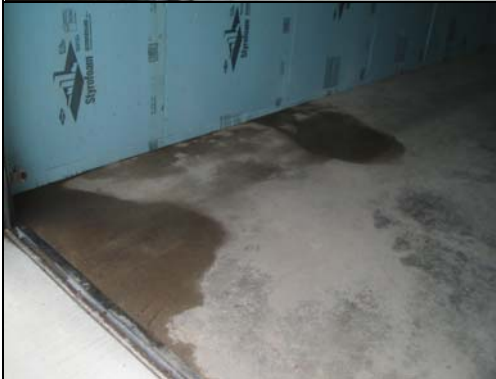
<p>8/02/12 – Photo 41 Unit 32 Threshold South</p> <p>Note standing water.</p>	<p>Note</p>

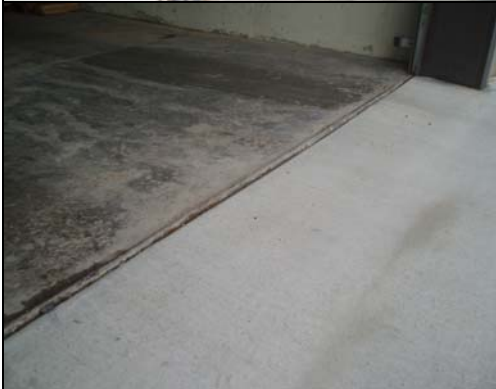
<p>8/02/12 – Photo 42 Unit 33 Threshold</p> <p>Opener Works: Yes Sensors Work: Yes Ceiling Condition: <i>No Stains Present</i> Clean Out Coordination: <i>None Noted</i> Threshold Bar: <i>Yes, Fair</i> Threshold Condition: <i>Fair</i></p>	<p>Note</p>

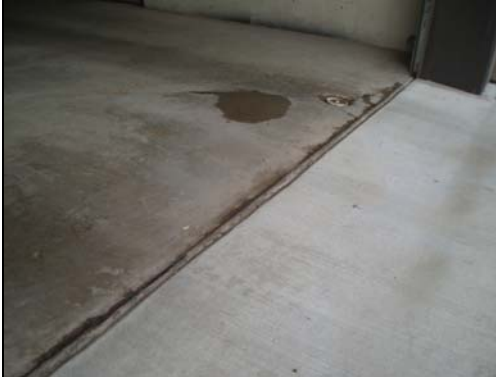
<p>8/02/12 – Photo 46 Unit 36 Threshold</p> <p>Opener Works: Yes Sensors Work: Yes Ceiling Condition: <i>No Stains Present</i> Clean Out Coordination: <i>Yes, Poor</i> Threshold Bar: <i>Yes, Fair</i> Threshold Condition: <i>Fair</i></p>	<p>Note</p>

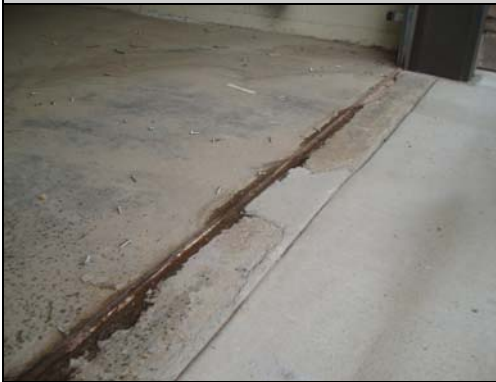
<p>8/02/12 – Photo 47 Unit 37 Threshold</p> <p>Opener Works: <i>Yes</i> Sensors Work: <i>Yes</i> Ceiling Condition: <i>No Stains Present</i> Clean Out Coordination: <i>None Noted</i> Threshold Bar: <i>Yes, Fair</i> Threshold Condition: <i>Fair</i></p>	<p>Note</p>

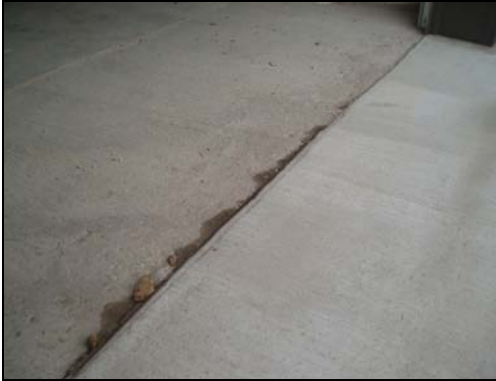
<p>8/02/12 – Photo 48 Unit 38 Threshold</p> <p>Opener Works: <i>No</i> Sensors Work: <i>None Present</i> Ceiling Condition: <i>No Stains Present</i> Clean Out Coordination: <i>None Noted</i> Threshold Bar: <i>None</i> Threshold Condition: <i>Fair</i></p>	<p>Note</p>

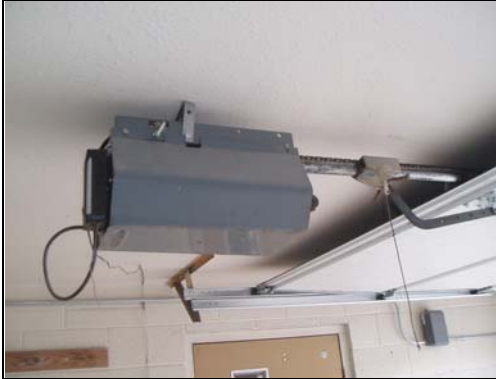
<p>8/02/12 – Photo 49 Unit 38 – Garage Door Opener</p> <p>Note Garage door opener is connected but inoperable. Due to the age and condition of the opener, no work has been performed regarding its operation. Warning: the garage is not secured due to this condition.</p>	<p>ENT CBL</p>

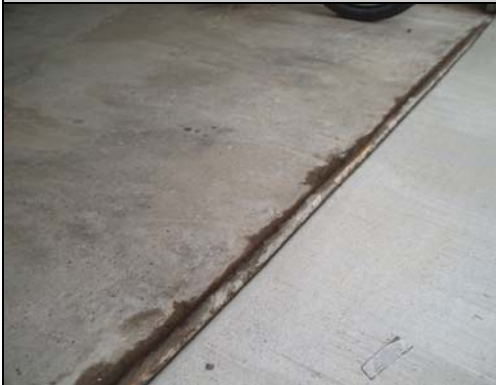
<p>8/02/12 – Photo 50 Unit 39 Threshold</p> <p>Opener Works: <i>Yes</i> Sensors Work: <i>Yes</i> Ceiling Condition: <i>No Stains Present</i> Clean Out Coordination: <i>None Noted</i> Threshold Bar: <i>Yes, Poor</i> Threshold Condition: <i>Poor</i></p>	<p>Note</p>

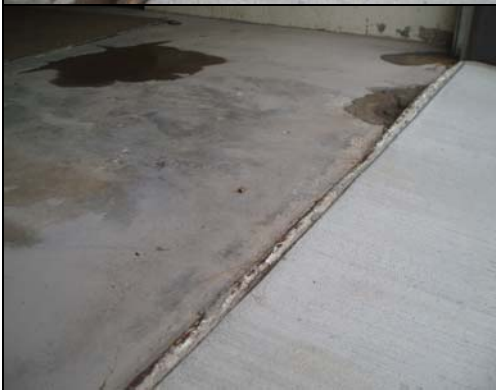
<p>8/02/12 – Photo 51 Unit 40 Threshold</p> <p>Opener Works: <i>None</i> Bolt and Rope: <i>Bolt Bent, No Rope</i> Ceiling Condition: <i>No Stains Present</i> Clean Out Coordination: <i>Yes, Poor</i> Threshold Bar: <i>Yes, Very Poor</i> Threshold Condition: <i>Very Poor</i></p>	<p>MHC</p>
