ARCHITECT'S FIELD REPORT

053

PROJECT	Eagle's Nest Townhouses 11 Morning Glory Way & 31 Marcellina Lane Mt. Crested Butte, CO 81225	DATE	6/08/11
----------------	--	-------------	---------

WORK OBSERVED	
Phase II – Sewer and Asphalt Pre-Construction	
TRADES PRESENT	
Lacy Construction

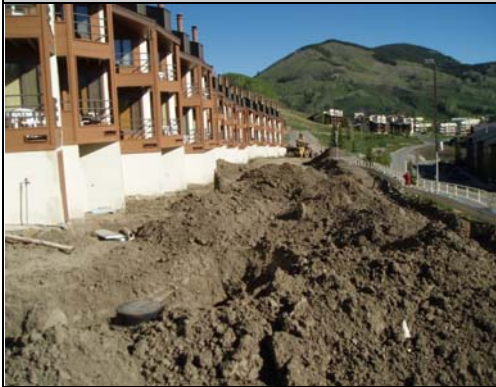
<p>6/08/11 – Photo 1 Lower Level Site Looking North</p> <p>Note Manhole #6 in lower left corner.</p>	<p>Note</p>

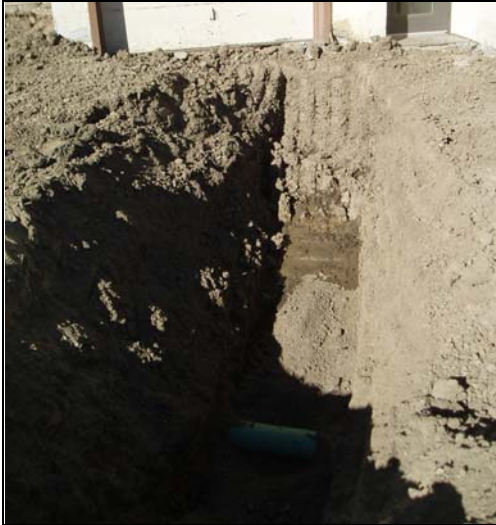
<p>6/08/11 – Photo 2 Lateral Line Excavated at Unit 34</p> <p>Note damp subgrade at base of trench.</p>	<p>Note</p>

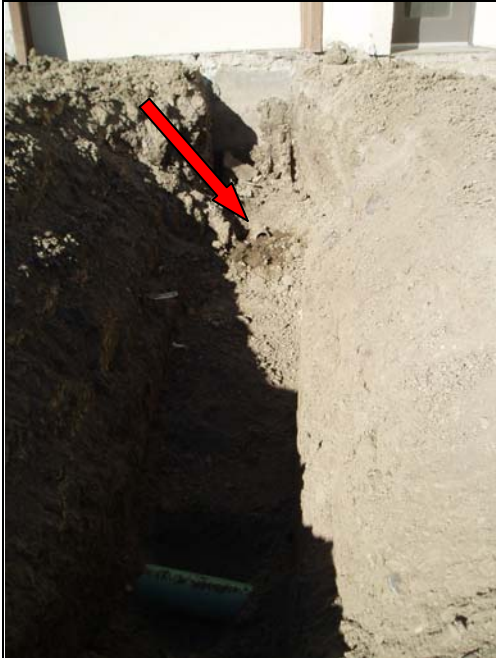
<p>6/08/11 – Photo 3 Lateral Line Excavated at Unit 36</p> <p>Red arrow shows the tie-in. Green sewer line is at the bottom of the picture.</p>	<p>Note</p>

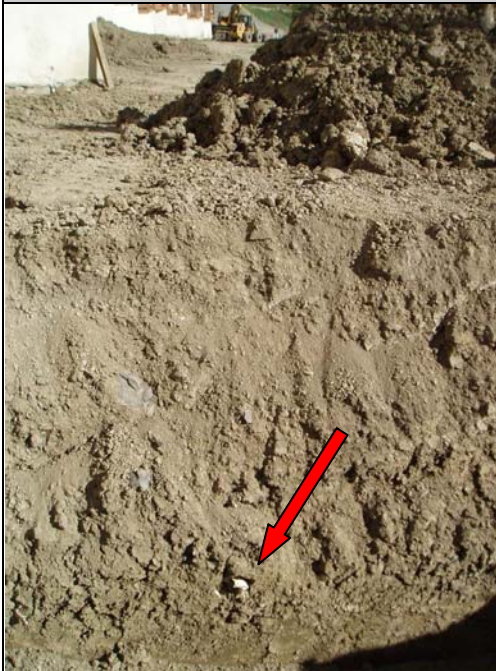
<p>6/08/11 – Photo 4 Lateral Line Excavated at Unit 36</p> <p>Looking South.</p> <p>Red arrow shows the old, abandoned sewer line.</p>	<p>Note</p>

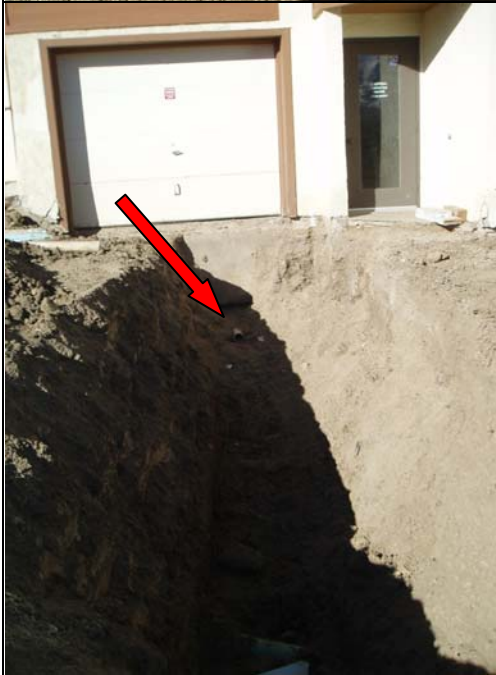
<p>6/08/11 – Photo 5 Lateral Line Excavated at Unit 38</p> <p>Red arrow shows the tie-in. Green sewer line is at the bottom of the picture.</p>	<p>Note</p>

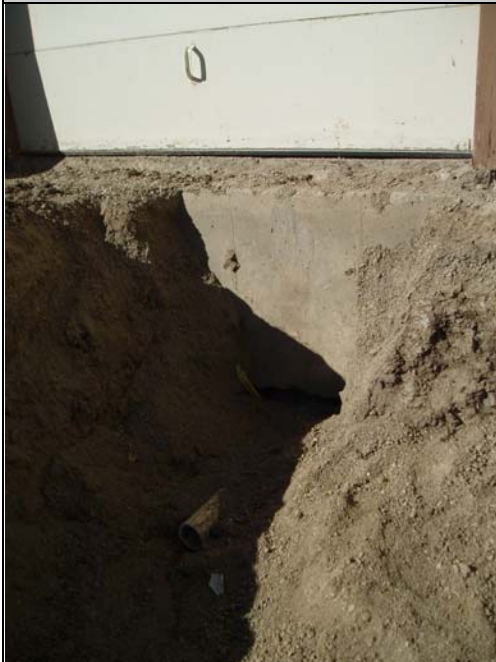
<p>6/08/11 – Photo 6 Lateral Line Excavated at Unit 38</p> <p>Photo shows the foundation below the garage door. There is slight undercut on the foundation.</p> <p>Tie in is located approximately 4 feet below grade.</p>	<p>Note</p>

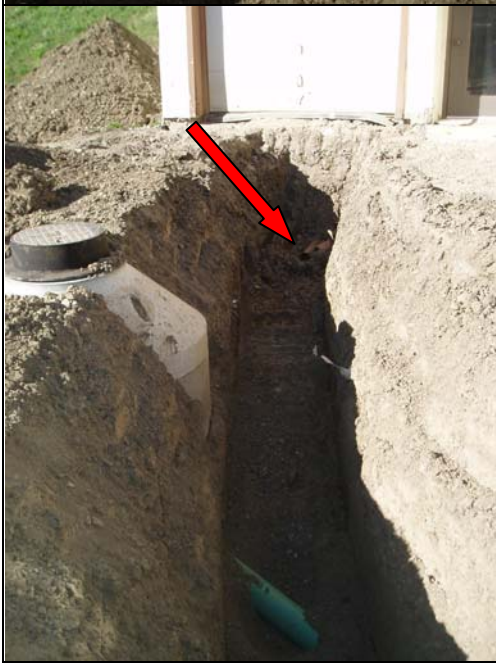
<p>6/08/11 – Photo 7 Lateral Line Excavated at Unit 40</p> <p>Red arrow shows the tie-in. Green sewer line is at the bottom of the picture.</p> <p>Manhole #6 is on the left.</p>	<p>Note</p>

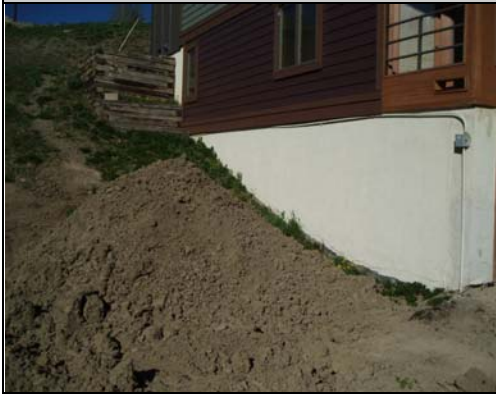
<p>6/08/11 – Photo 8 South of Unit 40</p> <p>Stockpile is located south of Unit 40 on Eagle’s Nest property. However, any runoff could flow downhill off the property.</p>	<p>Note</p>

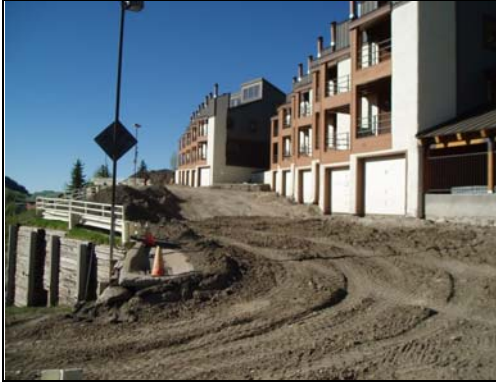
<p>6/08/11 – Photo 9 Upper Level Parking</p> <p>Potholing in this area revealed the location of the main Upper Level sewer. This line can be used.</p>	<p>Note</p>

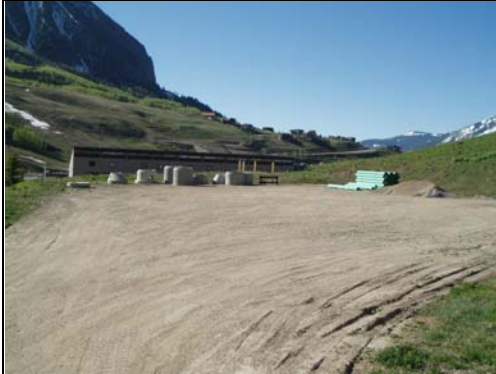
<p>6/08/11 – Photo 10 Material Stockpile</p> <p>Material stockpiled at the lot below the lower level.</p>	<p>Note</p>
