ARCHITECT'S FIELD REPORT

026

PROJECT	Eagle's Nest Townhouses 11 Morning Glory Way & 31 Marcellina Lane Mt. Crested Butte, CO 81225	DATE	12/08/10 Revised 12/10/10
----------------	--	-------------	--

WORK OBSERVED	
Phase I – Construction	
TRADES PRESENT	
Holgate Construction Company

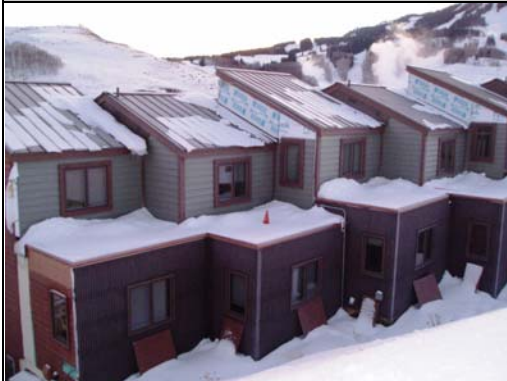
<p>12/08/10 – Photo 1 Units 17 through 20</p> <p>Electrical Conduit is in place. No change otherwise.</p>	<p>None</p>

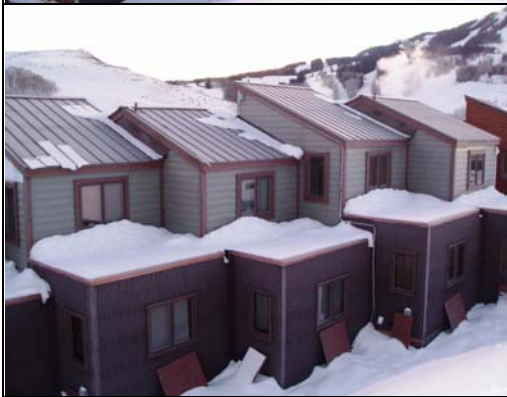
<p>12/08/10 – Photo 2 Units 21 through 24</p> <p>Unit 23 complete. Electrical conduit in place.</p>	<p>None</p>

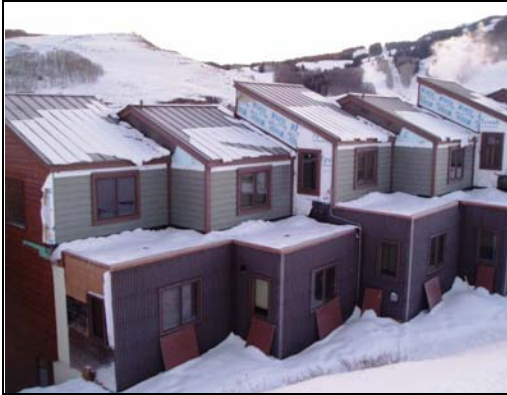
<p>12/08/10 – Photo 3 Units 25 through 28</p> <p>Electrical conduit. Otherwise no change from previous week.</p>	<p>None</p>

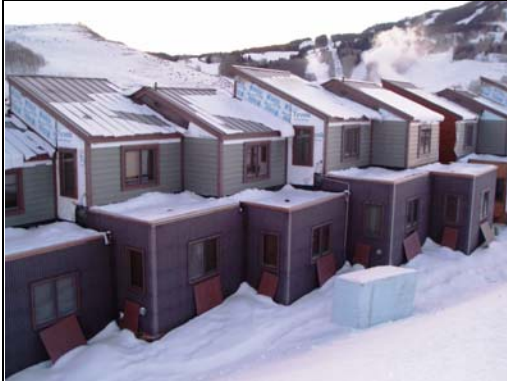
<p>12/08/10 – Photo 4 Units 29 through 32</p> <p>Electrical conduit. Otherwise no change from previous week.</p>	<p>None</p>

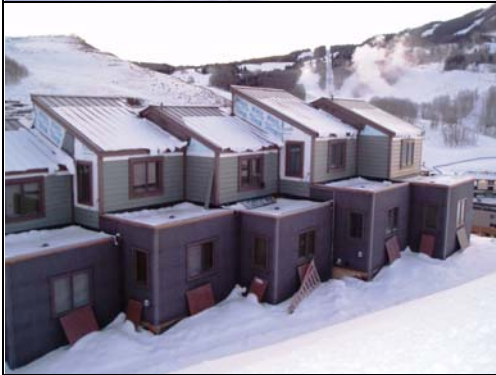
<p>12/08/10 – Photo 6 Units 37 through 40</p> <p>Electrical conduit. Otherwise no change from previous week. Note: Horizontal stripping on brown corrugated metal is frost and furring strips below. Typical and expected condition.</p>	<p>None</p>

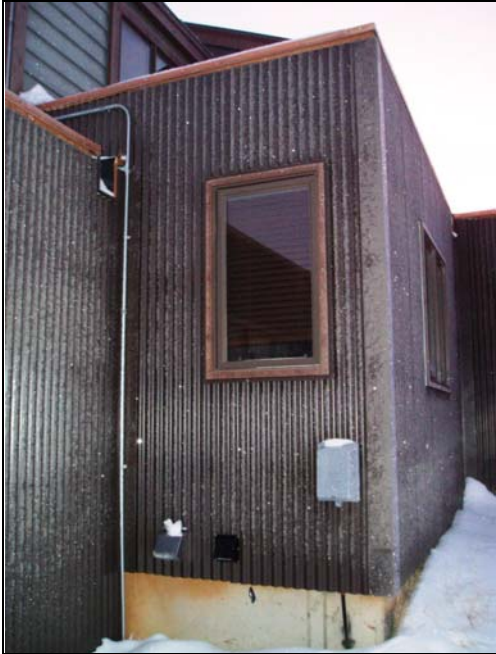
<p>12/08/10 – Photo 7 Unit 35</p> <p>Note electrical conduit attached to corner trim, exhaust vents and cable box installation complete. Awaiting installation of parapet cap.</p>	<p>None</p>

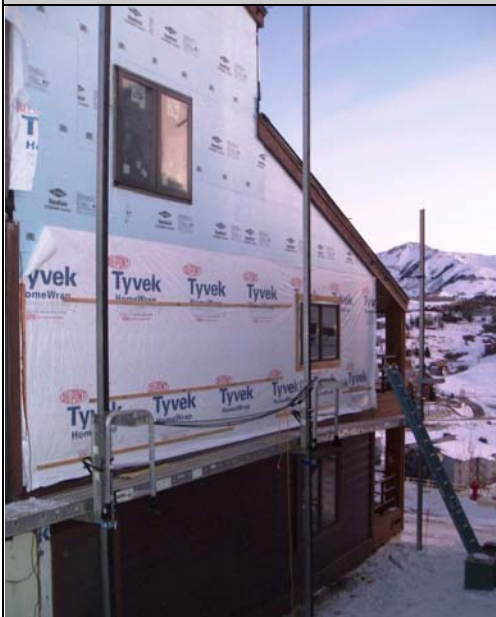
<p>12/08/10 – Photo 8 Unit 9 – End Elevation</p> <p>Siding installation is 60% complete. Awaiting upper window trim and green horizontal siding.</p>	<p>None</p>

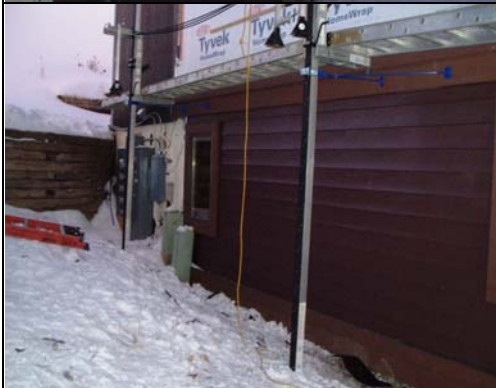
<p>12/08/10 – Photo 9 Unit 9 – End Elevation</p> <p>Brown horizontal siding is complete on the 2nd level.</p> <p>Note: corrugated metal installed on rear elevation, 3rd floor.</p>	<p>None</p>

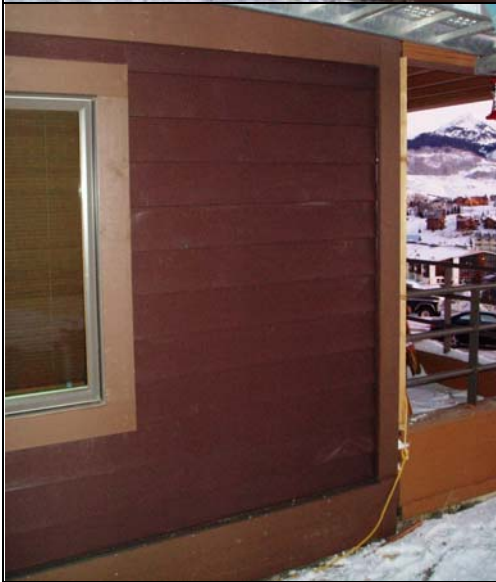
<p>12/08/10 – Photo 10 Unit 9 End Elevation</p> <p>Detail of brown horizontal siding installation.</p> <p>Note: Bottom 3 courses align with bottom of window trim. Metal siding is also installed above the top window trim and upper wood belly band – this detail is an improvement from the design documents.</p>	<p>None</p>

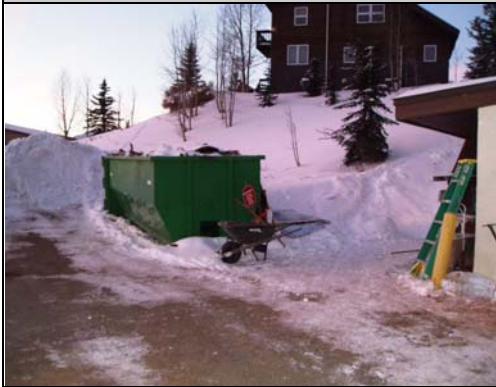
<p>12/08/10 – Photo 15 Upper Level Work Area</p> <p>Dumpster is full and ready to be removed for the holiday break. Snow removal is unhindered.</p>	<p>None</p>

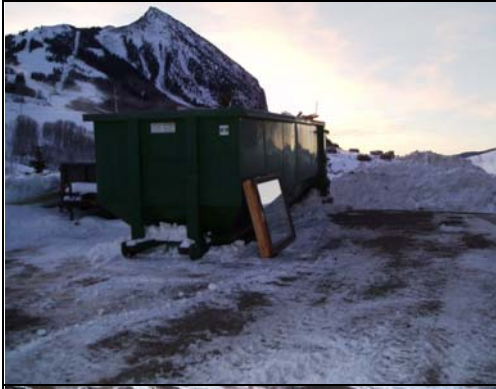
<p>12/08/10 – Photo 16 Lower Level Work Area</p> <p>Dumpster is full and out of the way for snow removal.</p>	<p>None</p>

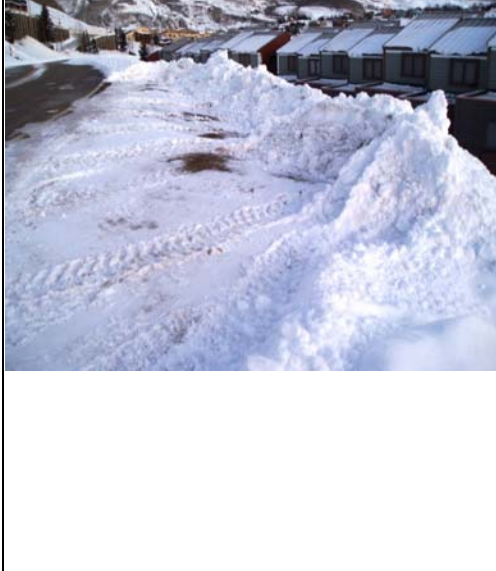
<p>12/08/10 – Photo 17 Lower Level – Morning Glory Way</p> <p>Note: City is pushing snow from the road into the site. This practice could add to larger snow piles behind the units and additional moisture in the crawlspaces during the spring melt.</p> <p>12/10/10 Note: Subsequent conversations with Mick Holgate determined that this work was done by MHC to clear an area to stage materials and not done by the Town of Mt. Crested Butte. - BW</p>	<p>None</p>
