# ARCHITECT'S FIELD REPORT

054

<b>PROJECT</b>	<b>Eagle's Nest Townhouses</b> 11 Morning Glory Way & 31 Marcellina Lane Mt. Crested Butte, CO 81225	<b>DATE</b>	6/15/11
----------------	--	-------------	---------

WORK OBSERVED	
Phase II – Sewer and Asphalt	
TRADES PRESENT	
Lacy Construction

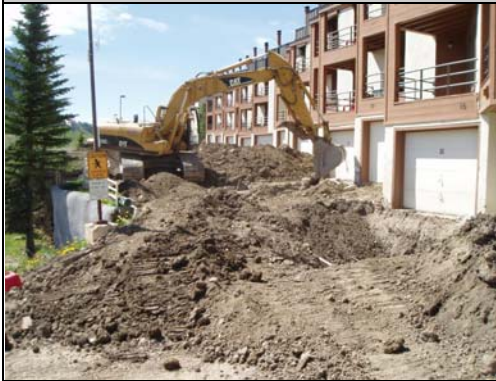
<p>6/13/11 – Photo 1 Lower Level Driveway &amp; Parking</p> <p>Trench bottom compaction is underway. Lateral sewer lines are installed.</p> <p>(Please note photos 1 through 10 were taken on Monday.)</p>	<p>Note</p>

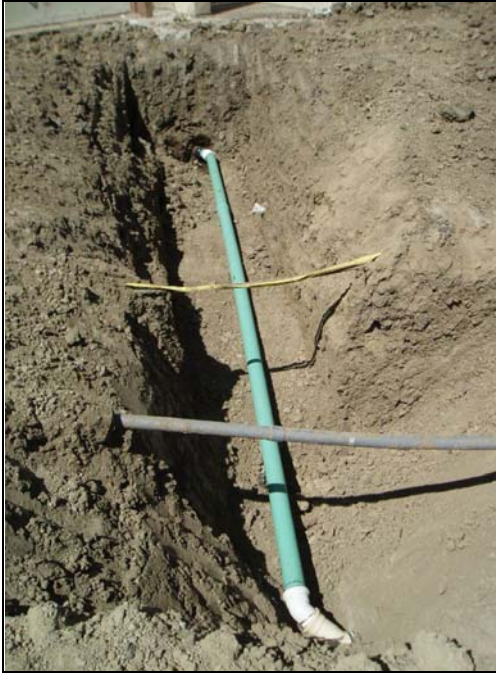
<p>6/13/11 – Photo 2 Unit 26</p> <p>Lateral line is installed.</p>	<p>Note</p>

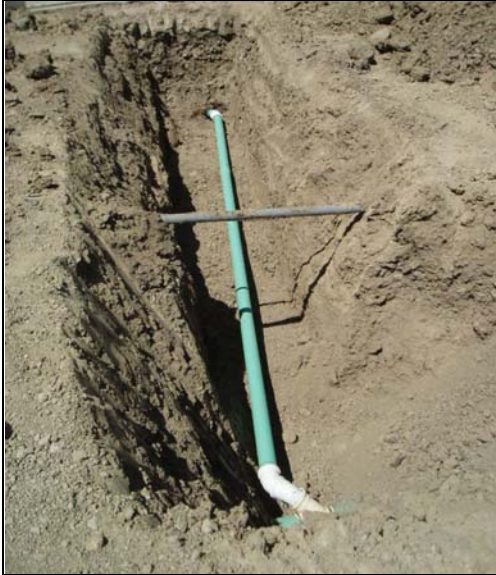
<p>6/13/11 – Photo 3 Unit 28</p> <p>Lateral line is installed.</p>	<p>Note</p>

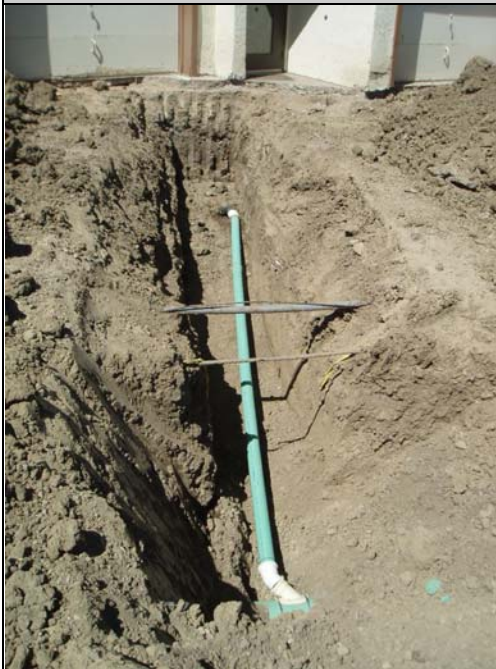
<p>6/13/11 – Photo 4 Unit 30</p> <p>Lateral line is installed.</p>	<p>Note</p>

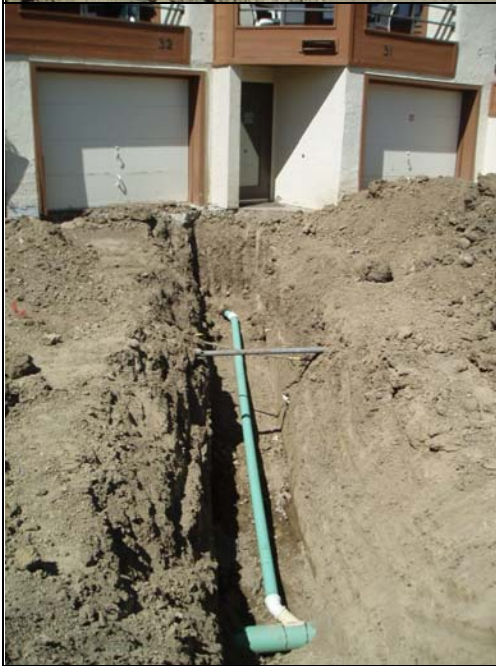
<p>6/13/11 – Photo 5 Unit 32</p> <p>Lateral line is installed.</p>	<p>Note</p>

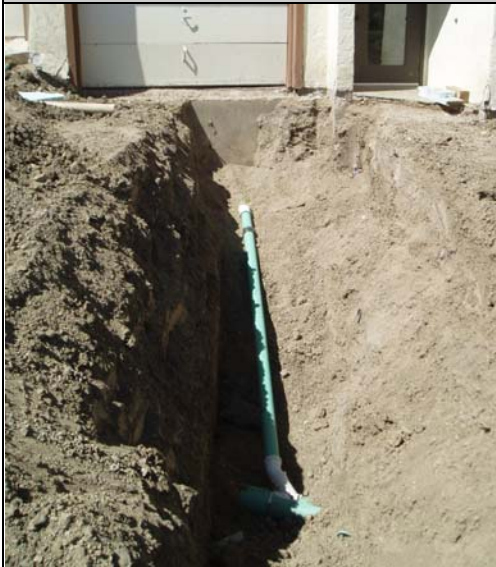
<p>6/13/11 – Photo 8 Unit 38</p> <p>Lateral line is installed.</p>	<p>Note</p>
 	<p>6/13/11 – Photo 9 Unit 40</p> <p>Lateral line is installed.</p>	<p>Note</p>
 	<p>6/13/11 – Photo 10 Inside Manhole #6</p> <p>The blue hose is for testing the new pipe.</p>	<p>Note</p>

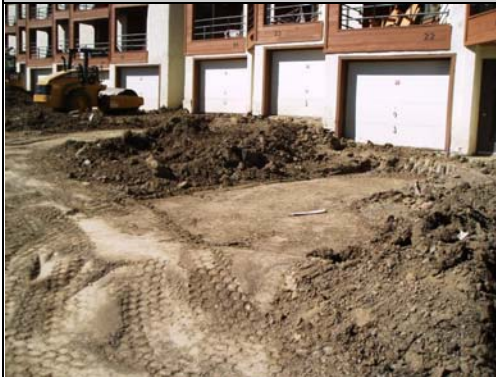
<p>6/15/11 – Photo 14 Lower Level Units</p> <p>Lateral sewer lines are buried and roller is providing final compaction. (Visible in top left of photo.)</p>	<p>Note</p>

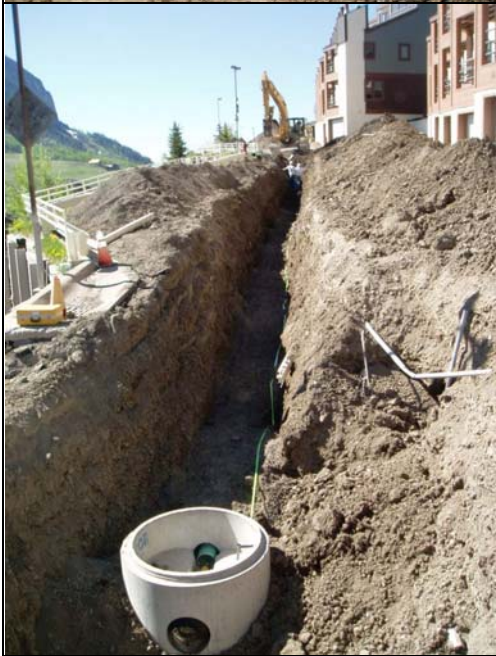
<p>6/15/11 – Photo 15 Upper Level Driveway &amp; Parking</p> <p>Main sewer trench is underway. Trench has been excavated from Manhole #2 to Unit #8.</p> <p>The base of Manhole #2 is visible at the bottom of the photo.</p>	<p>Note</p>

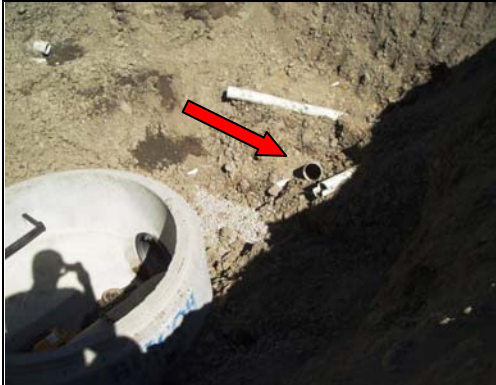
<p>6/15/11 – Photo 16 Upper Level Sewer Tie-in</p> <p>The red arrow shows the existing 6" sewer line tie-in.</p>	<p>Note</p>

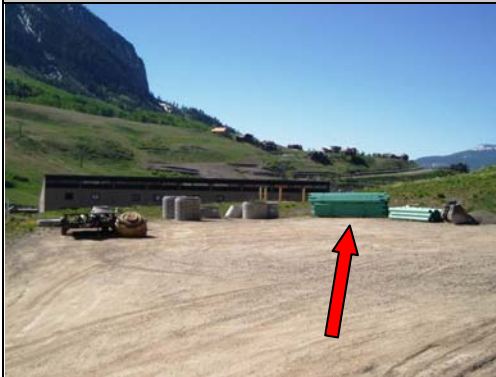
<p>6/15/11 – Photo 17 Materials Stored at the Lower Level</p> <p>Arrow points to sewer line delivered for the Upper Level.</p>	<p>Note</p>

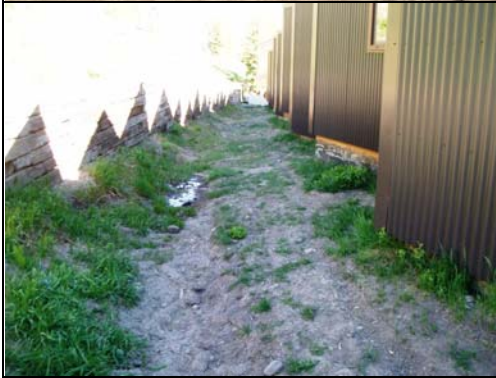
<p>6/15/11 – Photo 18 Building C – Clean-Up Condition</p> <p>Holgate Construction has finished site clean-up and contacted the Building Department for a follow-up inspection.</p>	<p>Note</p>

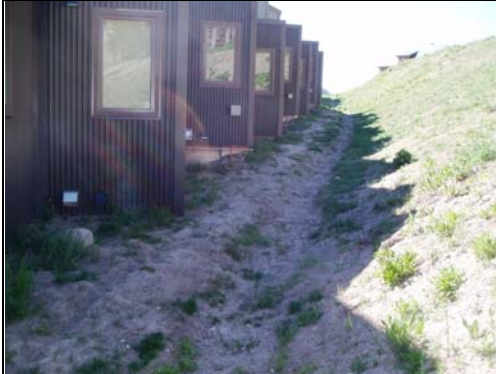
<p>6/15/11 – Photo 19 Building D – Clean-Up Condition</p> <p>Site is clean.</p>	<p>Note</p>
