**ARCHITECT'S FIELD REPORT**

**090**

<b>PROJECT</b>	<b>Eagle's Nest Townhouses</b> 11 Morning Glory Way & 31 Marcellina Lane Mt. Crested Butte, CO 81225	<b>DATE</b>	9/19/12
----------------	--	-------------	---------

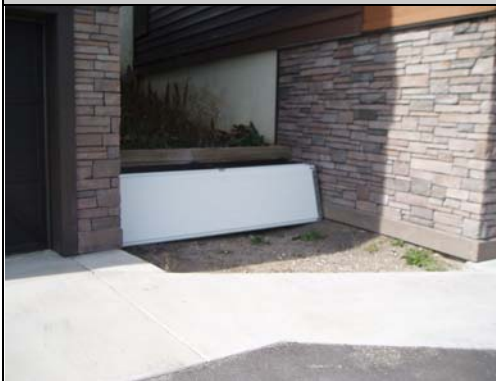
<p>9/19/12 – Photo 1 Lower Level Units</p> <p>Wavy garage doors have been exchanged. Extra usable panels (total of 6) can be stored in the Maintenance Shed.</p>	<p>Note</p>

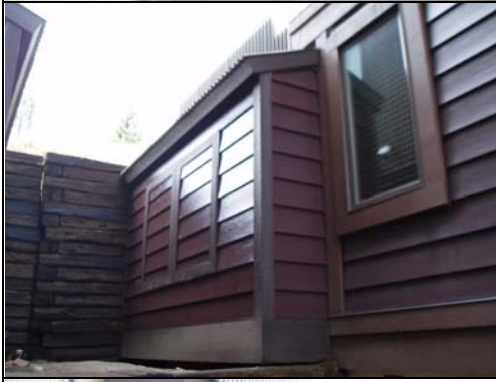
<p>9/19/12 – Photo 2 Unit 32 Electrical Meter Cover</p> <p>Meter cover is finished.</p>	<p>Note</p>

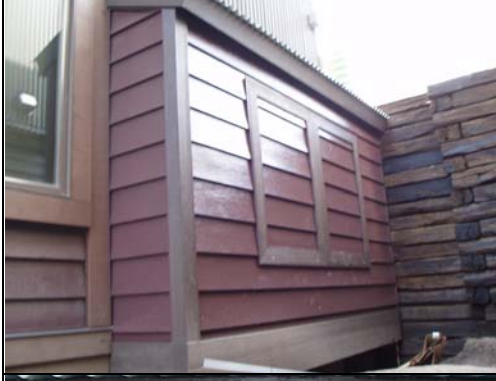
<p>9/19/12 – Photo 3 Unit 33 Electrical Meter Cover</p> <p>Meter cover is finished.</p>	<p>Note</p>

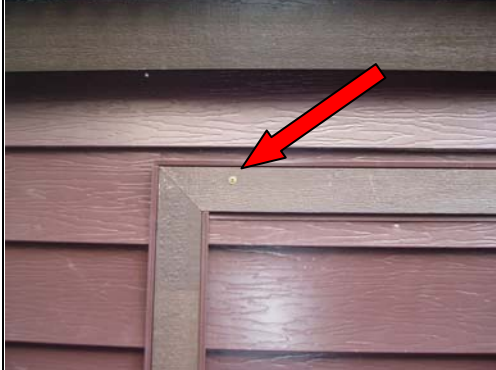
<p>9/19/12 – Photo 4 Unit 33 Electrical Meter Cover Detail</p> <p>Note star-head attachment screw for meter cover door.</p>	<p>Note</p>

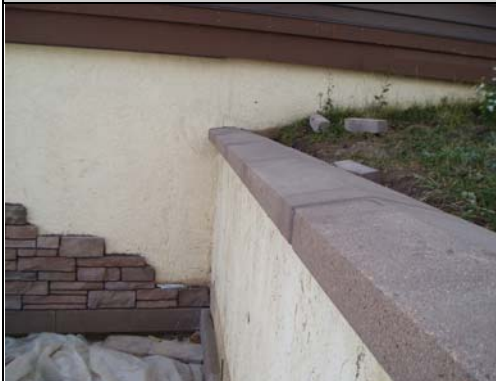
<p>9/19/12 – Photo 9 Retaining Wall at Units 8 &amp; 9</p> <p>Precast cap is in place.</p>	<p>Note</p>

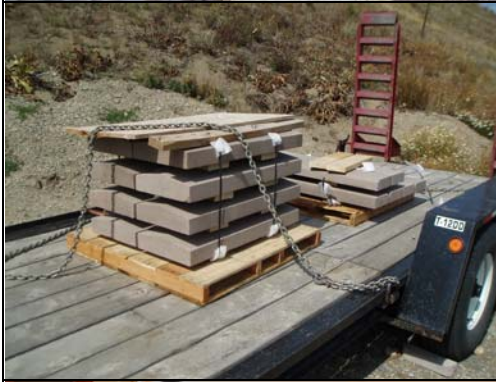
<p>9/19/12 – Photo 10 Upper Level North Storage Area</p> <p>Precast cap and base for the Upper Level Hot Tub area is on-site.</p>	<p>Note</p>

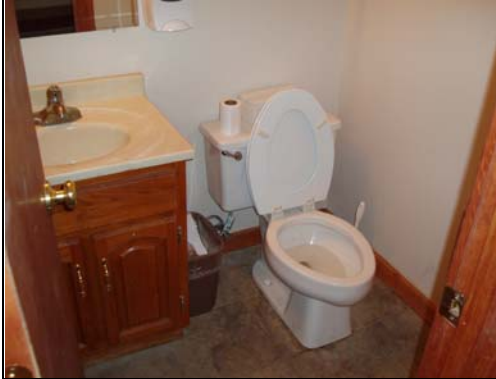
<p>9/19/12 – Photo 11 Upper Level Restroom</p> <p>Restroom is relatively clean.</p>	<p>Note</p>

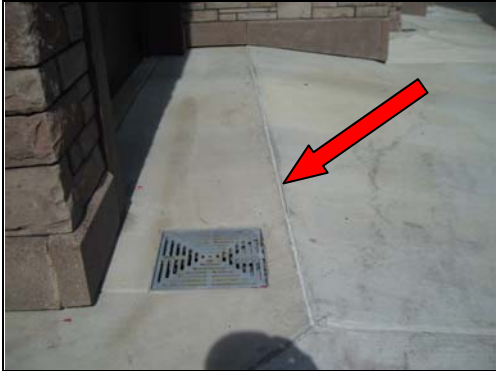
<p>9/19/12 – Photo 12 Unit 23 Apron</p> <p>Sealant between valley pan and apron is in place. (Grey caulk line at red arrow.)</p>	<p>Note</p>

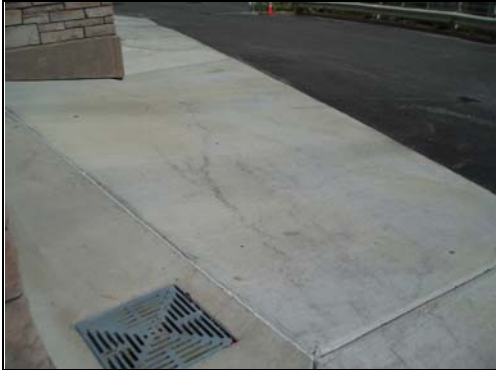
<p>9/19/12 – Photo 13 Unit 23 Apron</p> <p>With sealant in place, the asphalt leak can be inspected after the next rain.</p>	<p>BWA</p>
