**ARCHITECT'S FIELD REPORT**

**060**

<b>PROJECT</b>	<b>Eagle's Nest Townhouses</b> 11 Morning Glory Way & 31 Marcellina Lane Mt. Crested Butte, CO 81225	<b>DATE</b>	9/01/11
----------------	--	-------------	---------

<b>WORK OBSERVED</b>	
Phase II – Garage Apron Photos from Owner Punch List Items	
<b>TRADES PRESENT</b>	
None

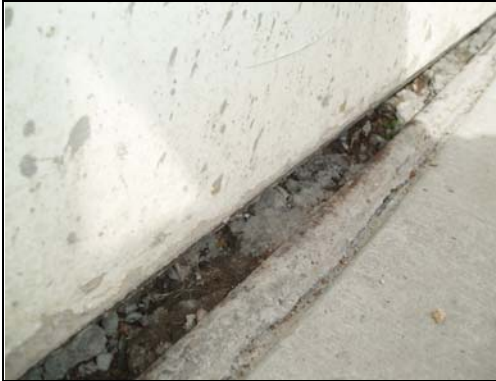
<p>9/01/11 – Photo 5 Unit 3 Mid Threshold</p> <p>Detail of garage door threshold.</p>	<p>Note</p>

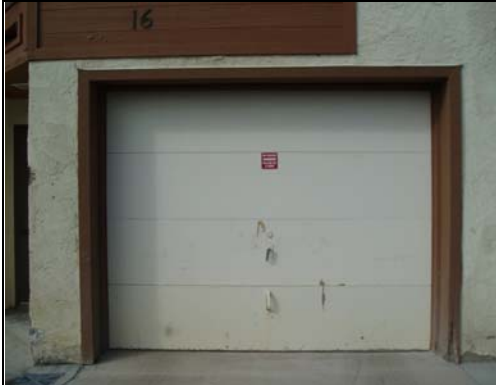
<p>9/01/11 – Photo 24 Unit 16</p>	<p>Note</p>
 	<p>9/01/11 – Photo 25 Unit 16</p> <p>Threshold</p>	<p>Note</p>
 	<p>9/01/11 – Photo 26 Unit 16 North Threshold Outside Valley Pan Slope: CORRECT</p>	<p>Note</p>
